WEEKLY LIST OF ACTIONS TAKEN ON PROPERTIES: 12/10/2021 THROUGH 12/15/2021

COLORADO, LARIMER COUNTY,
Fall River Pass Historic District,
Fall River Pass, Rocky Mountain National Park,
Estes Park vicinity, MP100007216,
LISTED, 12/10/2021
(Historic Park Landscapes in National and State Parks MPS)

Historic Photos and Drawings

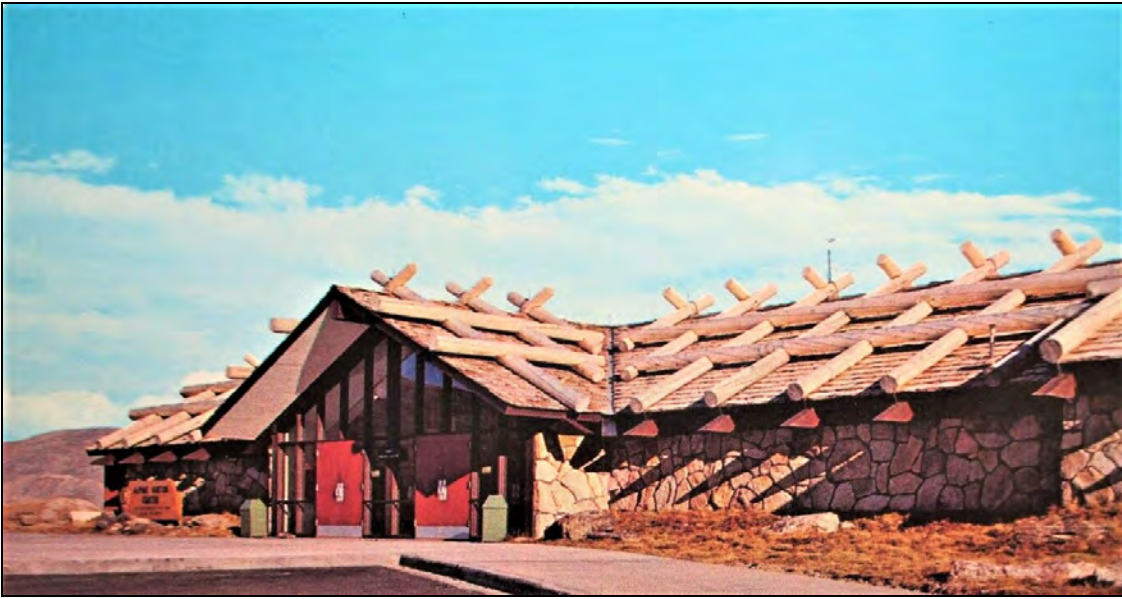
Figure 1 - Alpine Visitor Center c.1970 (Source: <https://www.ebay.com>)

In *The Mission 66 Program at Rocky Mountain National Park: 1947-1973* (2010), historians Janet Ore and Maren Bzdek described this building "as Rocky Mountain's first and most unaltered Mission 66 visitor center," recognizing it as important for its association with Mission 66 and as an intact example of Park Service Modern architecture. Exterior changes included the replacement of the original red-painted front doors, addition of satellite dishes and utility piping, design and material changes to the barrier on the rear terrace, and a new door into the clinic. Interior changes are far more extensive with a major renovation in 1986 and the conversion of the apartments into the clinic and offices in 1998-1999.

There have been very few exterior changes to the Alpine Visitor Center since construction. Early postcards show wood front doors painted a rusty red (Figure 1). The change from these original doors to the current glass doors likely occurred in 1986 when the "lobby at the Alpine Visitor Center was completely renovated" (Superintendent Report, 1986). As materials on the rear terrace deteriorated, the park has replaced them numerous times and modified the design by adding a "barrier" of latticework; an undated historic drawing from the Rocky Mountain National Park archives showed this portion of the terrace with simple, wood rails. The park has installed numerous small satellite dishes to support both park operations and the Rocky Mountain Conservancy retail store plus provide internet service to park employees. The dishes are all located on the rear (south) side of the roof and are not visible from the front. As utilities have been upgraded over time, utility pipes have been removed and added. For example, the 500-gallon underground propane tank was abandoned in 2008 and replaced with a new 1000-gallon underground tank. This alteration required installation of steel gas piping attached to the exterior of the building. A new metal door was added to the northwest corner of the building in ca. early 2000s as part of the alterations for the small medical clinic. The building received a new roof in 2008, with replacement in kind of all materials.

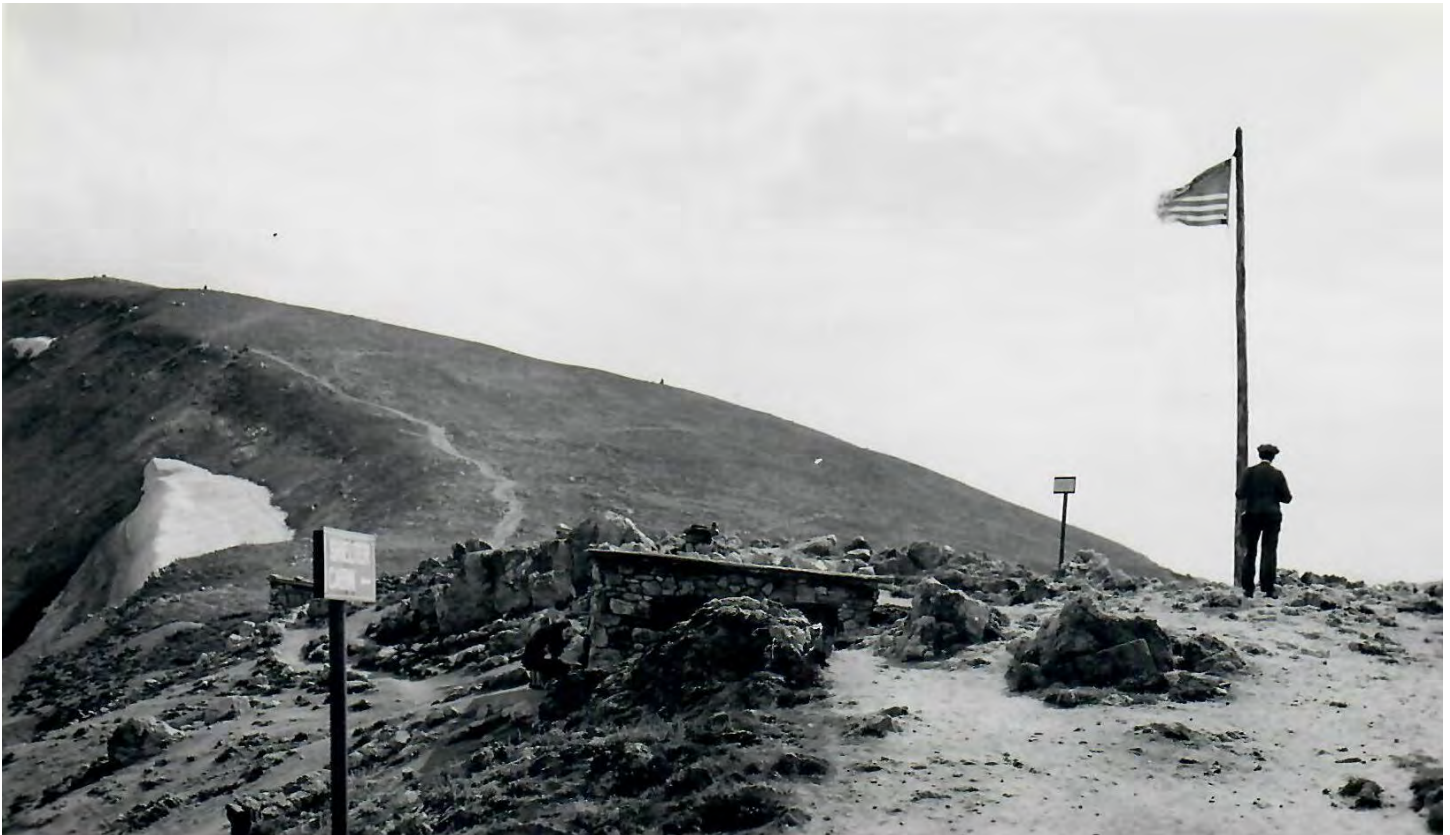
Figure 2 - Fall River Pass Ranger Station/Museum ca. 1932-1936 (Source: ROMO-11-Q-3, neg. 5577)

The NPS Rustic building, constructed in 1922, served as a warming hut, rest house, and Ranger Station. Its use and architecture both reflect the rather meager offerings available to visitors during the earliest years of public access to Fall River Pass. With the arrival of Trail Ridge Road in 1932, visitor demand for interpretation encouraged the park to create a small museum. The limited exhibits within the former Ranger Station proved exceedingly popular, attracting crowds far larger than practical for such a small venue. Also visible in this photo is a second stone building (behind the sign) and a trail that is still apparent - though unused - today.

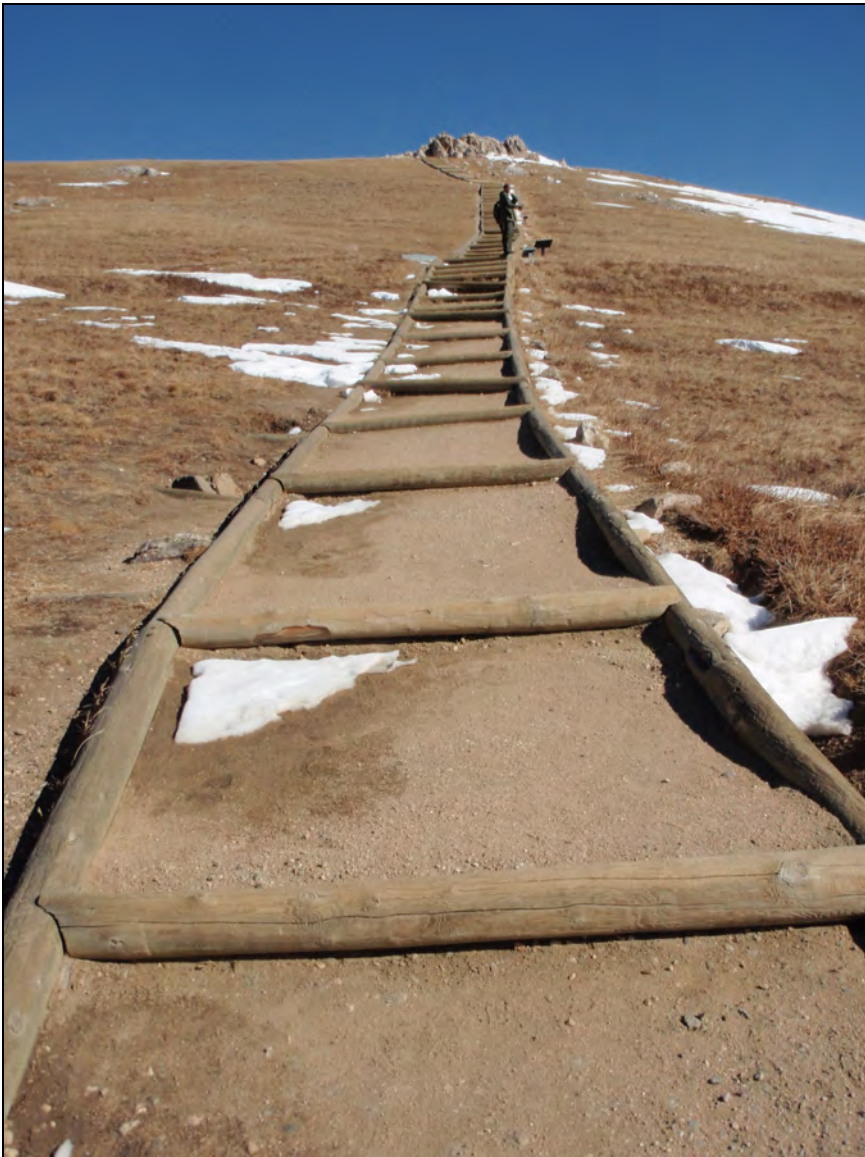
Figure 3 – Alpine Ridge Trail 2008 (Source: NPS-ROMO-Trail Crew)

The current alignment of the Alpine Ridge Trail is based upon a social trail that visitors developed, creating the most direct route to the summit but trampling the fragile alpine tundra plants. Over the years park trails crews have experimented with materials that not only withstand the site's harsh weather conditions but also serve as the most sustainable option.

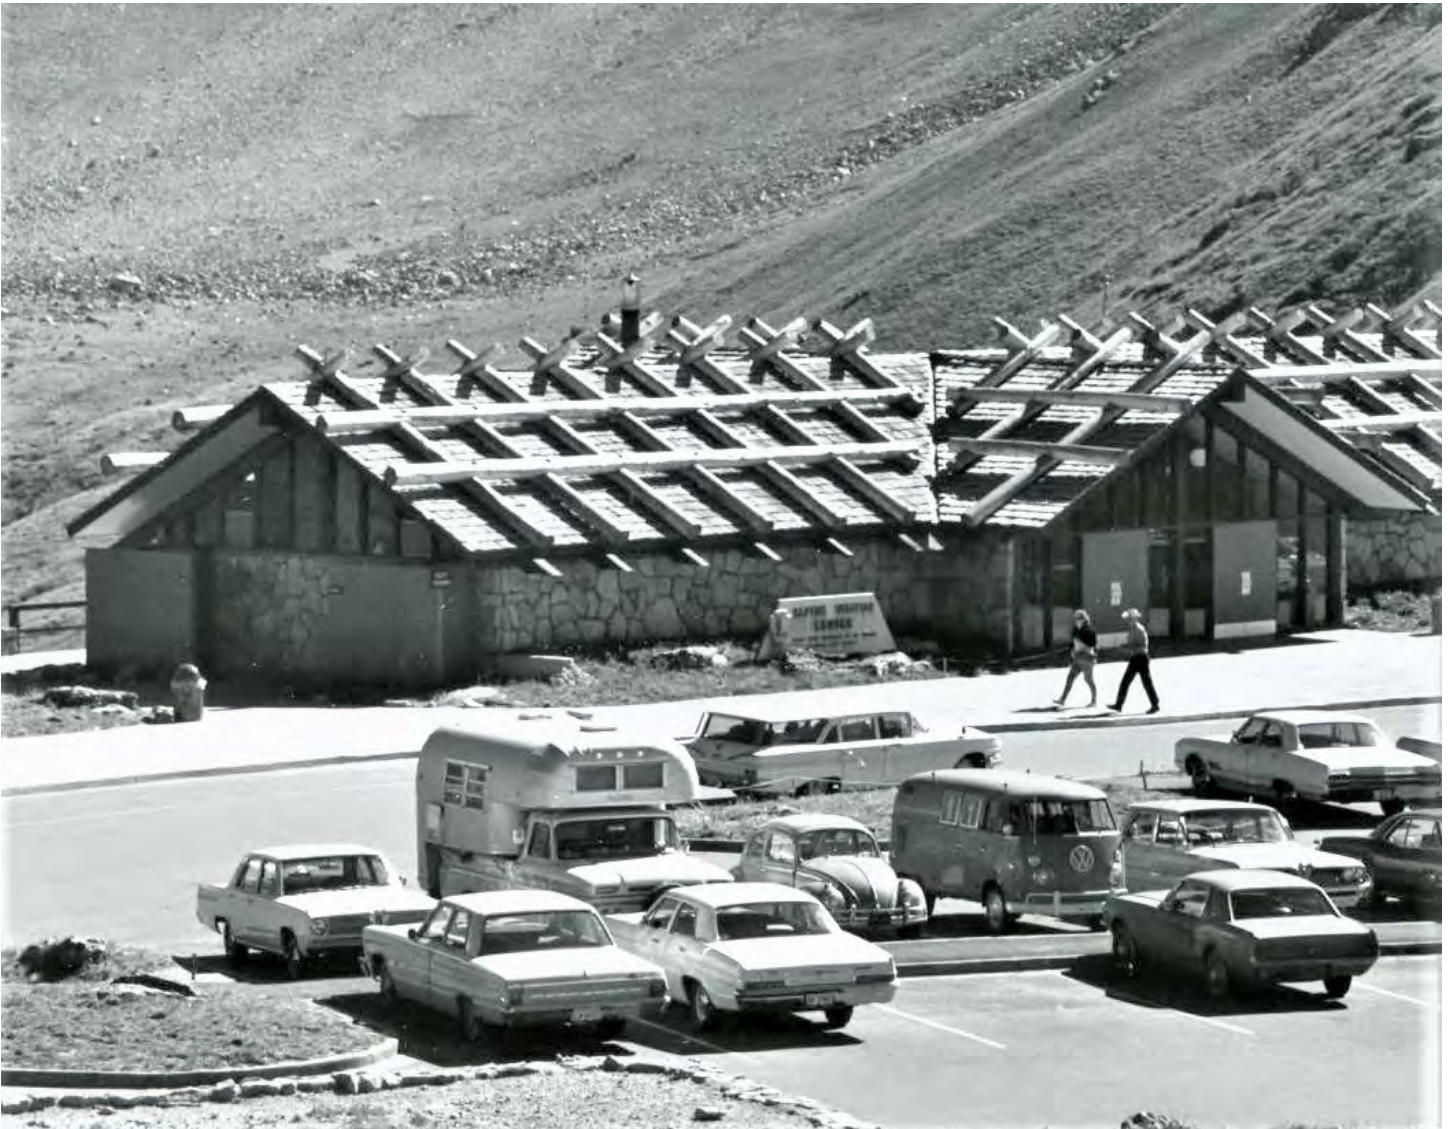
Figure 4 - Alpine Visitor Center Public Plaza c. 1970s (Source: ROMO_121_P7_ALPINE VISITOR CENTER)
The photograph and architectural drawing (Figure 5) highlight one of the minor alterations to the Public Plaza. Both images show a small landscaped island with a few rocks and very low vegetation. It is not clear when the landscaped island at the corner of the Public Plaza was removed. However, it seems likely such formal landscaping proved difficult to maintain due to not only the large number of visitors but also the extreme weather conditions of the site.

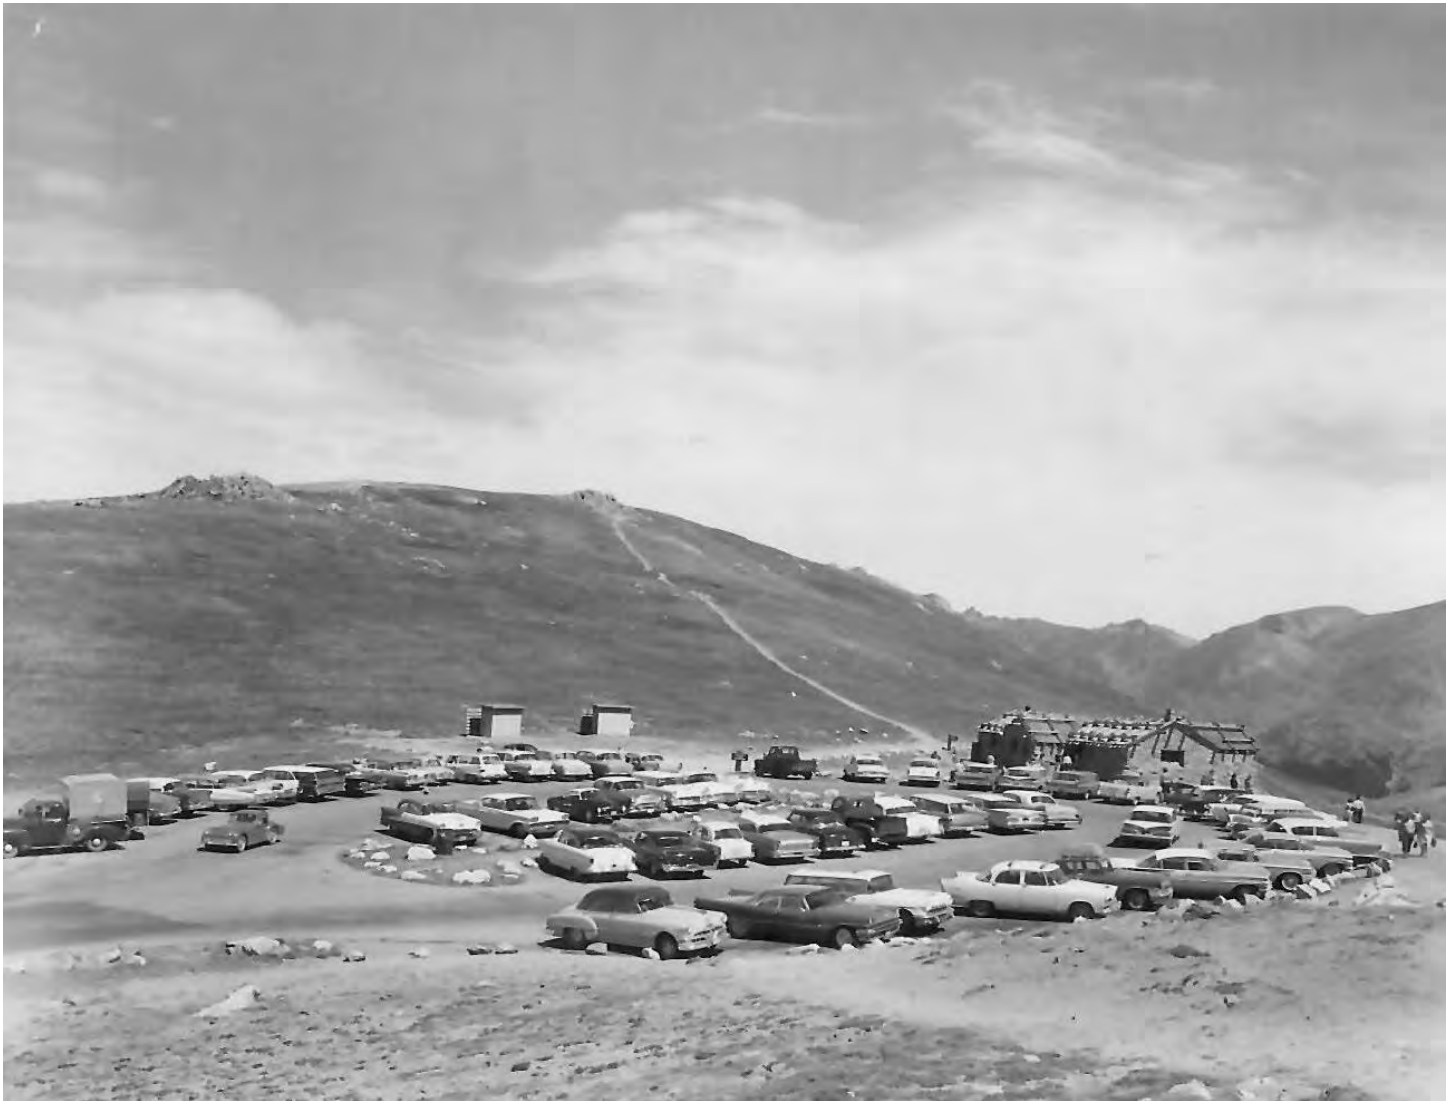
Figure 6 -Fall River Pass August 1959 (Source: ROMO-11-Q-2-a, neg 5638)

This historic image from 1959 shows the Trail Ridge Store, Alpine Ridge Trail, and the parking lot. This image pre-dates numerous Mission 66-era improvements, most notably construction of the Generator House, erection of numerous concrete and stone veneered walls to protect the fragile alpine tundra, and hardening of the path to the summit of "Huffer Hill." The grid of peeled logs was removed from the roof of the Trail Ridge Store in the late-1960s.

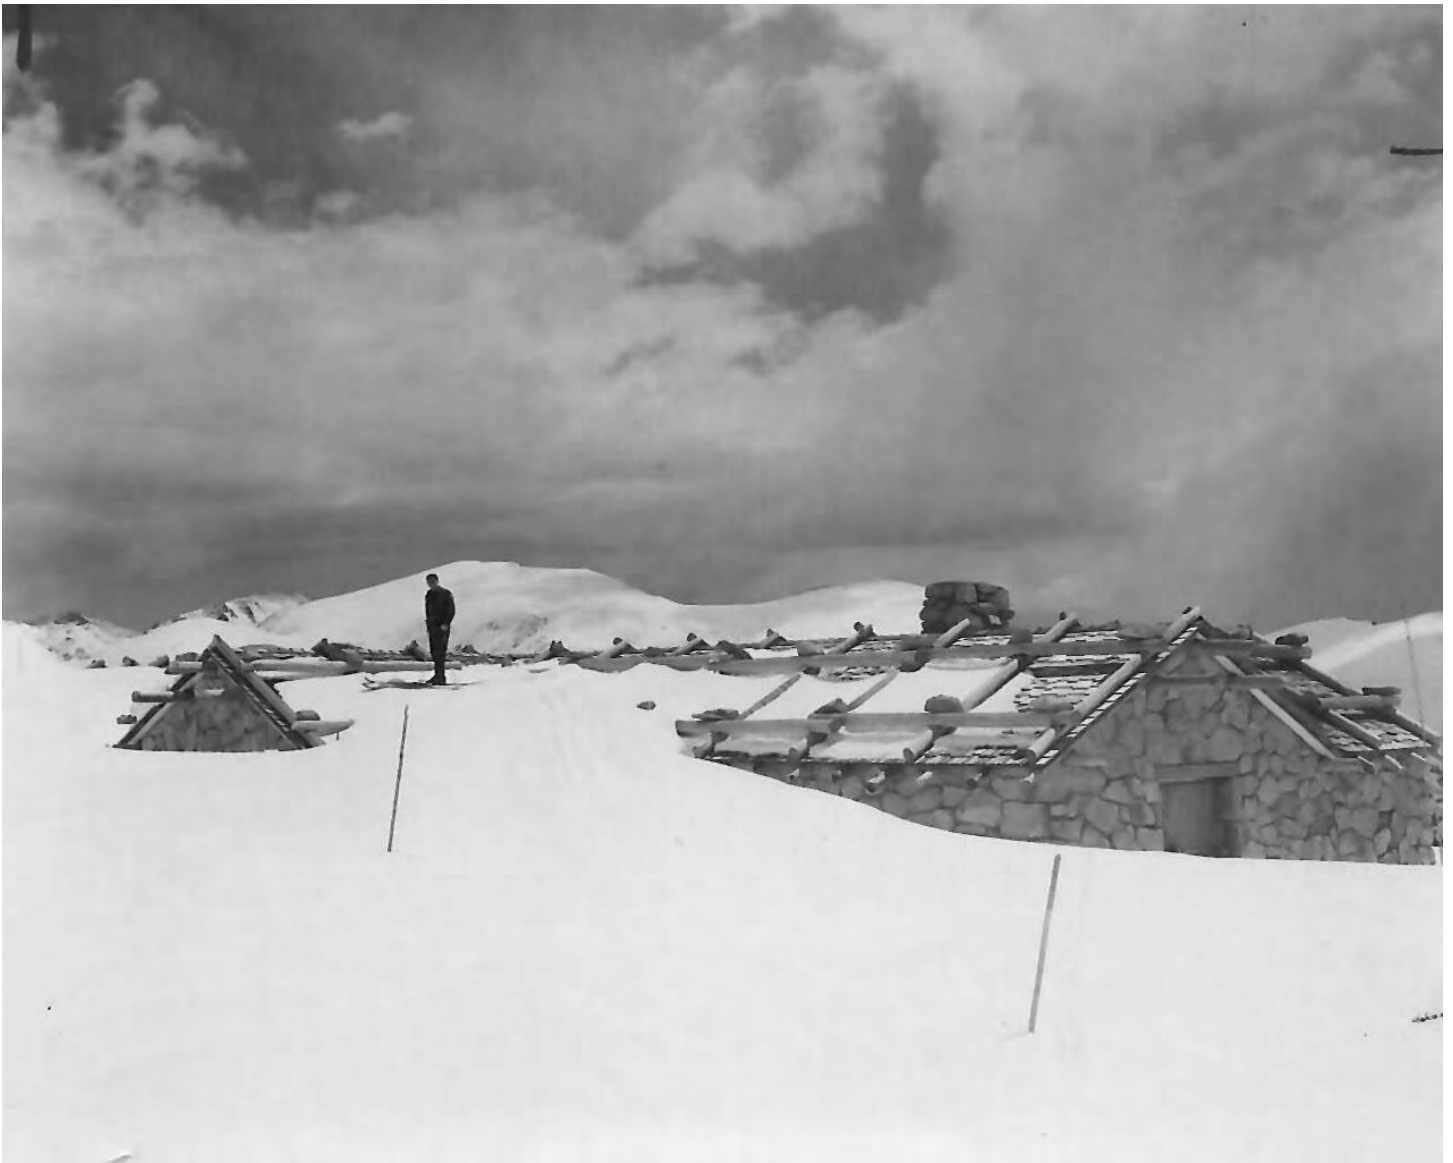
Figure 10 – Trail Ridge Store in May 1958 (Source: ROMO-11-Q-2-a, neg 5640)

Snow routinely reaches the eaves (and above) on buildings at Fall River Pass. The harsh conditions lead to heavy maintenance and repair every summer, generally between Memorial Day and mid October each year. Snow at this elevation is possible every day of the year.

There is a low to moderate level of material integrity. Harsh winds in winter and summer, intense rain storms, and plowing operations in spring affect the condition of the facilities (Figure 10). During ongoing summer maintenance, park staff replaces, repairs, and rebuilds small scale features such as signs, benches, curbs, stone walls, and even building eaves. Original historic materials are present in some locations, but there have been many repairs, patches, and replacements over time.

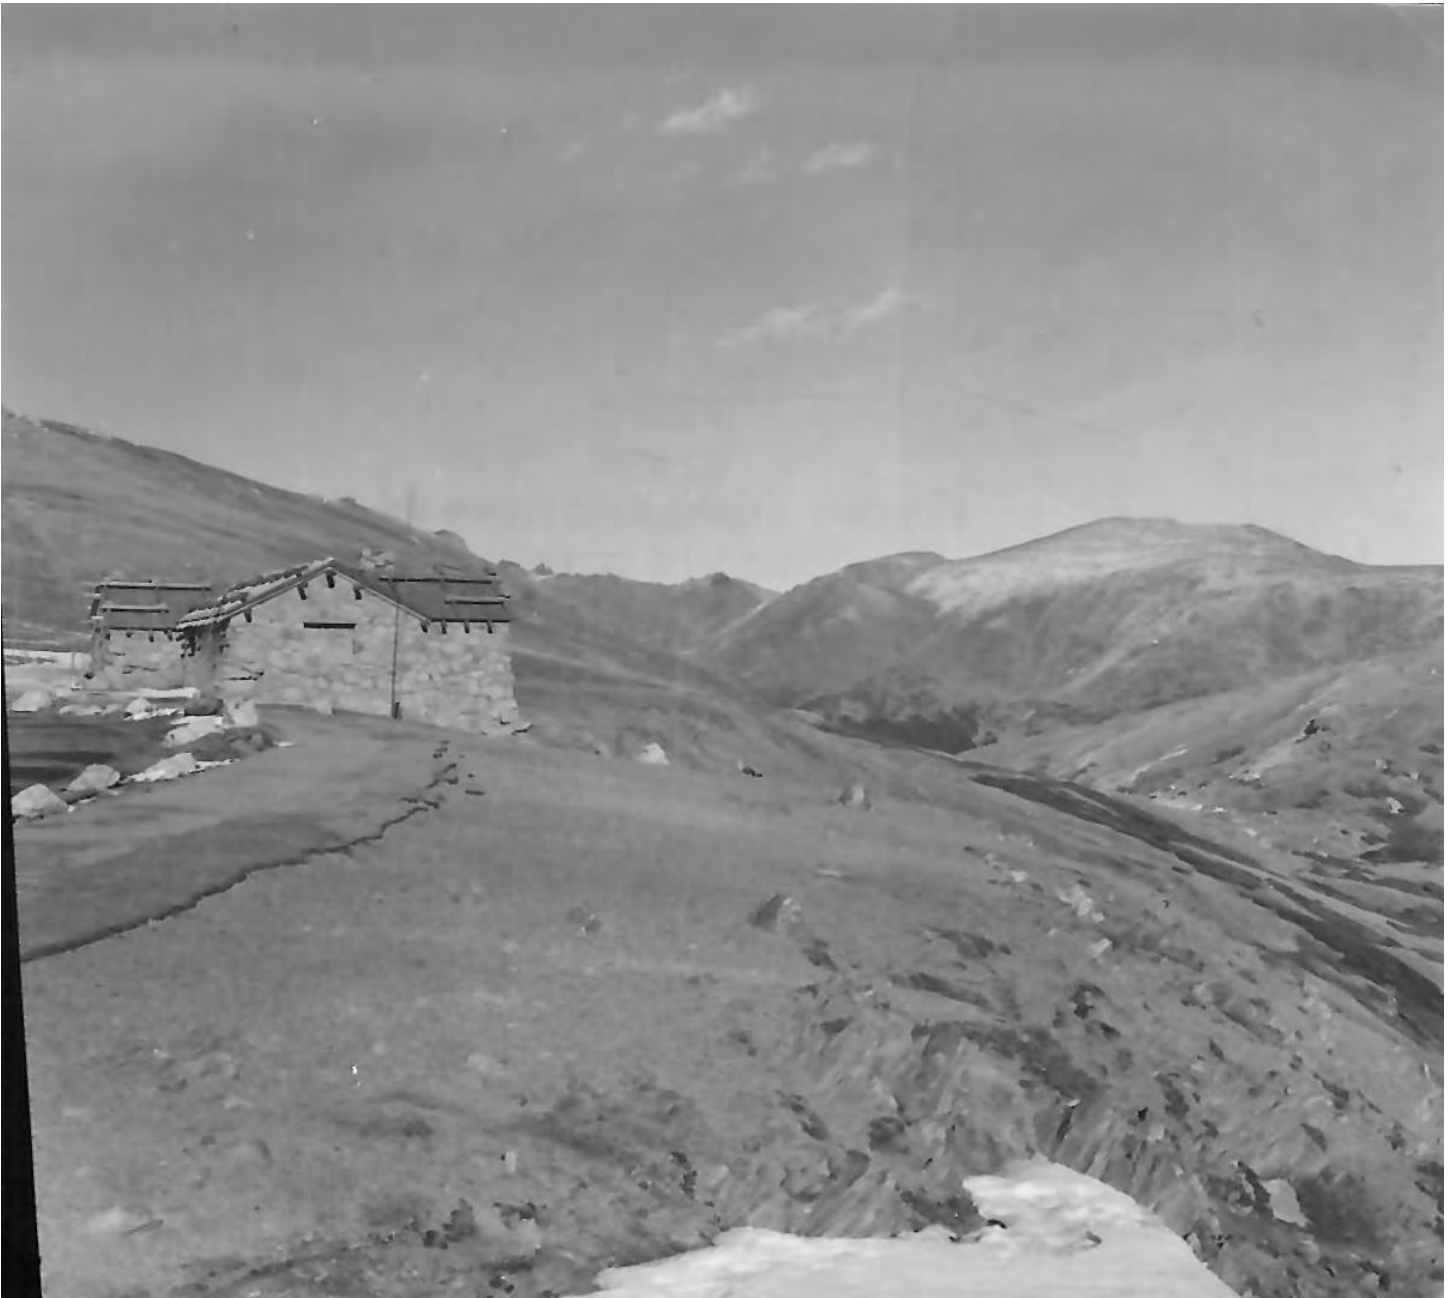
Figure 15 – Trail Ridge Store October 1962 (Source: ROMO-11-Q-2-a, neg 1130)

Over time as visitation increased, the park curated the experience through formalized landscaping like sidewalks, paved parking, and formalizing the visitor-created Alpine Ridge Trail. The foreground in this image is the future location of the Alpine Visitor Center.

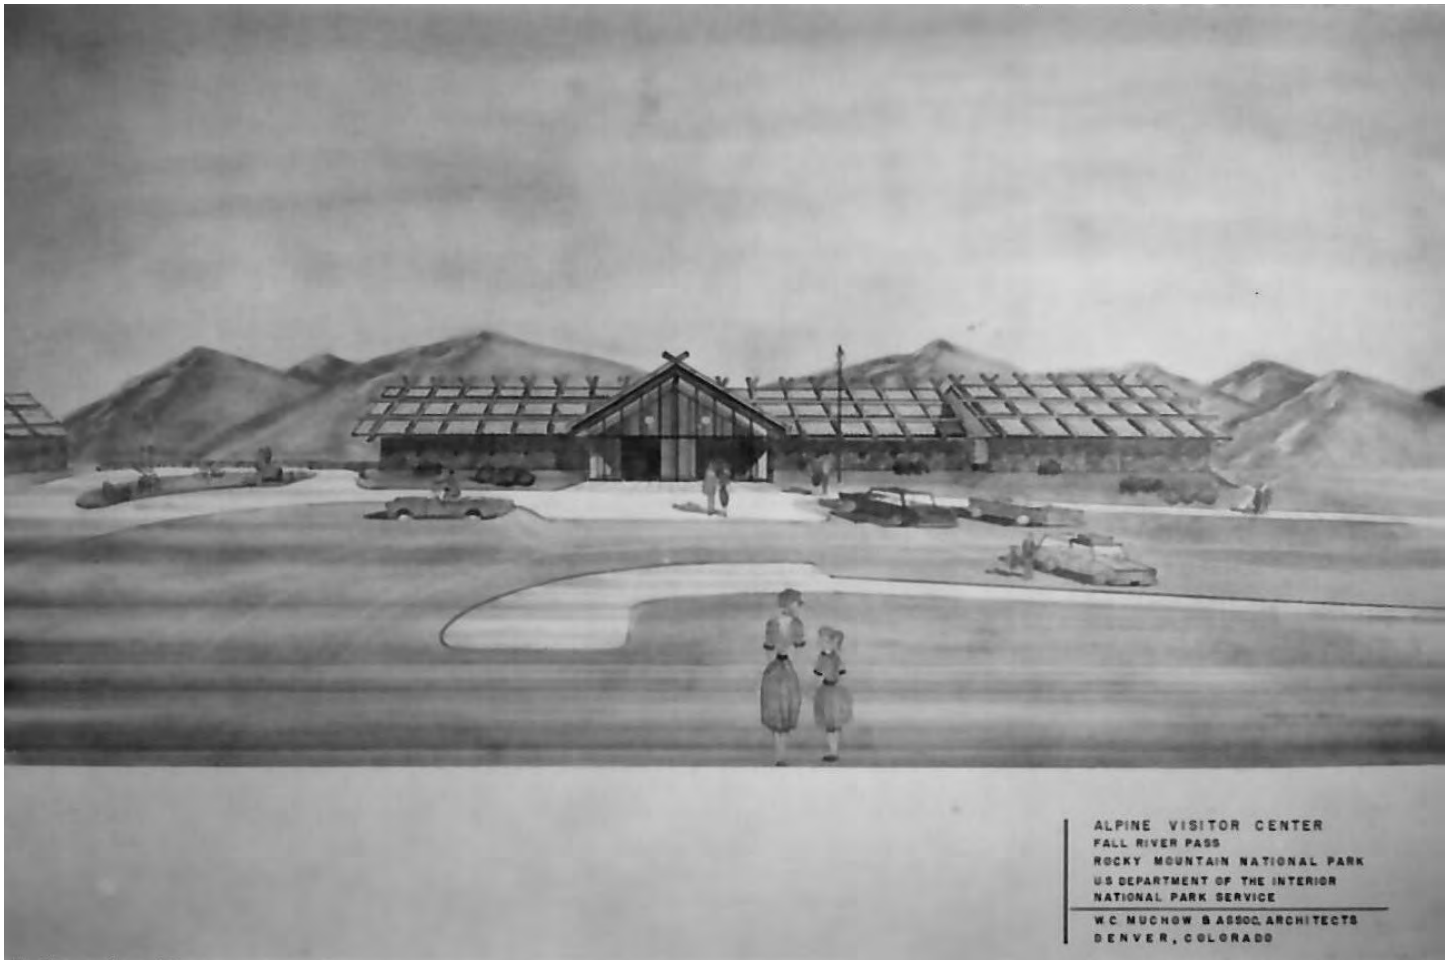
Figure 16 - The Mission 66 rendering of Alpine Visitor Center August 1962. (Source: ROMO-11-Q-2-a, neg 1161).

In response to rising and changing visitation, the National Park Service invented a new type of facility, the Visitor Center. These "all in one" buildings differed from "park village" developments of the 1920s to 1940s period when decentralized complexes, much like Fall River Pass, housed dispersed functions such as museums, privies, shops, and other visitor facilities in multiple buildings. During Mission 66 all of these activities were relocated into a single, larger building where park staff provided all visitors with basic orientation and interpretation in a well-organized manner.

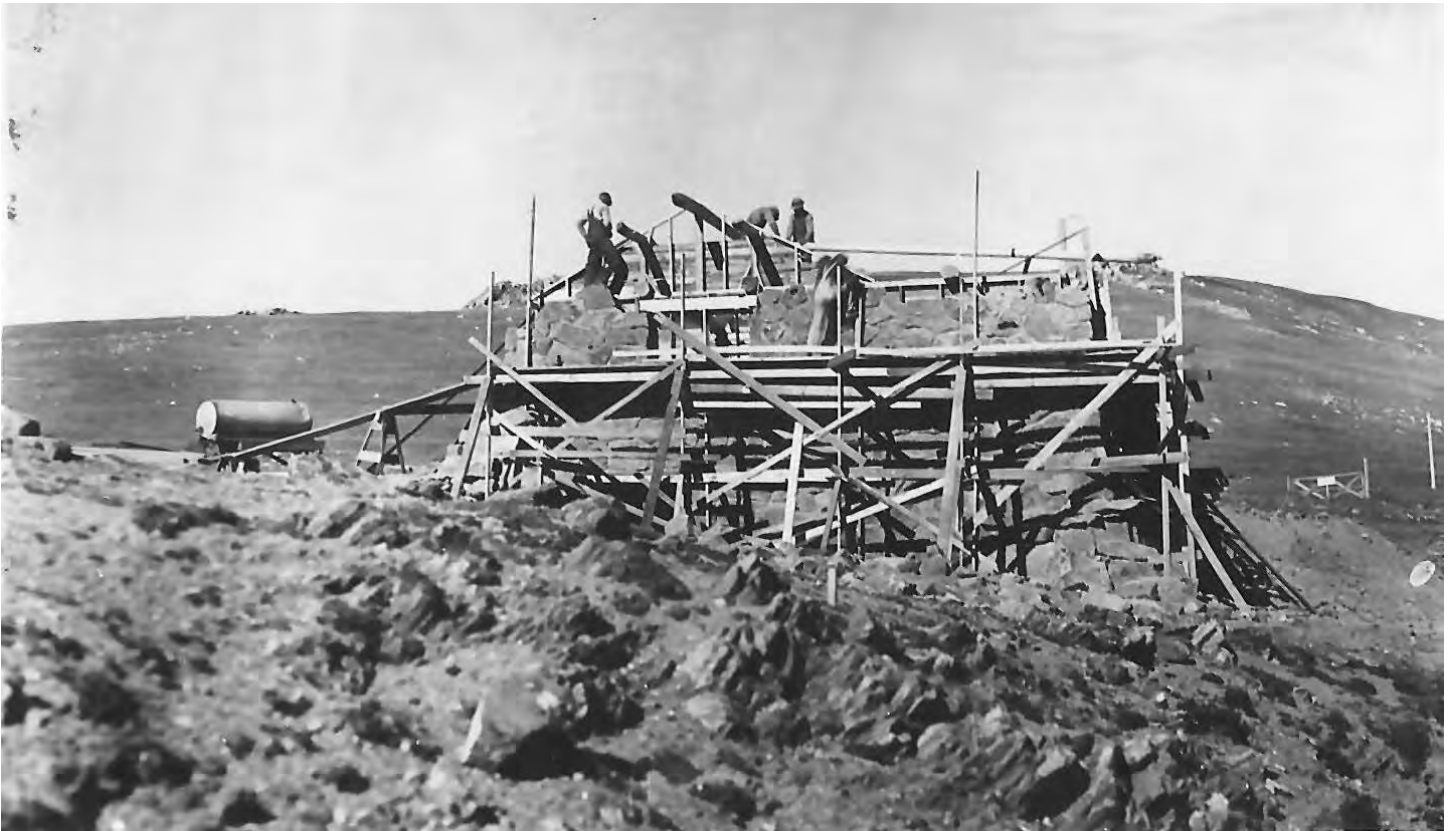
Figure 18 - Construction of the Fall River Pass Rest House (now the Trail Ridge Store) August 1936 (Source: ROMO-11Q-2-a, neg 5951)
Roe Emery, the owner of Rocky Mountain Motor Company and concessioner for the Fall River Pass Shelter House, initially considered use of CCC crews to construct his new Rustic building. However, he found the bureaucracy involved with the relief program too time consuming and instead opted to hire private contractors and finance all of the construction himself.

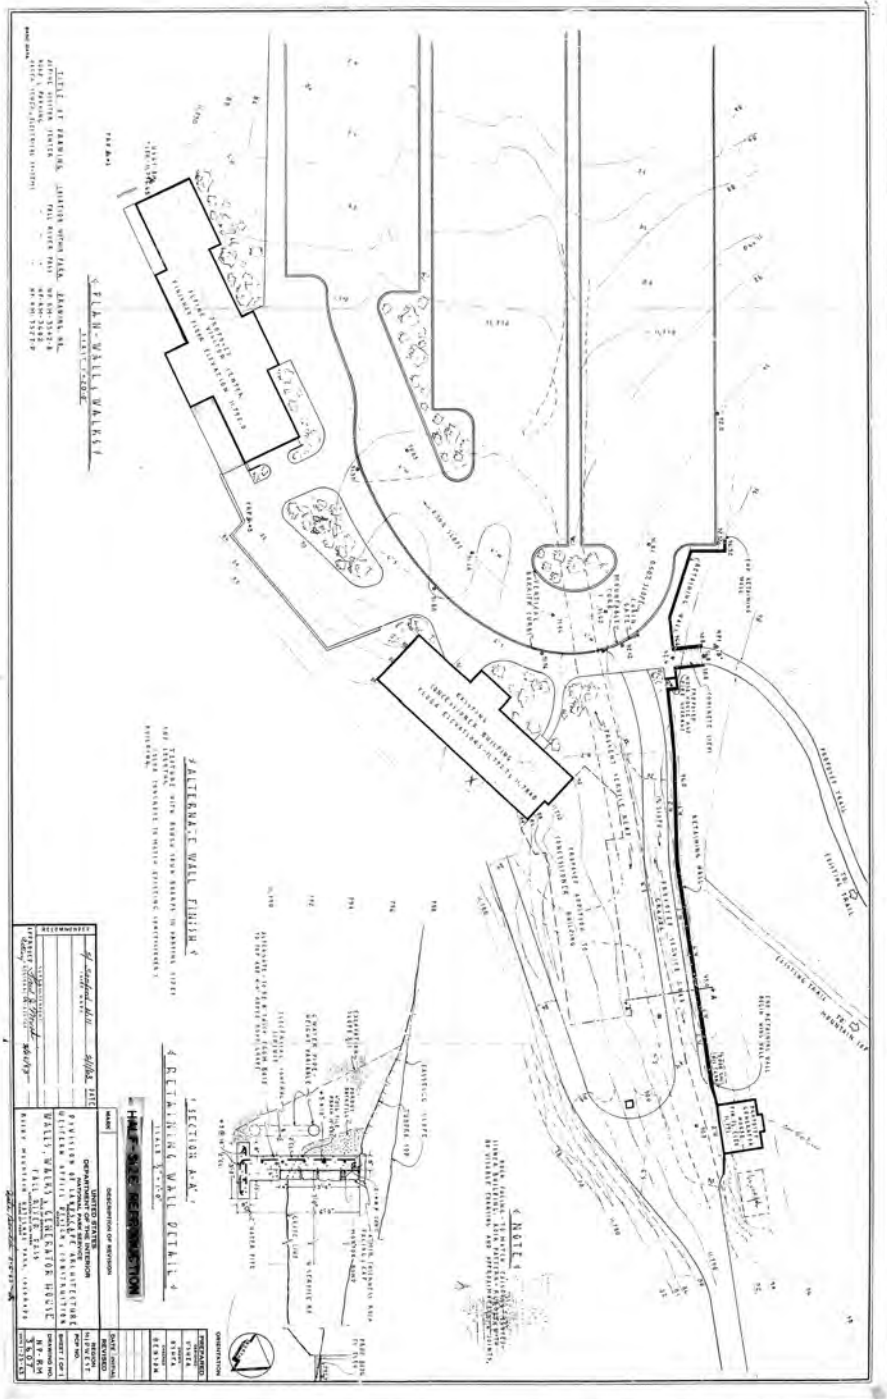
Figure 19 – Site plan for Mission 66 development 1963 (Source: ROMO_3607)
 Mission 66 landscape plans included a formal plaza and retaining walls, separating the alpine tundra from the paved visitor area. The park increased the separation as the work of Dr. Beatrice Willard focused park management’s attention on the long-term impacts of visitors on alpine tundra.

All of these features allowed for new buildings “that, when successful, provided more programmatic and functional space for less architectural presence” (Allaback). The appropriate exterior wall cladding for new buildings at Fall River Pass was stone, or at least stone veneer. The use of this material on the Alpine Visitor Center and Generator House, both constructed during the Mission 66 era, made these two new elements coordinate well with the existing stone NPS Rustic buildings in the complex. Having accommodated visitors since 1920, the Pass already featured a system of parking lots and walkways. But, in association with construction of the Alpine Visitor Center and in keeping with Mission 66 planning practices, NPS landscape architects updated these aspects of the site. The entry from Trail Ridge Road was formalized, the parking lot better delineated, and the walkways were paved in concrete. The Plaza visually and operationally formalized the connection between the Trail Ridge Store—where visitors shopped for souvenirs—and the Alpine Visitor Center—where they met a ranger. This new space also provided a formal place for ranger talks, signs, pay-to-view telescopes, and benches. Retaining walls, curbs, and fences kept pedestrians and vehicles in their respective spaces (Figure 19).

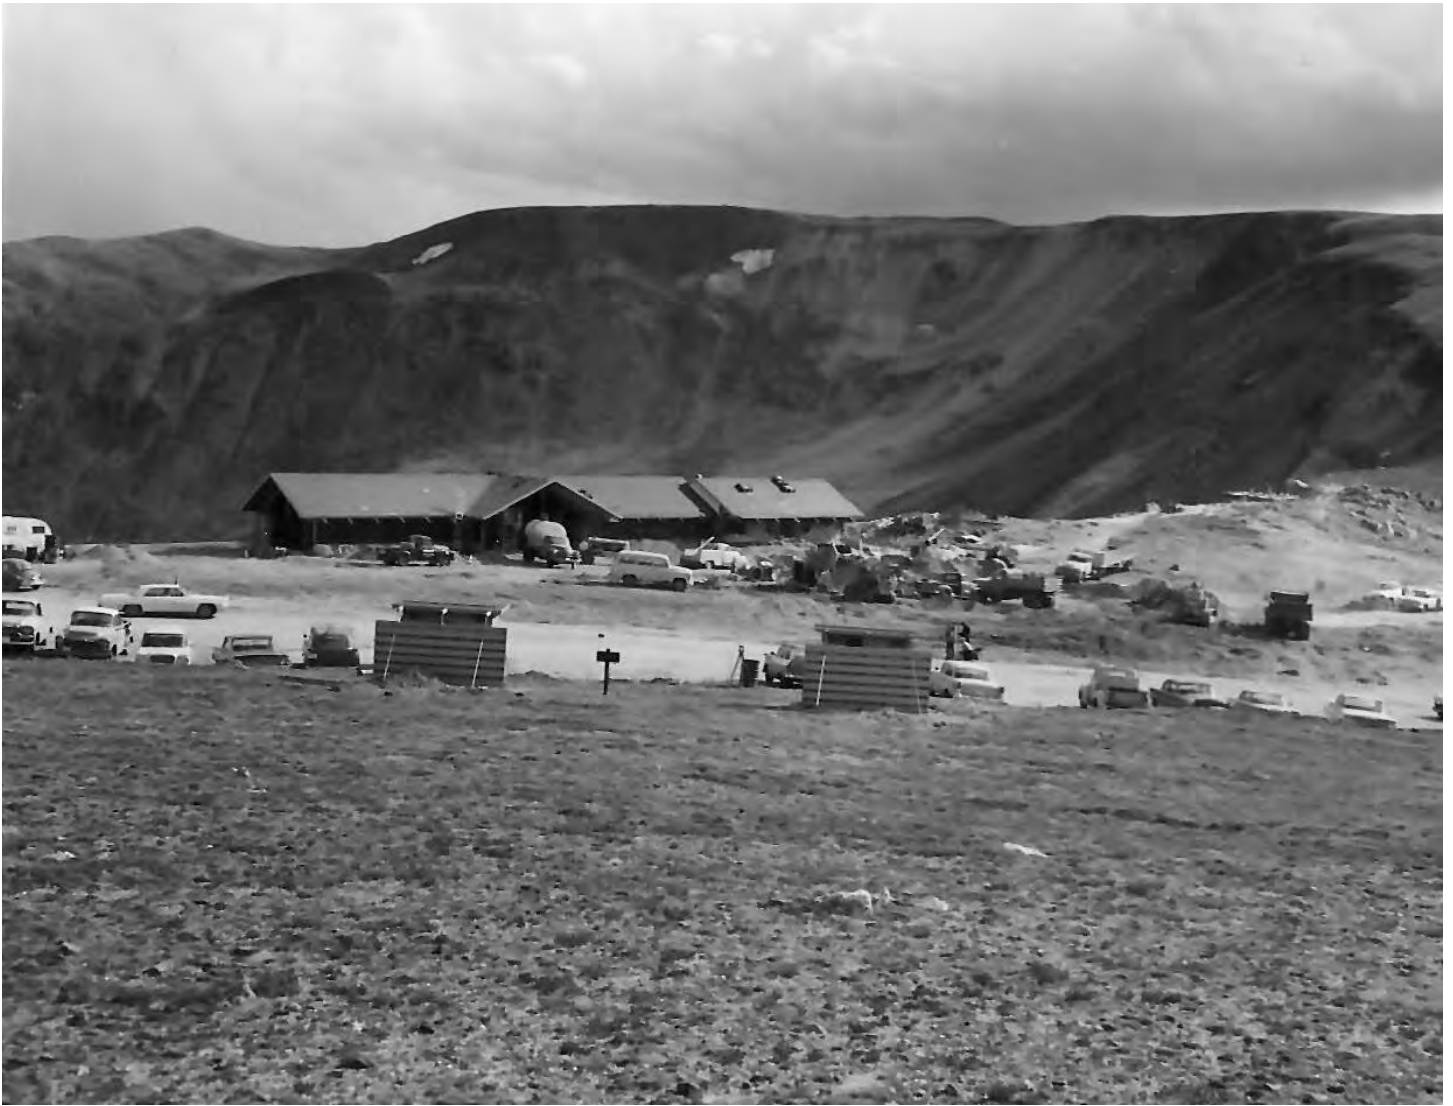
Figure 19 – Alpine Visitor Center under construction, September 1963 (Source: ROMO-11-Q-2-a, neg 4993)

In September 1963, the Alpine Visitor Center was nearing completion, though site elements including the Public Plaza were not finished. The buildings in the foreground are vault toilets.

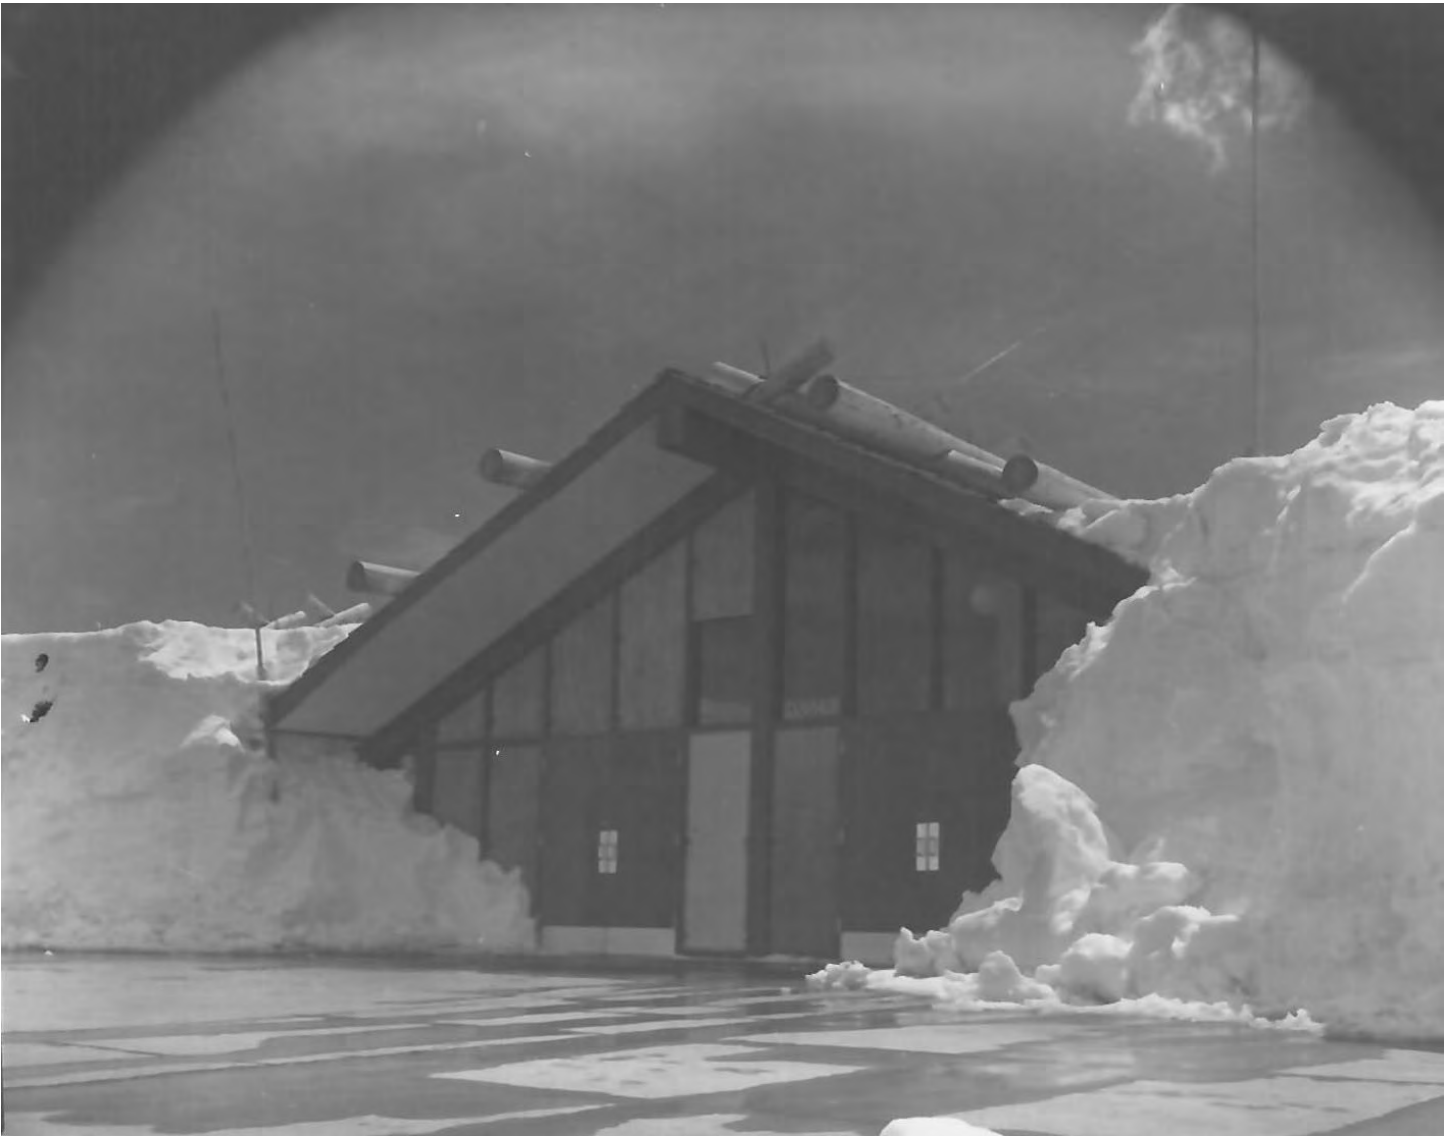
Figure 20 – Alpine Visitor Center in June 1983 (?) (Source: ROMO-11-Q-2-a, neg 1153)

The architecture of the Alpine Visitor Center's reflects modern design tenets, uses prefabricated materials, and fits into its site in both spring and summer. The heavy timbers on the roof are both aesthetic and functional, they reinforce the roof structure during heavy snow loads.
