National Register of Historic Places Registration Form

historic name ROCK CREEK FARM RURAL HISTORIC DISTRICT

street & number 2005 S. 112TH ST.

city or town BROOMFIELD

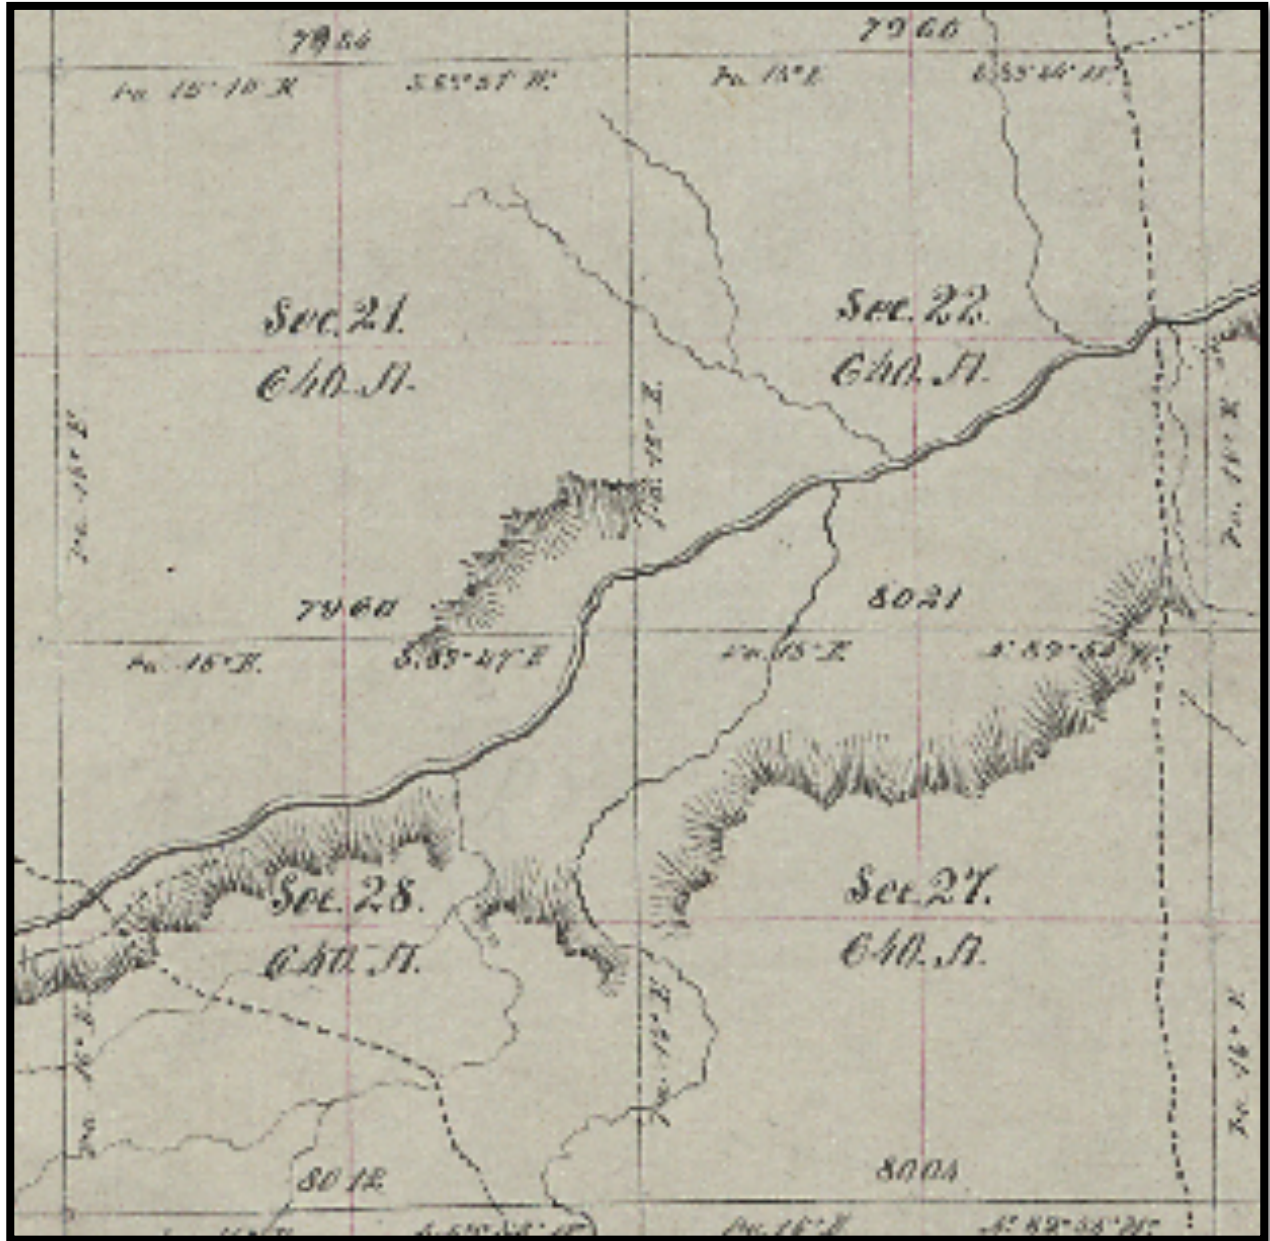
General Land Office Map, Surveyed 1864 T1S-R69W, Sections 21, 22, 27, 28

The north-south dashed line on the right marks the route of the Cherokee Trail and Overland Stage Road

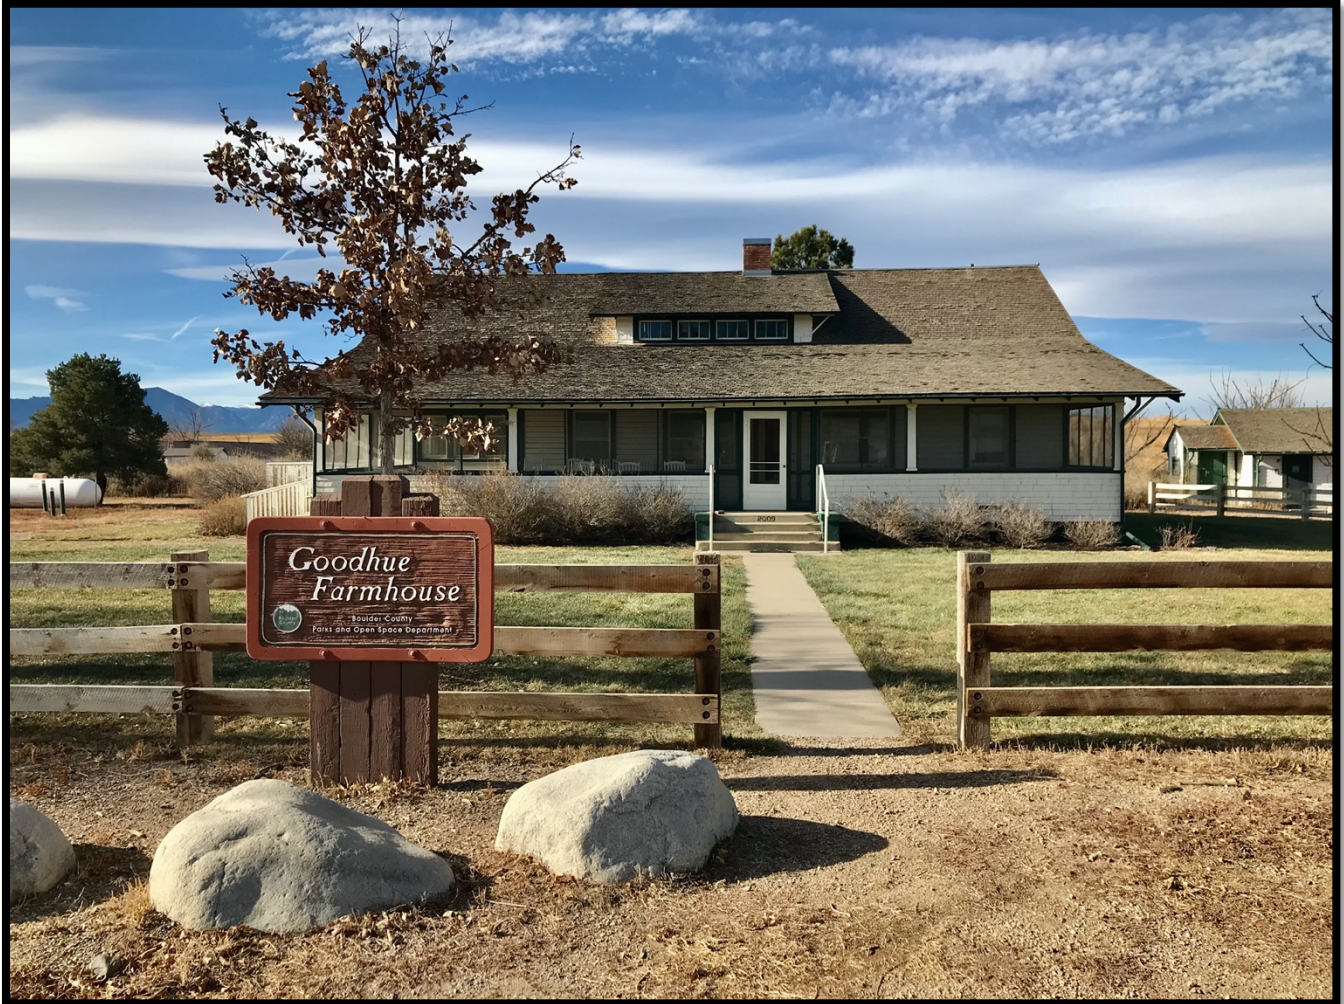
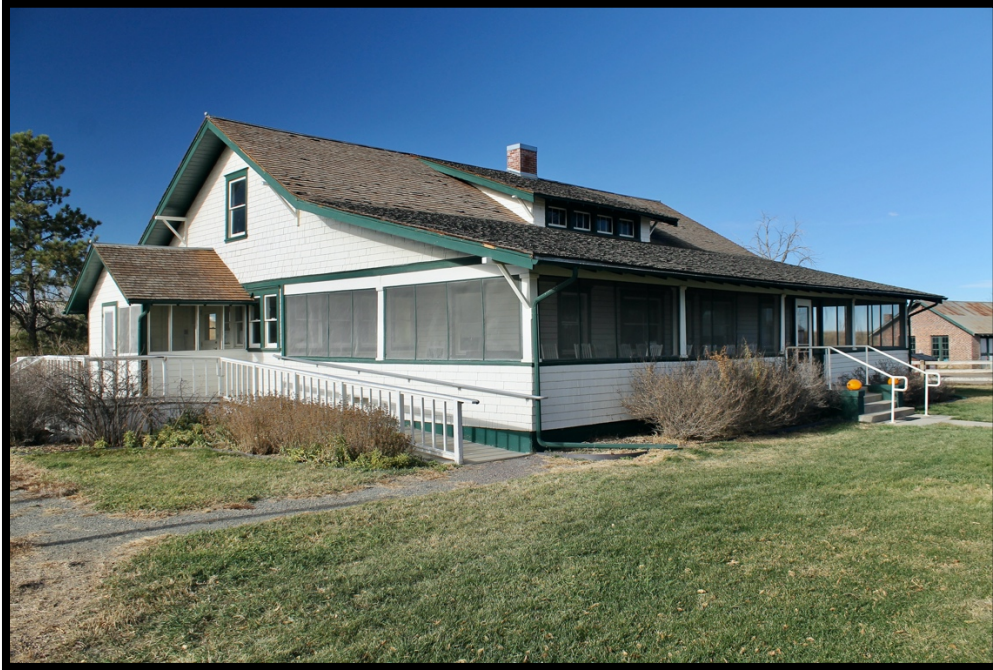
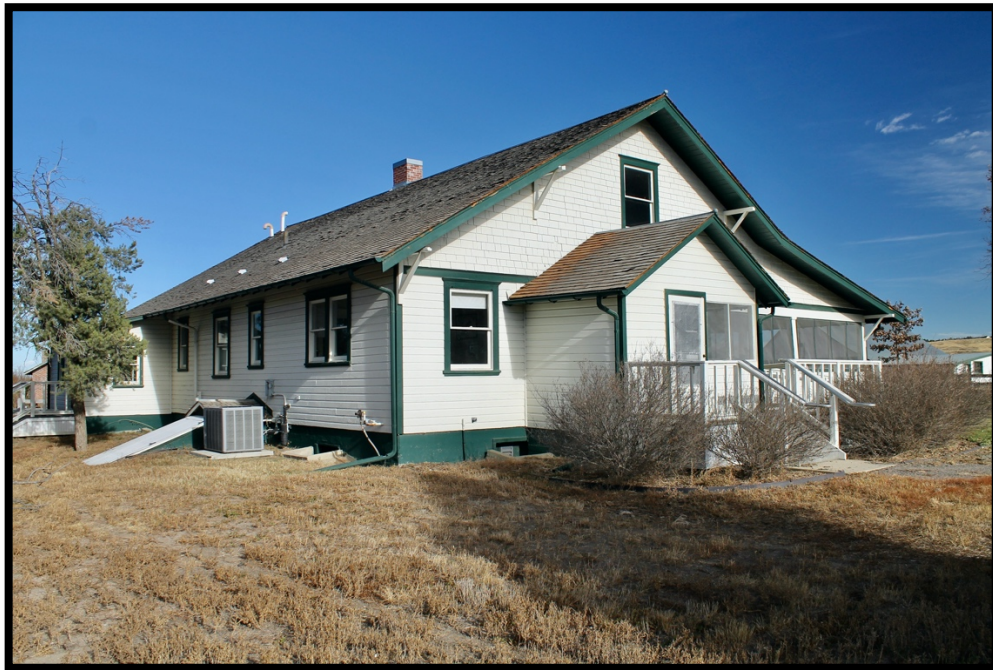
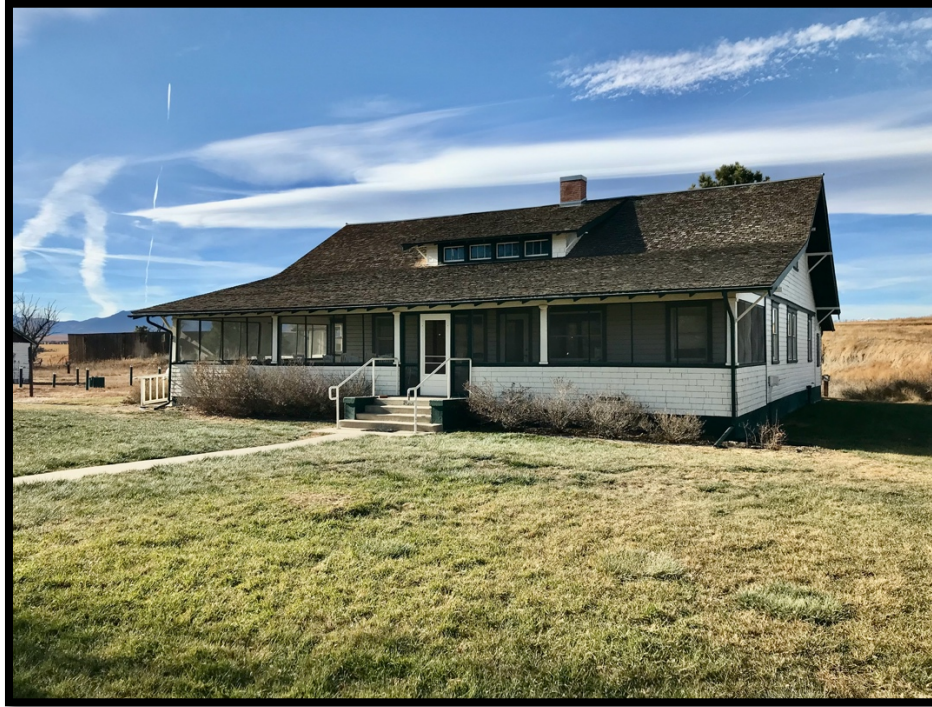
Photo 5
Goodhue Farmhouse. View to the Northwest.

Photo 6
Goodhue House. View to the North.

Photo 7
Goodhue House. View to the Northeast.

Photo 8
Goodhue House. View to the West.

Goodhue Farmhouse, 1916 (photos 5-8): Built in 1916 to replace a circa late-1880s house at this location, the farmhouse is a Craftsman bungalow residence. It stands in a commanding location at the northwest end of the entry drive. Beyond that are the farmyard and livestock buildings. Rock Creek passes behind the house to the west. The large grassed front yard containing two mature deciduous trees is bisected by a concrete sidewalk that runs from the driveway on the southeast to the house's front door. A non-historic wood post and rail fence wraps around the yard to the north, east and south. Along the drive at the southeast end of the sidewalk is a sign placed there by the Boulder County Parks and Open Space Department identifying the building as the Goodhue Farmhouse.

The 1½-story farmhouse has 1,908 square feet of finished space, rests upon a raised concrete foundation, and has a rectangular plan measuring approximately 55' x 60'. Facing southeast toward the main entry drive, the wood frame building's exterior walls are clad in horizontal weatherboard siding, with square-butt wood shingles on the upper gable end walls on the northeast and southwest. The broadly pitched side-gabled roof is finished with wood shingles along with open eaves and exposed rafter ends. Wood knee braces are present just below the eaves on the end walls. Along the roof's ridgeline are a short slightly off-center brick chimney, along with a tin ridge cap with ball finials. A dormer described in detail below is present on the southeast roof slope.

A wood door with a large light enters the house from the porch. On either side of the entrance are two one-over-one double-hung sash windows with wood frames. Five additional one-over-one double-hung sash windows with wood frames are found around the corner in the south area of the porch. The windows have wood sills and lintels with crown molding. Centered on the roof's southeast slope is a wide, low shed dormer with four small three-light windows along its face, square butt wood shingles cladding its walls, exposed rafter ends, and wood knee braces on the sides.

The northwest wall holds a rear entrance into the building. This is in an enclosed shed-roof porch that projects from the building's northwest corner. The entry is accessed by way of a three-step wood stoop with wood skirting and wood and metal handrails. In the entry is a wood panel door with a single light. Three basement windows are located along the northwest wall, all set into the raised concrete foundation and lined with concrete wells. While one retains its three-light window, the other openings hold louvered metal vents. The basement is entered through a bulkhead door of wood frame and beadboard construction. This provides access to a concrete-walled stairway with eight concrete steps dropping into the ground. Close to the house wall, the low roof over the bulkhead entrance is gabled and finished with wood shingles and a tin ridge cap with a ball finial. Along the main floor wall are several one-over-one double-hung sash windows with wood frames, along with wood sills and lintels with crown molding.

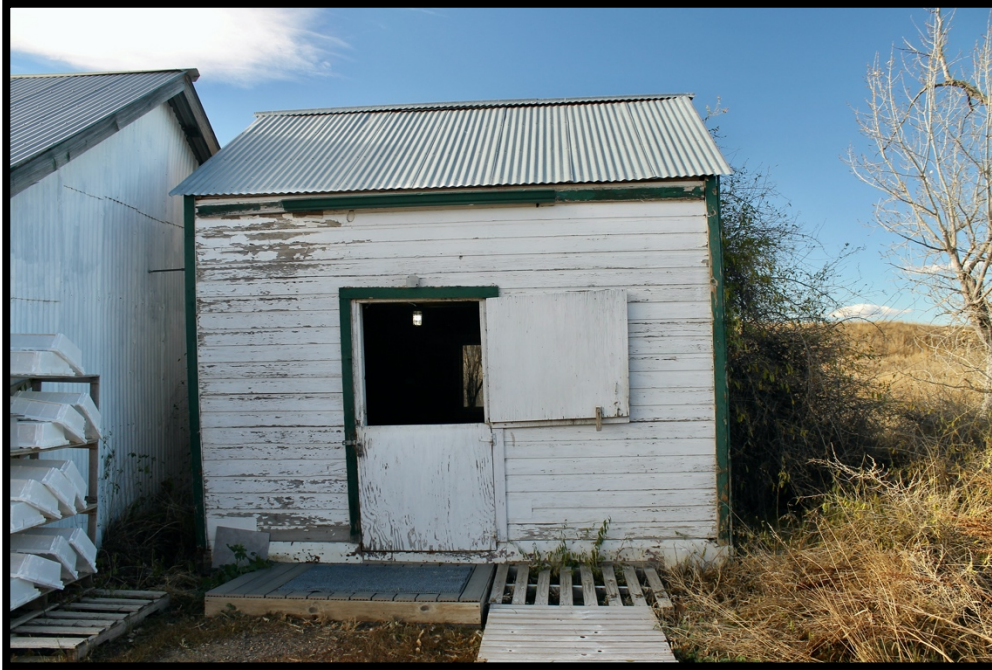
Photo 12
Granary. View to the Northwest.

Granary, circa 1933 (photo 12): This small one-story wood frame building is located northeast of and adjacent to the garage. Facing toward the southeast, it rests upon a concrete foundation and has a square plan measuring 14' x 14'. The exterior walls are clad in horizontal weatherboard siding. Deteriorated concrete foundation ruins measuring an additional 14' x 16' abut the building to the northeast. These are now overgrown with vegetation. The side-gabled roof has no eaves and is clad in corrugated metal panels. On the southeast façade is a centered entry that contains a plywood Dutch door. A weatherboard opening, no longer used, is present in the upper gable end wall on the northeast. No windows are present and the building is double-walled to serve as a granary. Strips of sheet metal have been placed around the lower walls to prevent vermin from infiltrating the interior.

Alterations – Given the building's historic use as a granary, it seems unlikely that the current plywood Dutch door is original and when it was installed is unclear. There are no other signs of significant exterior alterations to this building. What stood on the adjacent concrete foundation is unknown.

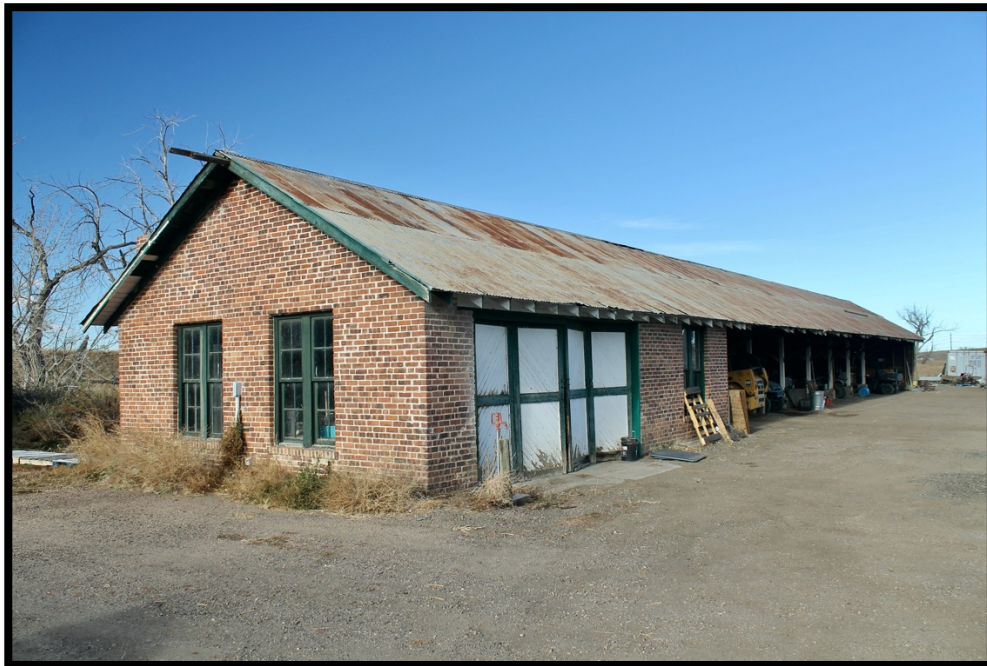
Photo 13
Blacksmith Shop and Equipment Shed. View to the North.

Blacksmith Shop & Equipment Shed, circa 1933 (photo 13): This long one-story combination masonry and wood frame building is located northeast of and adjacent to the granary. The blacksmith shop is on the southwest, with the larger equipment shed extending to the northeast. Facing toward the southeast, the shop rests upon a concrete foundation and has a rectangular plan measuring 24' x 36'. Its exterior walls are constructed of variegated red pressed bricks laid in running bond coursing. The southeast façade holds a wide main entrance occupied by two pairs of bifold sliding doors hung from interior metal rails. The large wood doors are constructed of beadboard panels set on a diagonal, along with plank trim and bracing. The side-gabled roof is finished with exposed rafter ends, open eaves, and corrugated metal panels. A square chimney rises from the northwest roof slope and a wood beam projects from the southwest eave just below the ridgeline. Along the wall northeast of the main entrance is a pair of four-over-four double hung sash windows with wood frames and surrounds and brick rowlock sills. The same windows are found on the rear northwest wall and the southwest side wall holds two pairs of these windows.

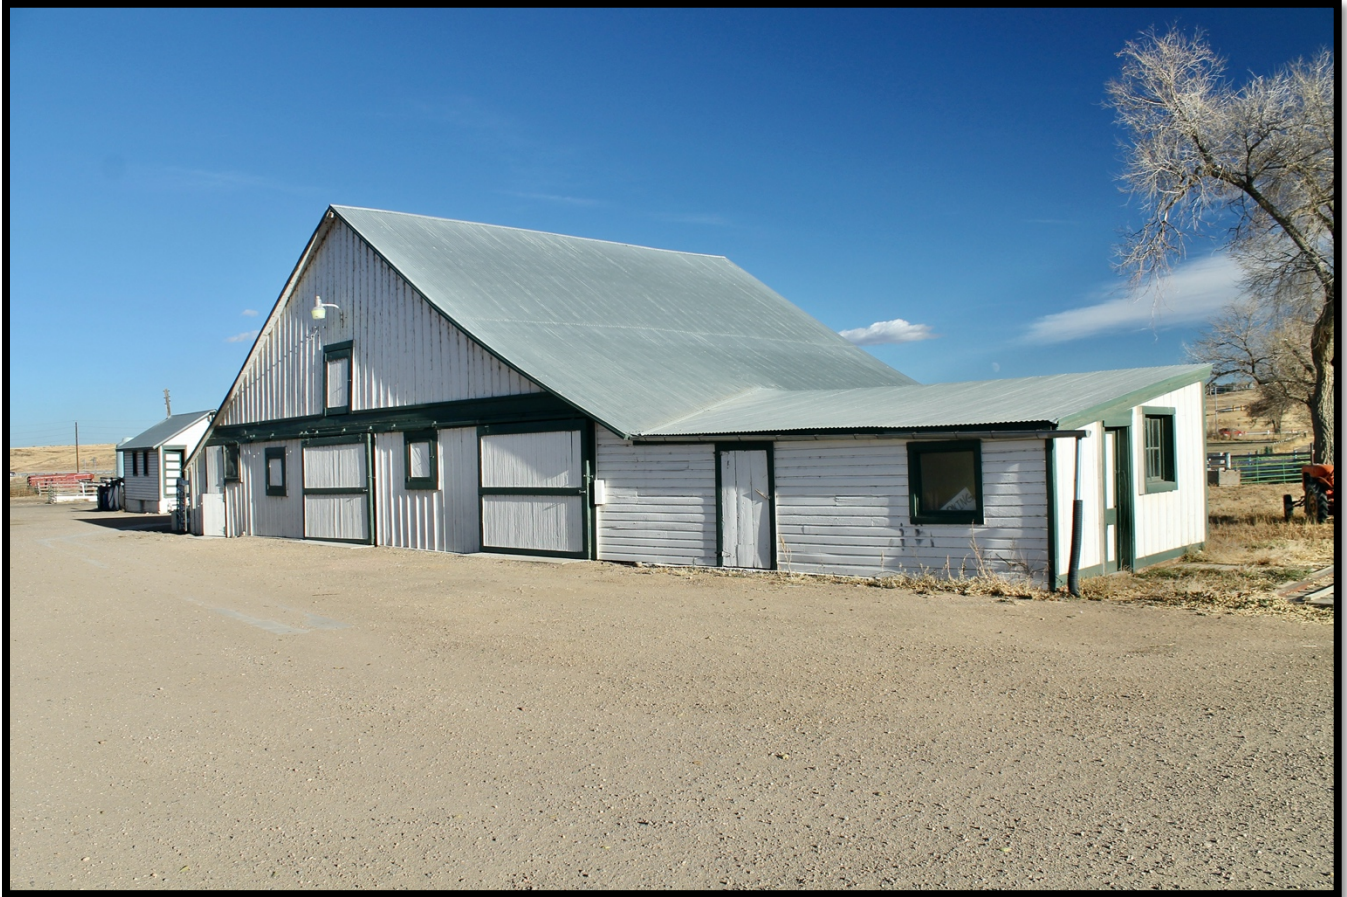
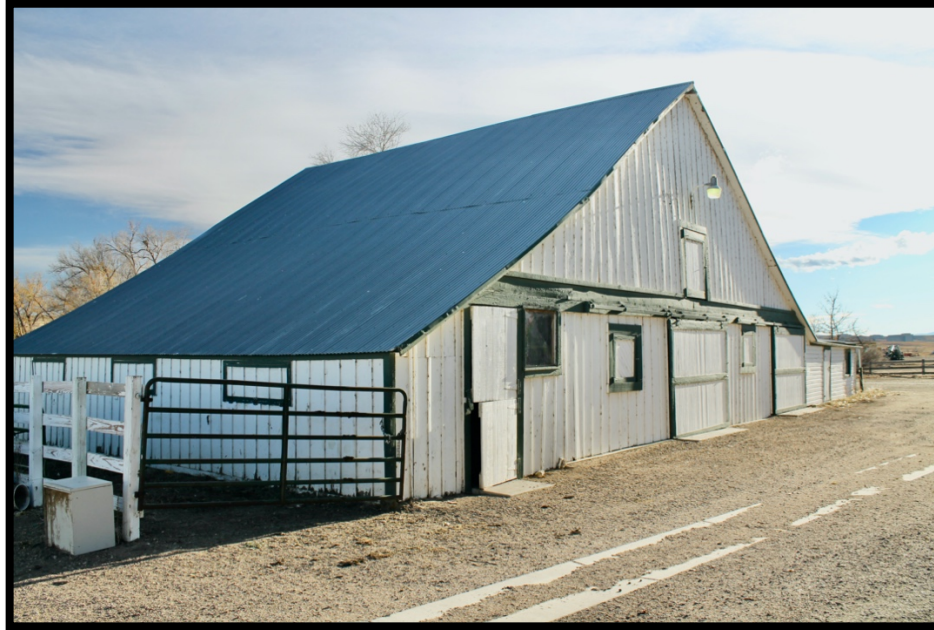
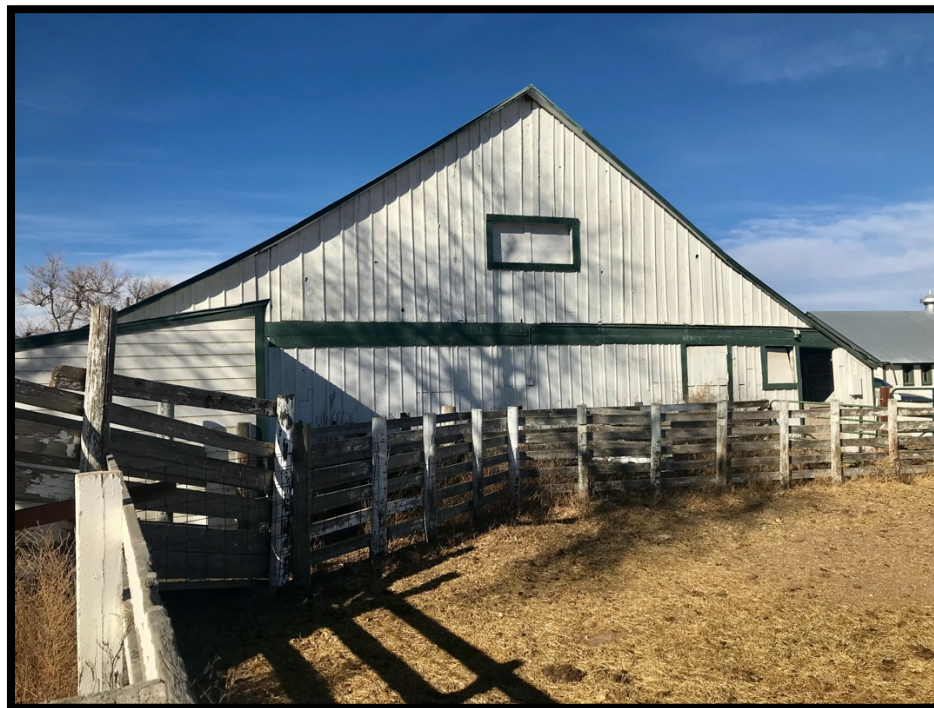
Photo 14
Horse Barn. View to the Northeast.

Photo 15
Horse Barn. View to the South.

Photo 16
Horse Barn. View to the Northwest.

Horse Barn and Scale House, circa 1880s (photos 14-17): This building, the oldest in the farmstead, is located across the farmyard east of the house. It was historically used to shelter horses and store hay. The building is architecturally defined as a transverse-crib barn, with bays that run from front to back. Facing northwest, the wood post and beam building rests upon a concrete foundation, has a core footprint of 40' x 60', and was built using mortise and tenon joint construction secured with wood pegs. Except for a few small areas of horizontal siding, its exterior walls are clad in board and batten siding. Projecting from its southeast and southwest corners are two small historic wood frame additions with shed roofs. The approximately 18' x 22' addition on the southwest is divided into a storage room and scale house. The building's tall front-gabled roof has steep slopes with a subtle concave shape, along with shallow eaves and corrugated metal panel cladding.

The northeast side of the barn contains no entrances into the building. Other than its board and batten siding, the wall holds three horizontal window openings. Each of these contains a board and batten panel with wood trim. The panels are hinged at the bottom so they can be lowered outside the building to provide interior ventilation. The southeast rear wall of the barn holds a single entrance at its southeast corner. This contains a Dutch door with the upper half missing and screened with chicken wire. Along the wall to the southwest are two window openings. One is boarded closed with plywood and the other contains an operable wood plank panel. A northeast-facing window opening in the southeast addition is boarded closed with horizontal planks. Cuts in the siding along the barn's primary wall suggest that there might have been additional openings at some time. Centered in the upper gable end wall is a horizontal hayloft opening that is closed with a wood panel composed of diagonal beadboards.

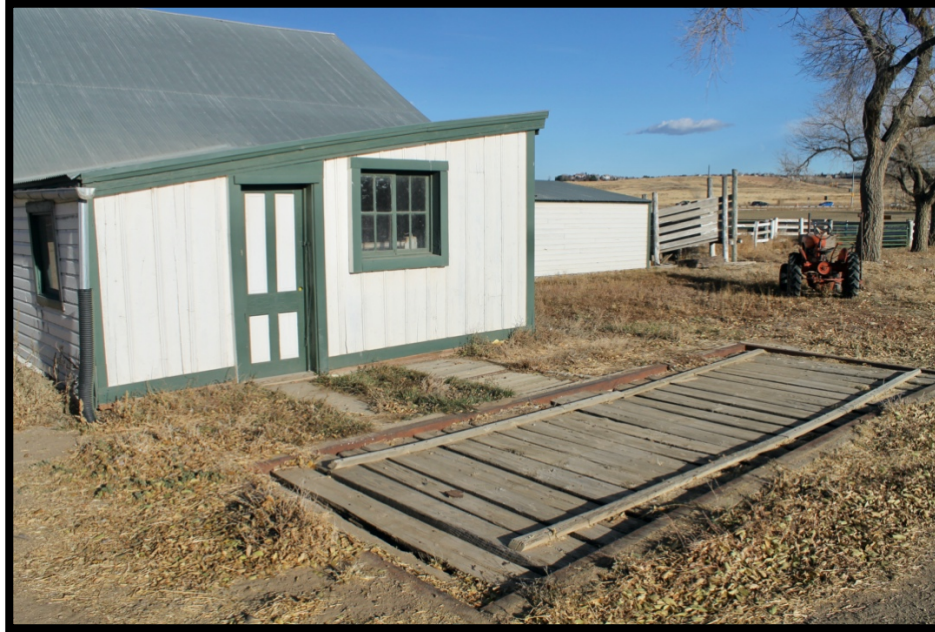
Photo 17
Scale House and Truck Scale. View to the Northeast.

The interior of the scale house is finished with a concrete floor and beadboard walls. Just inside the southwest window is a historic Howe truck scale mounted atop two fluted cast iron columns. With a patent date of 9 November 1897, it appears to have been manufactured sometime between the turn of the twentieth century and perhaps 1920. The scale has the capacity to weigh vehicles and their contents from 1,000 to 20,000 pounds and might have originally been used to weigh wagons before motorized trucks were introduced to the farm. Penciled mathematical calculations are found on the wood walls adjacent to the scale.

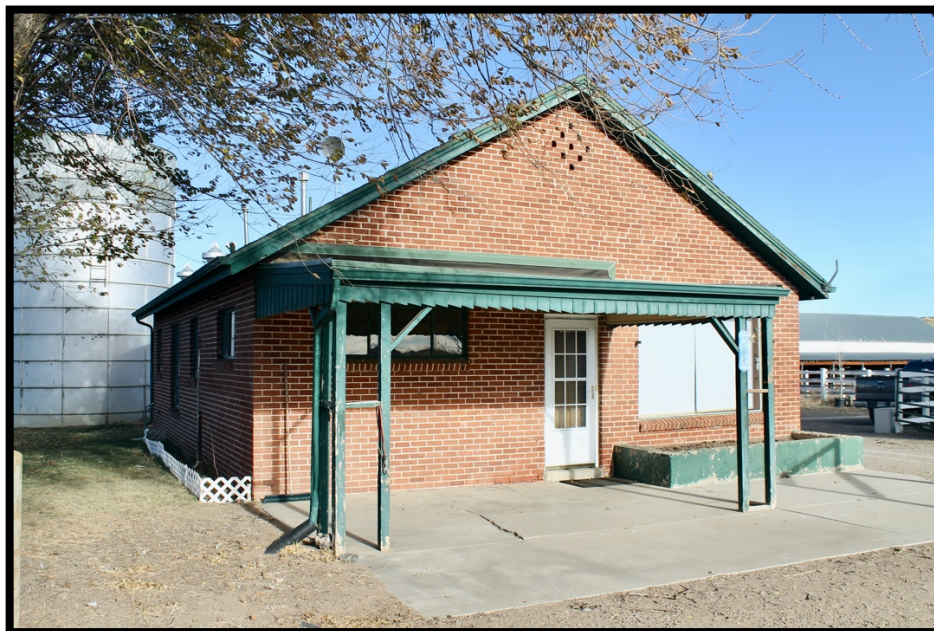
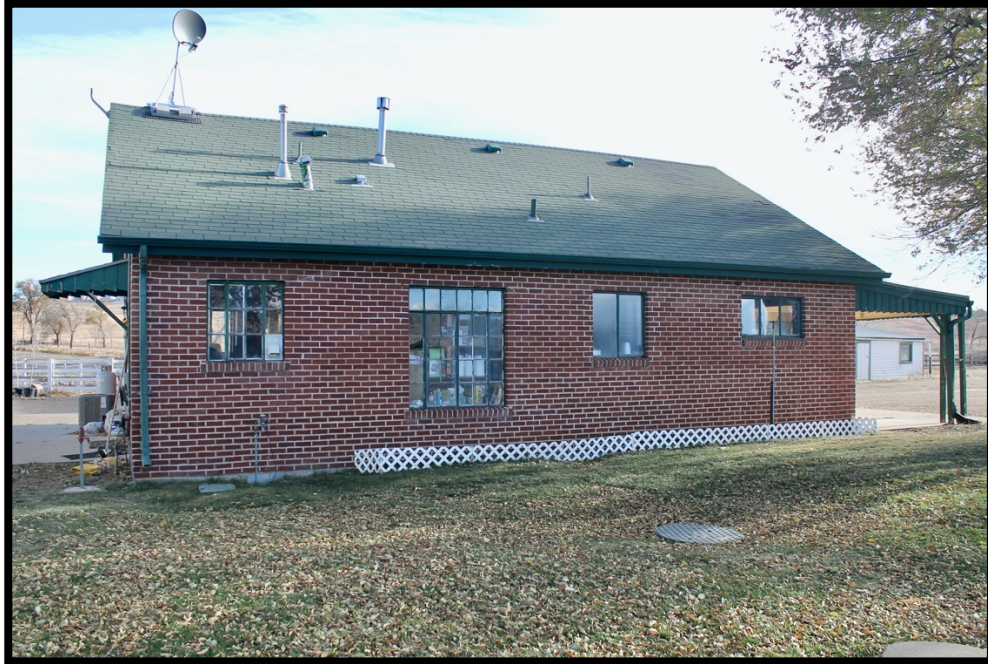
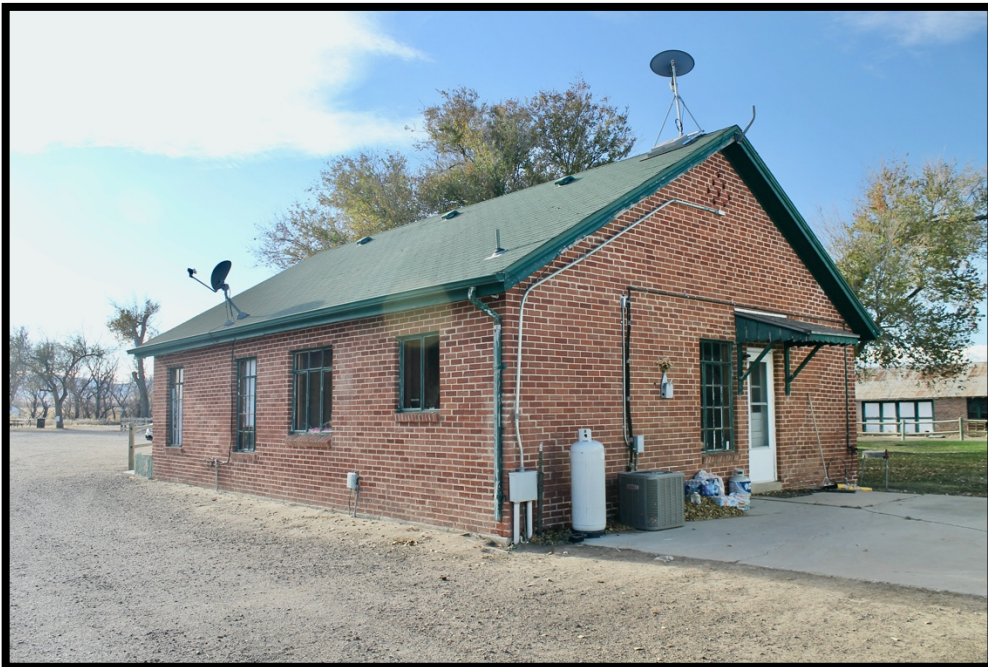
Photo 20
Milk Cooling House. View to the Northeast.

Photo 21
Milk Cooling House. View to the Southeast.

Photo 22
Milk Cooling House. View to the Southwest.

Milk Cooling House / Equipment Wash House, circa 1933 (photos 20-22): This one-story masonry building is located across the drive north of the horse barn. The adjacent ground to the northwest is planted with grass and bordered by a non-historic post and rail fence. This was the location of another early Goodhue barn that was demolished many decades ago. Facing toward the southwest, the milk cooling house rests upon a concrete foundation with no basement. Its rectangular plan measures 28' x 38'. The exterior walls are constructed of variegated rough-faced red bricks laid in common bond coursing on the front and back walls and running bond coursing on the side walls. The front-gabled roof is finished with boxed eaves and green asphalt shingles.

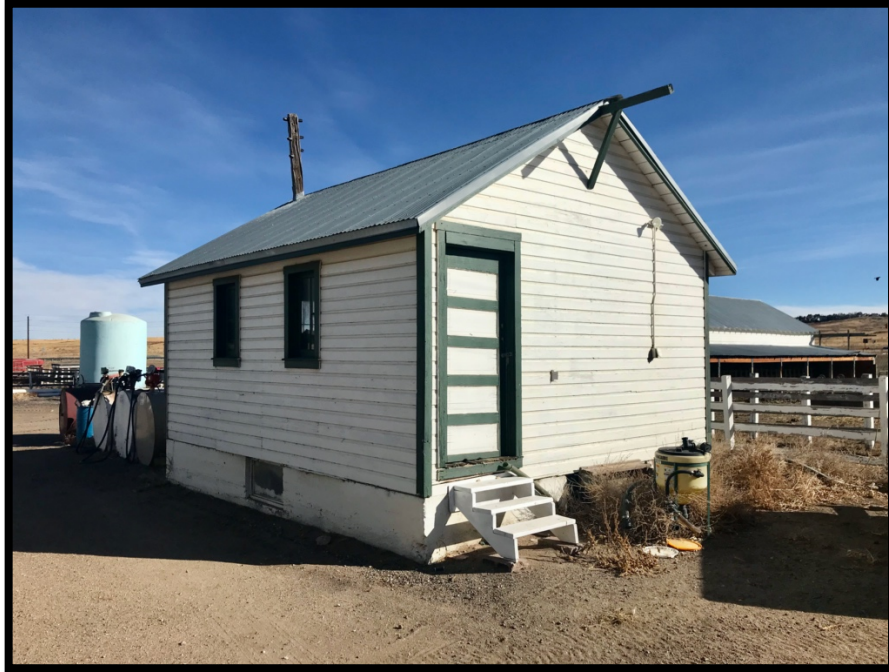
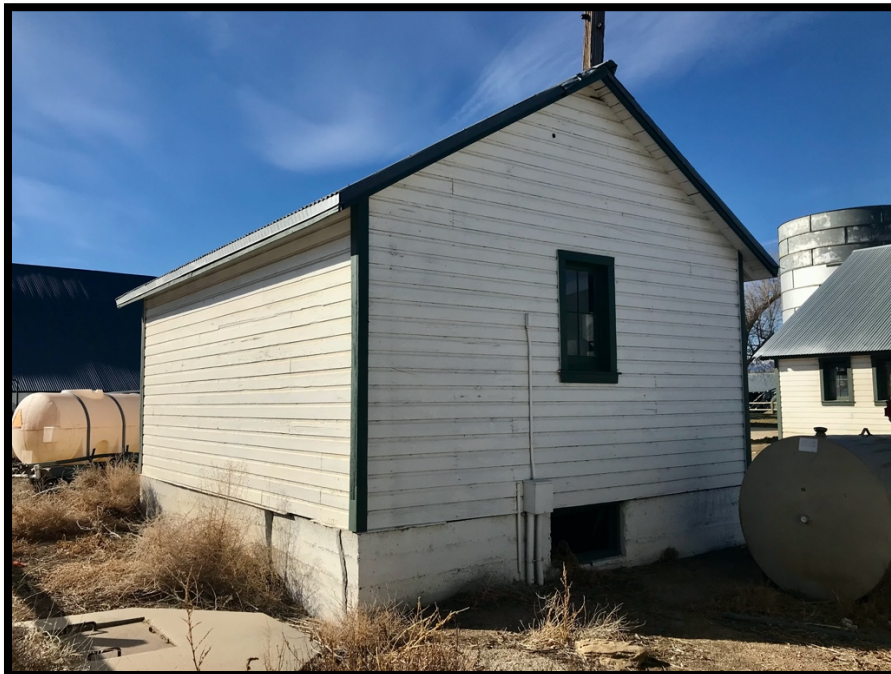
Photo 23
Water Pump House. View to the Northeast.

Photo 24
Water Pump House. View to the Southwest.

Water Pump House, circa 1933 (photos 23-24): This small one-story wood frame building is located across the drive east of the milk cooling house. Facing toward the southwest, it has a rectangular plan measuring 16' x 20' and rests upon a raised concrete foundation enclosing a basement that is accessed by way of an interior plywood panel set in the wood plank floor. The building's exterior walls are clad in horizontal weatherboard siding. Its front-gabled roof is finished with open eaves with exposed rafter ends and corrugated metal panels. A beam supported by a knee brace projects from the ridgeline at the front gable. At the rear of the building, a vertical wood post projects from the ridgeline and holds several ceramic electrical insulators.

The southwest façade holds the main entrance, which is located at the building's southwest corner. This is reached by way of a short set of wood steps and contains a wood panel door. Two fixed single-light basement windows are present in the raised concrete foundation, one on the northwest wall and the other on the northeast. The main northwest wall holds two four-light casement windows, and a single-light casement window is found in the northeast wall (this was also likely a four-light window). All of these windows have wood frames and surrounds and open to the interior of the building.

Alterations – This building does not appear to have experienced any substantial exterior alterations other than replacement of its original front entry stairs.

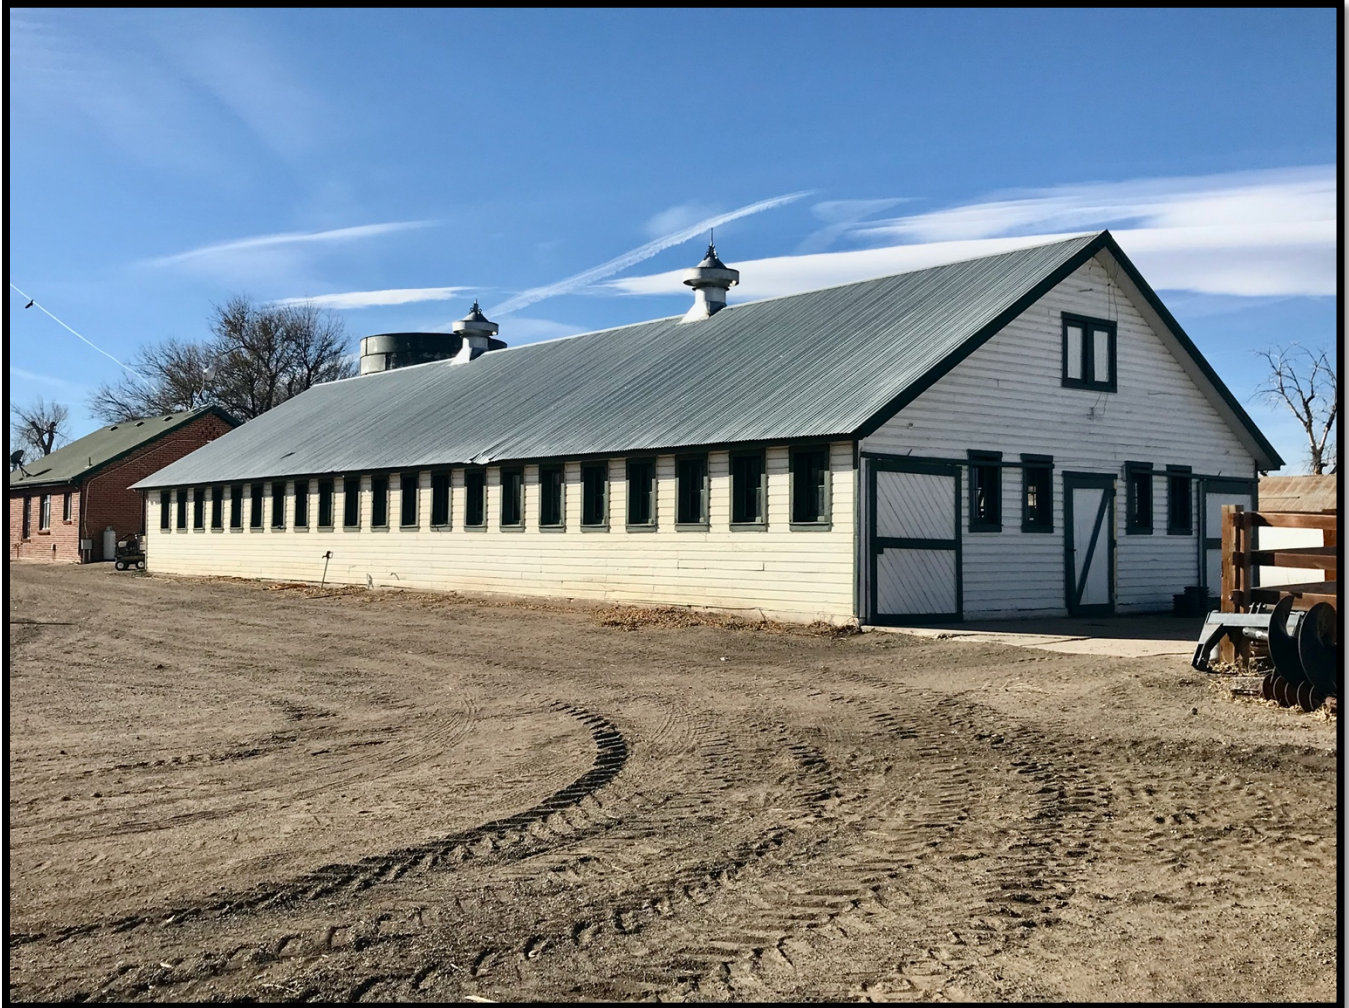
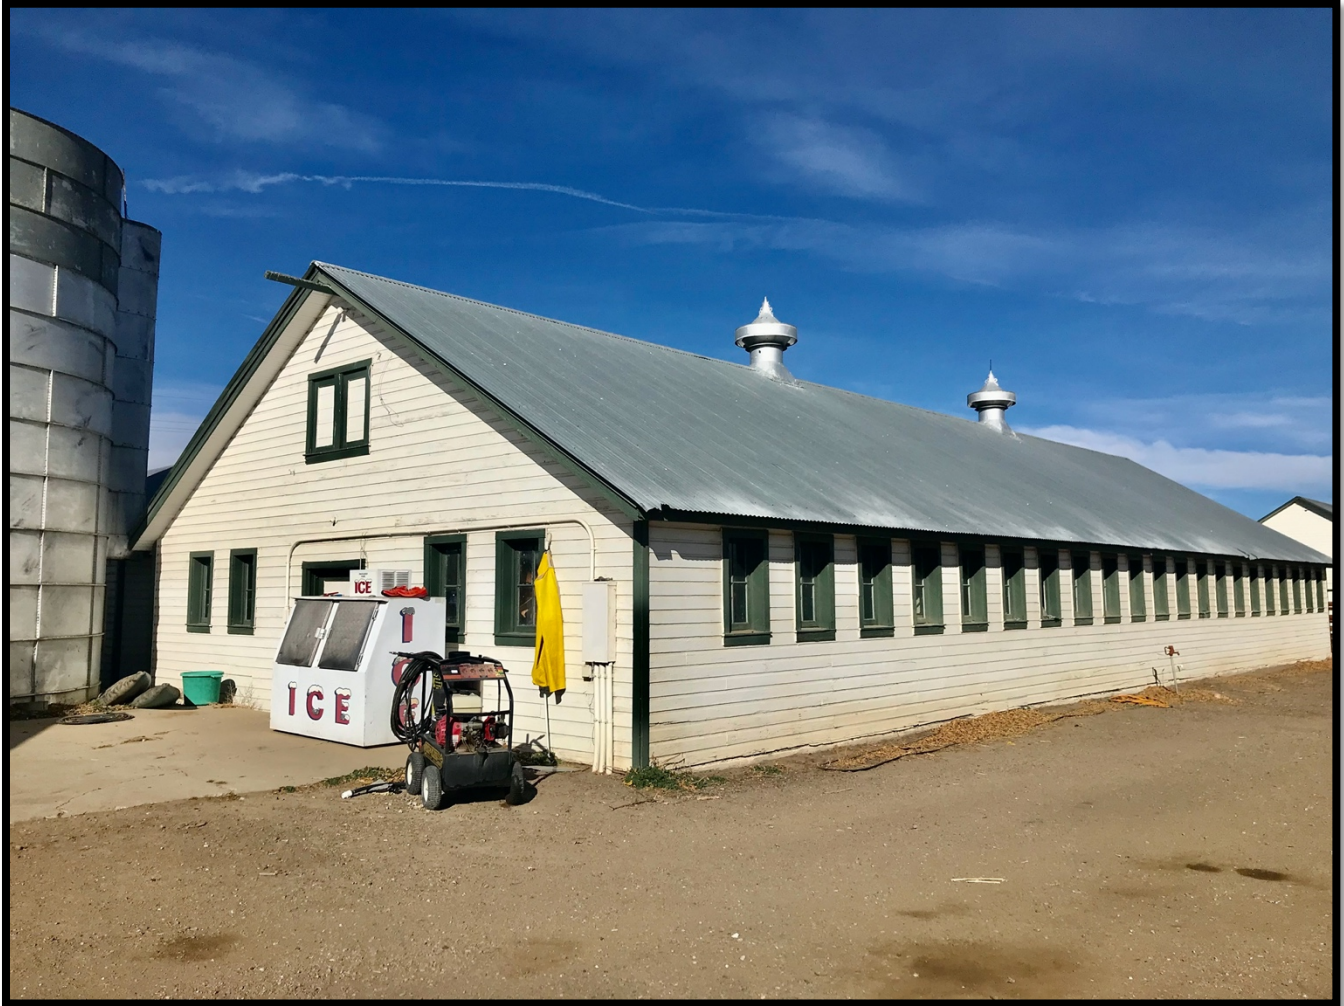
Photo 25
Milking Barn. View to the West.

Photo 26
Milking Barn. View to the North.

Milking Barn, circa 1933 (photos 25-27): This tall one-story wood frame building is centrally located across the concrete-paved courtyard northeast of the milk cooling house. Facing both northeast and southwest, it has a rectangular plan measuring 44' x 88' and rests upon a low concrete foundation. The building's exterior walls are clad in horizontal weatherboard siding. Its gabled roof is finished with shallow boxed eaves and corrugated metal panels. Two large round galvanized sheet metal ventilators with decorative finials rise from the ridgeline. These were fabricated by the Loudon Manufacturing Company of Fairfield, Iowa.

Three entrances are found on the northeast end of the building. The central one holds a vertical beadboard door with plank framing and diagonal cross bracing. This is flanked by four four-light hopper windows that open to the interior and have wood frames and surrounds. At the building's northeast and northwest corners are two large wood sliding doors that accommodated access and egress by dairy cows. Hanging from exterior rails, they are constructed of diagonal boards and beadboards with plank frames and bracing. Centered in the gable end wall above is a pair of attic access panels constructed of wood siding boards with wood frames and surrounds.

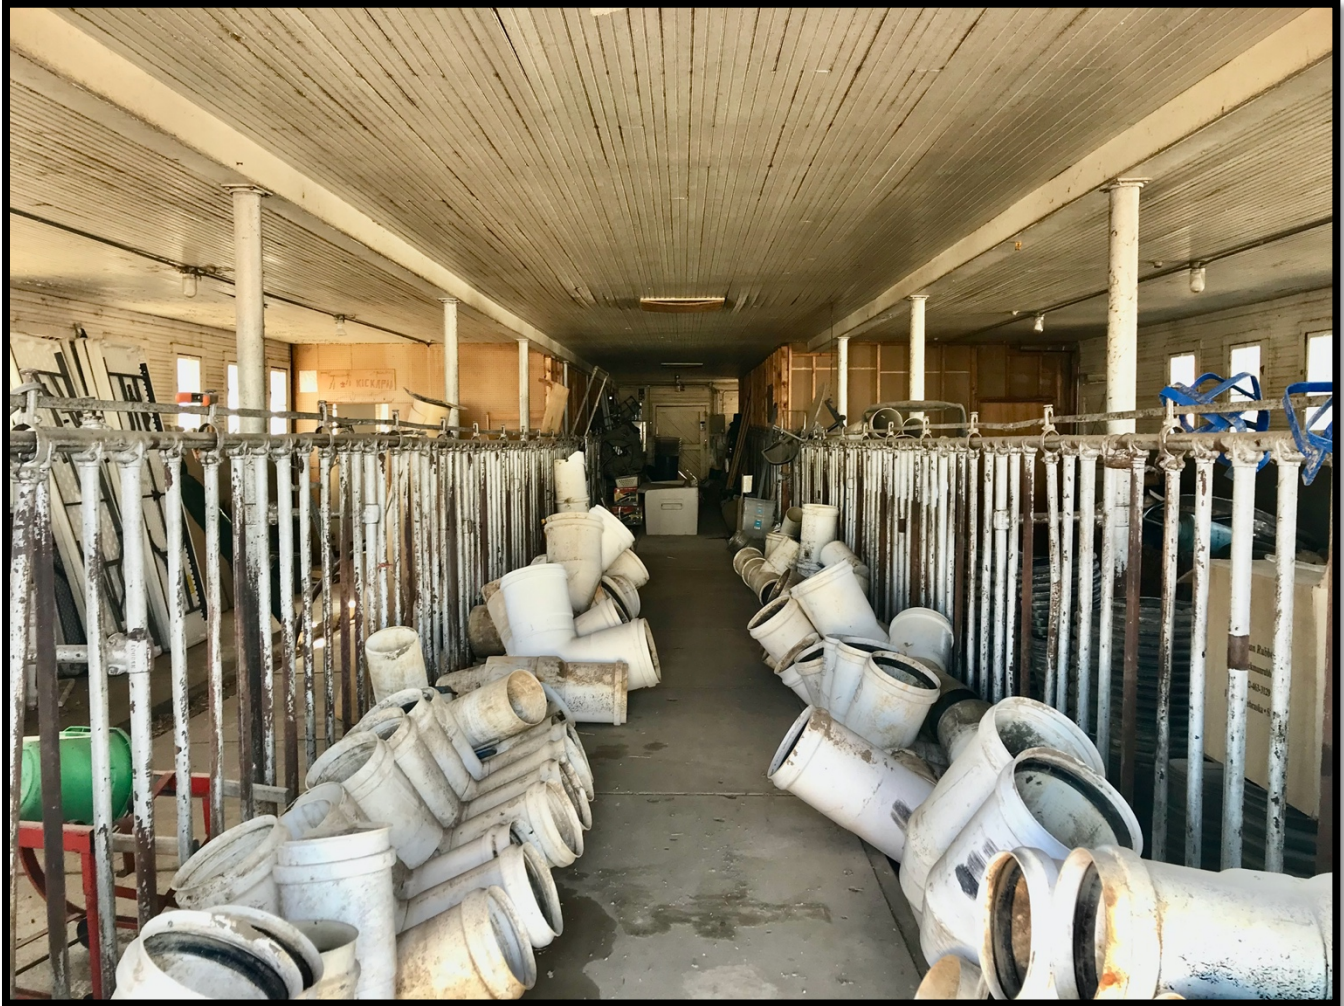
Photo 27
Milking Barn Interior. View to the Southwest.

The interior of the building holds a remarkably intact milking room dating from the 1930s. This space is finished with concrete floors, lower walls clad in flat waterproof boards, and beadboards on the upper walls and ceiling. The original bare bulb light fixtures are still in place along the ceiling, although they were replaced many decades ago by an electrical conduit system with glass-enclosed bulbs. The two centered, square openings for the ventilators are currently boarded closed. The long rectangular room is divided into three linear spaces. A central alley used by workers runs from northeast to southwest. Parallel to that on either side are the two milking areas where the cows stood.

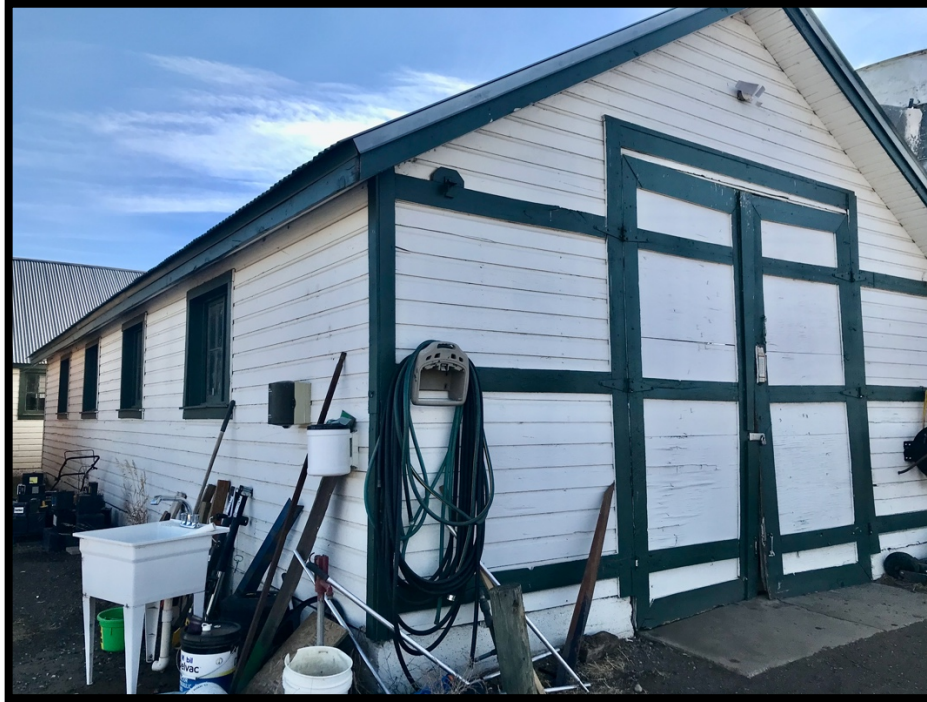
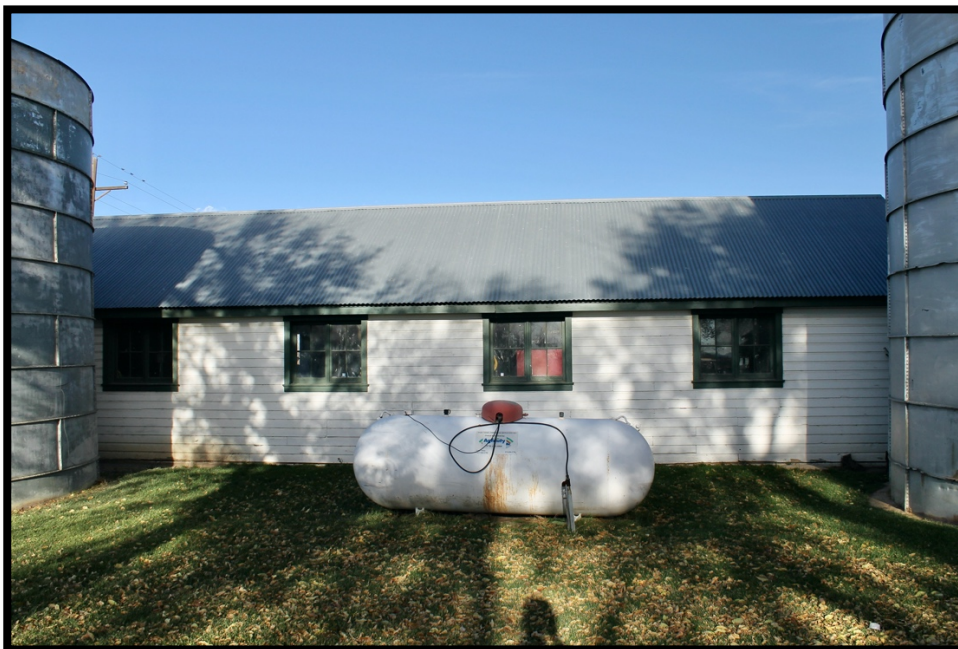
Photo 28
Milking Barn Annex. View to the Southeast.

Photo 29
Milking Barn Annex. View to the Northeast.

Milking Barn Annex, circa 1933 (photos 28-29): This one-story wood frame building is located west of and adjacent to the milking barn. It appears to have been used as a feed shop, where various grains were stored and mixed and then fed to the cows in the milking barn. The two buildings are minimally attached at the milking barn's southwest corner and the annex's southeast corner by a short, enclosed wood frame connector with a gabled roof. Facing northwest, the annex rests upon a low concrete foundation and its rectangular plan measures 21' x 50'. Its exterior walls are clad in horizontal weatherboard siding. The gabled roof is finished with shallow boxed eaves and corrugated metal panels. Two free-standing metal silos are located outside the building's southwest wall (these are addressed as contributing structures below). The silos are so close that they intersect with the building's eaves. Short concrete sidewalks and boarded openings in the wall adjacent to the silos suggest that silage was transferred directly into the building at those locations.
