National Register of Historic Places Registration Form

historic name ROCK CREEK FARM RURAL HISTORIC DISTRICT

street & number 2005 S. 112TH ST.

city or town BROOMFIELD

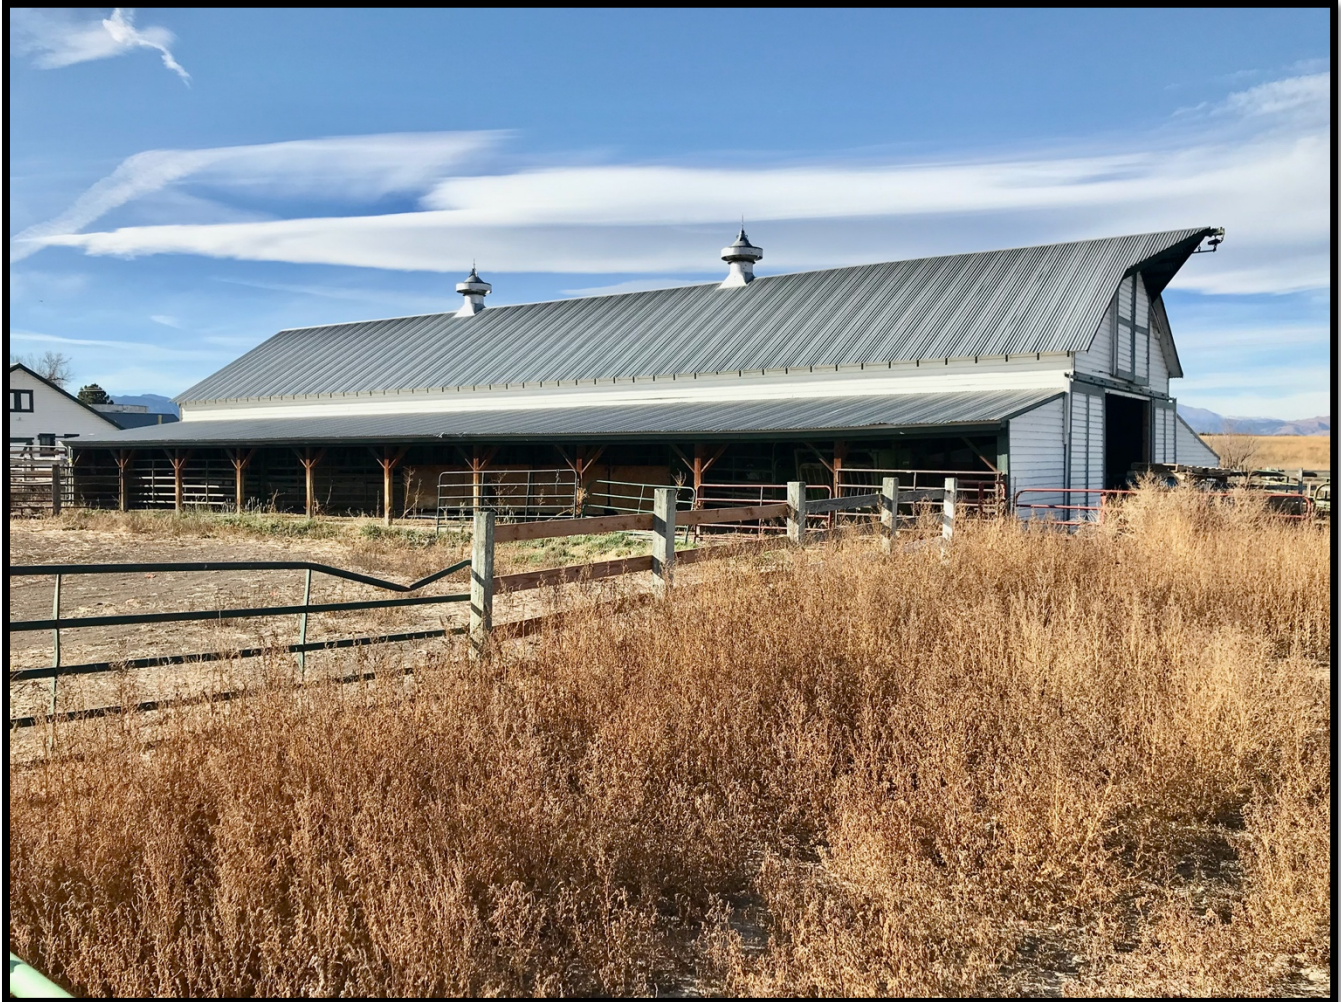
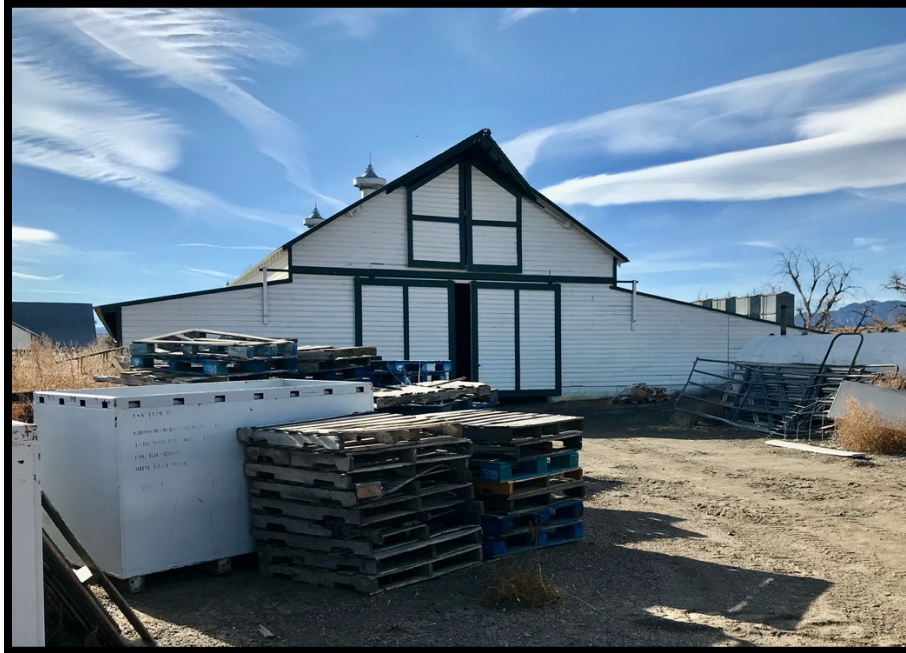
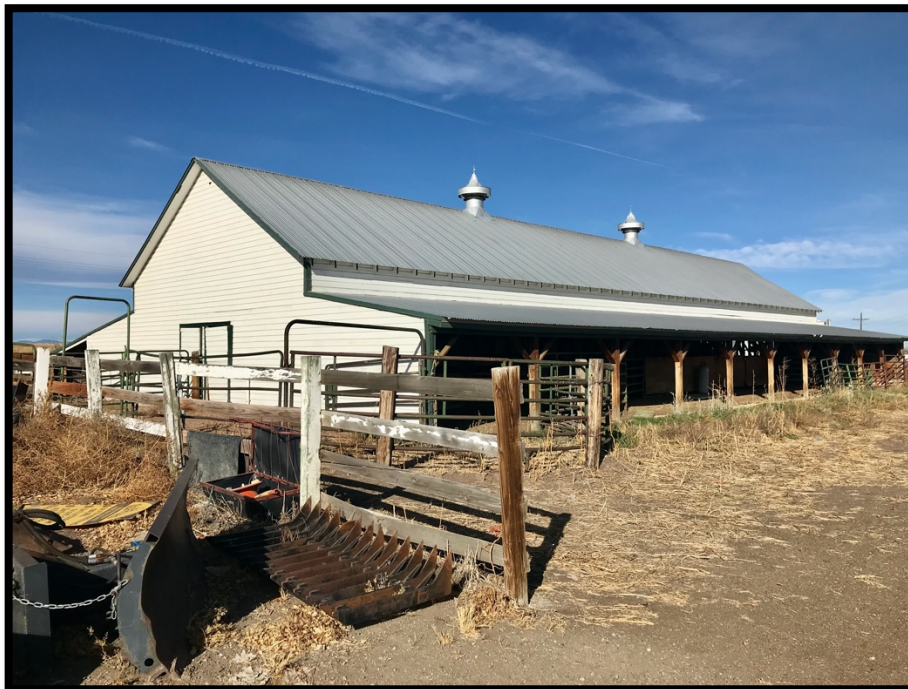
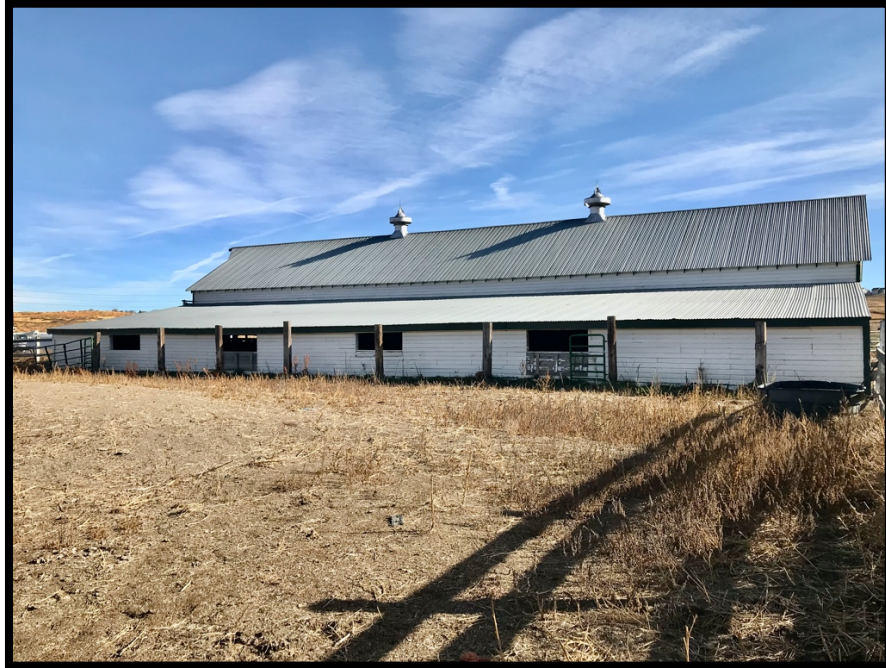
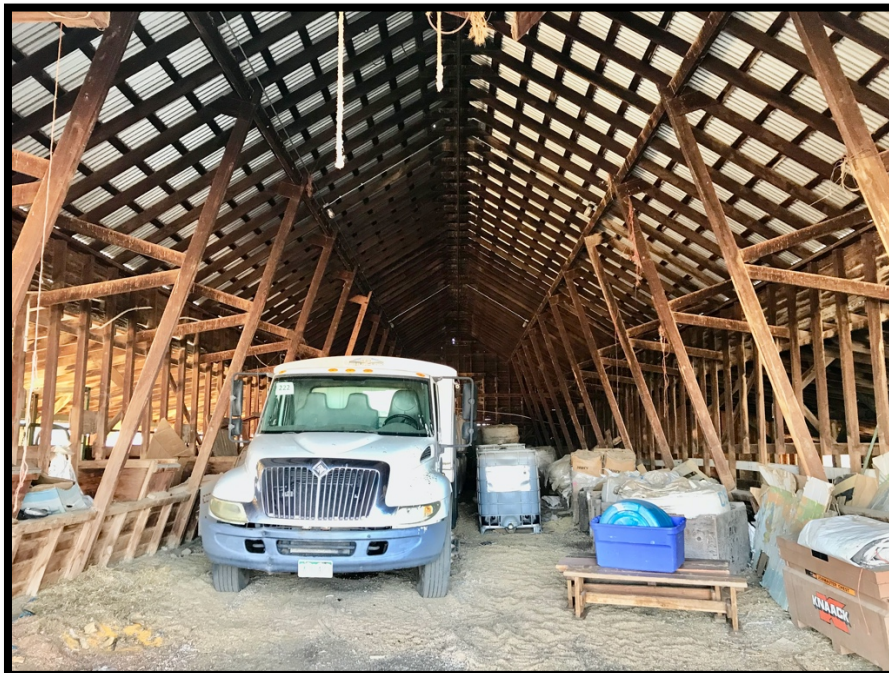
Photo 30
Feeding Barn. View to the West.

Photo 31
Feeding Barn. View to the Southwest.

Photo 32
Feeding Barn. View to the Northwest.

Photo 33
Feeding Barn. View to the East.

Photo 34
Feeding Barn Interior. View to the Southwest.

Feeding Barn, circa 1933 (photos 30-34): This wood frame building is located northeast of the milking barn and is the largest of all the buildings in the farmstead. It was used for the feeding of dairy cattle. Facing northeast, the barn rests upon a low concrete foundation and its rectangular plan measures 66' x 100'. Its exterior walls are clad in horizontal weatherboard siding. The building consists of a tall open central core measuring 28' x 100'. This has a gabled roof. Running parallel to that are two lower shed-roofed cattle wings to the northwest and southeast. All three roof levels are finished with shallow eaves, exposed rafter ends, and corrugated metal panels. A triangular hay hood projects from the main roof's ridgeline on the northeast end of the building. Also along the ridgeline are two large round galvanized sheet metal ventilators with decorative finials. These were fabricated by the Loudon Manufacturing Company of Fairfield, Iowa, and are similar if not identical to those found on the milking barn. The building's southeast roof slope was once painted with large lettering that identified the property as the "Stearns Dairy Co. Farm No. 2."

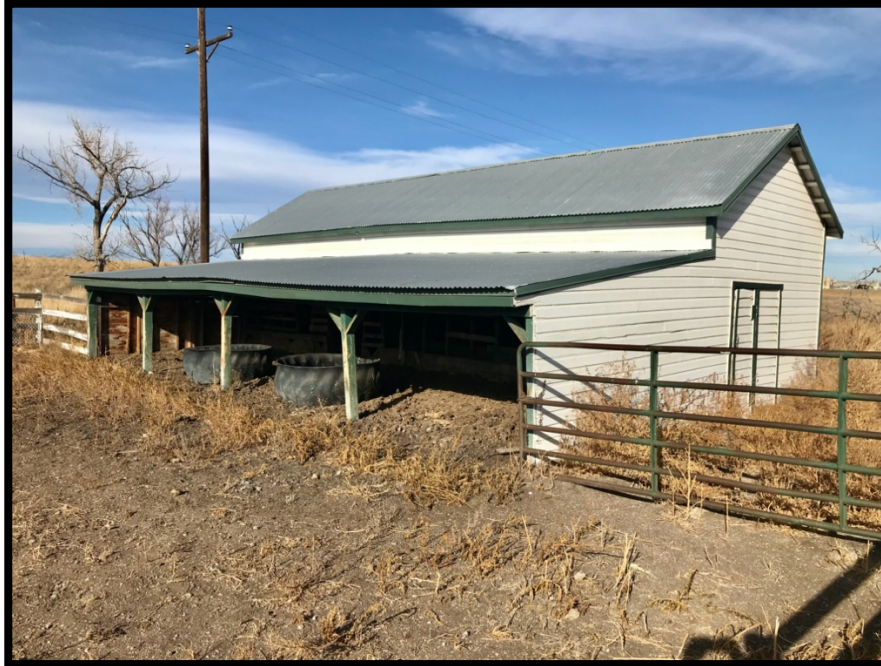
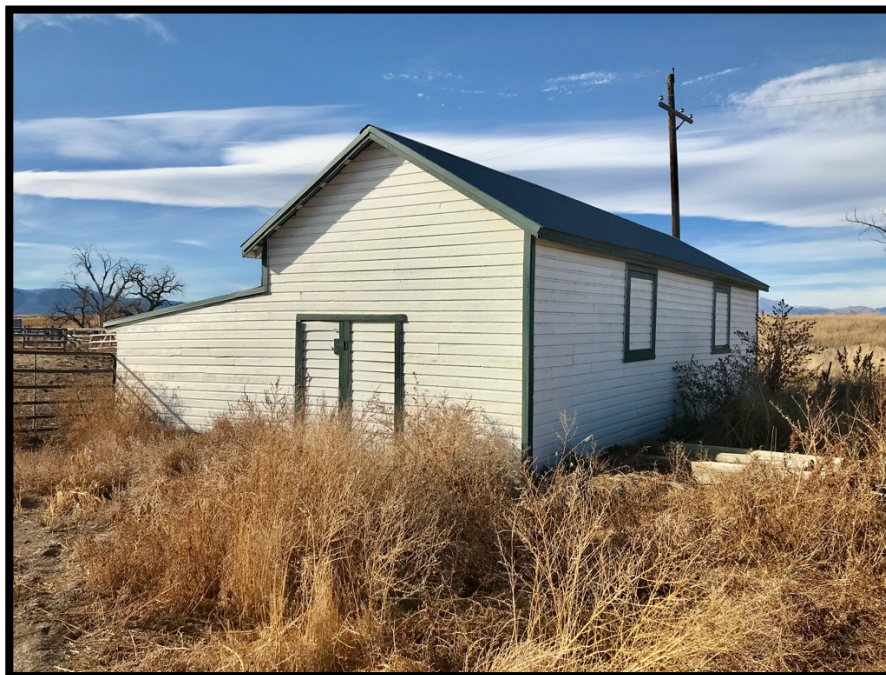
Photo 35
North Hay Barn and Loafing Shed. View to the North.

Photo 36
North Hay Barn and Loafing Shed. View to the West.

North Hay Barn & Loafing Shed, circa 1933 (photos 35-36): This one-story wood frame building is on the north edge of the farmstead, northeast of the feeder barn. Its rectangular plan measures 16' x 40'. Resting upon a low concrete foundation, the building is divided into two distinct areas. On the northeast is an enclosed 14' x 40' gabled hay barn that faces southeast. Southwest of that is a 12' x 40' open loafing shed that faces southwest onto a corral. The building's exterior walls are clad in horizontal weatherboard siding and its gabled and shed roofs have shallow open eaves with exposed rafter ends and corrugated metal panels.

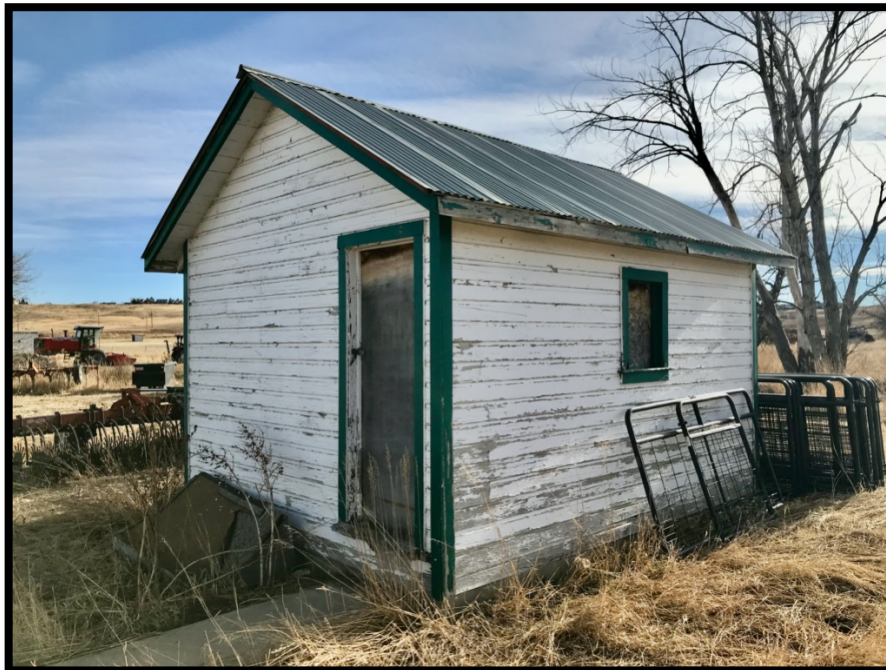
Photo 38
Old Well House. View to the Southeast.

Circa 1933 Well House (photo 38): This small one-story wood frame building is in the southwest area of the farmstead, on the west side of Rock Creek and directly across the farm road southwest of the hog house. It was the farm's original water pumphouse, located in the yard just southwest of the farmhouse. In its present location, the building has been used for storage. Facing toward the northeast, its rectangular plan measures 12' x 15'. The building rests upon a low concrete foundation and its exterior walls are clad in horizontal weatherboard siding. Its front-gabled roof has shallow open eaves with exposed rafter ends and corrugated metal panels.

Alterations – The building was moved to its present location about 125 yards southwest of the farmhouse around 1985, when it was replaced by the present pumphouse on the farmhouse grounds. Other than its new location, it does not appear to have experienced any substantial exterior alterations.

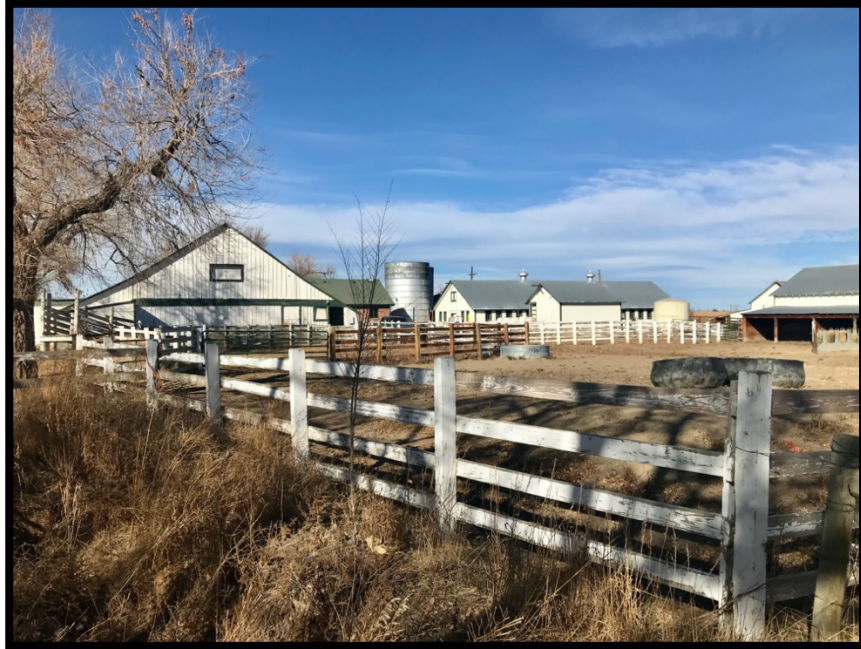
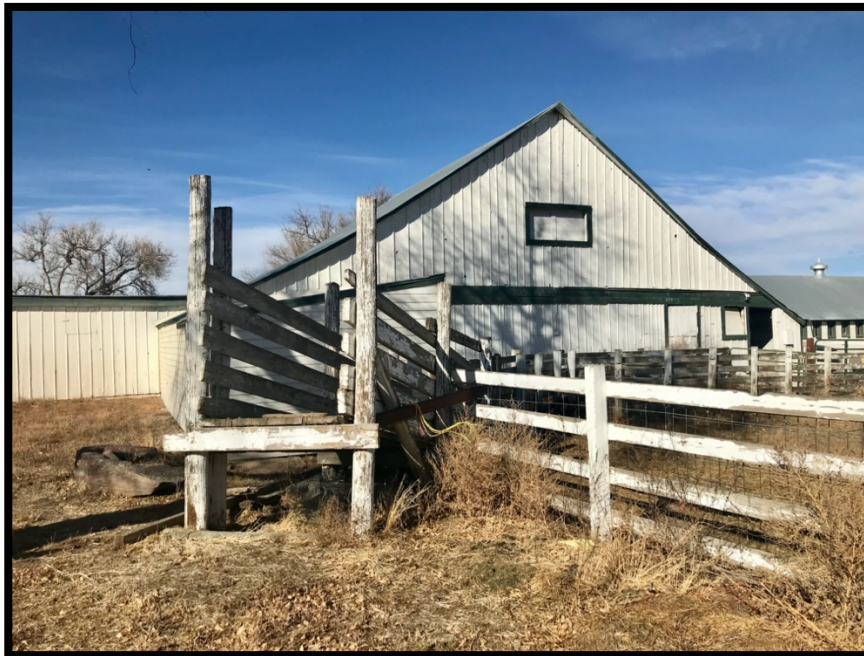
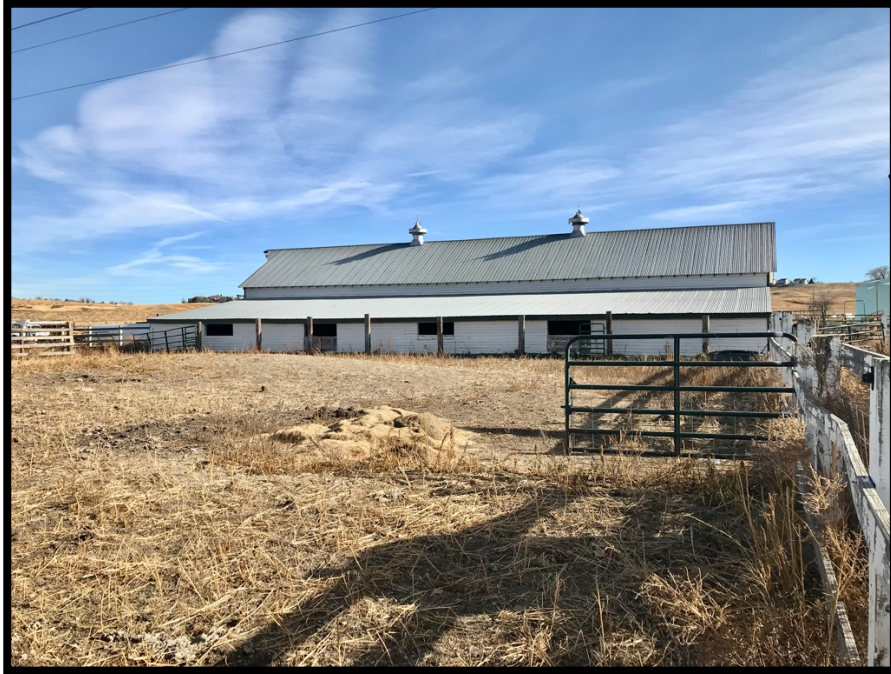
Photo 40
Corral East of the Horse Barn. View to the Northwest.

Photo 41
Loading Chute at the Corral East of the Horse Barn. View to the Northwest.

Photo 42
Corral West of the Feeding Barn. View to the Southeast.

Livestock Corrals, circa 1933 (photos 40-42): The corrals were used to hold dairy cattle and are found in two locations within the farmstead. One large corral occupies the grounds between the horse barn and the hay barn-loafing shed to the east. Within the west area of this corral is a smaller fenced enclosure. A cattle chute is located at the corral's southwest corner adjacent to the horse barn. Another set of interconnected corrals of various sizes is found around the feeding barn in the northern area of the farmstead. The small corral between the feeding barn and milking barn holds a rectangular raised concrete watering trough. All of the corrals are bordered by wood post and rail fencing.

Alterations – Livestock corrals have been present in association with the farmstead since it was constructed in the early decades of the twentieth century. Over the years, wood posts and rails would have been replaced with similar materials as needed. In general, the corrals do not appear to have experienced any substantial alterations.

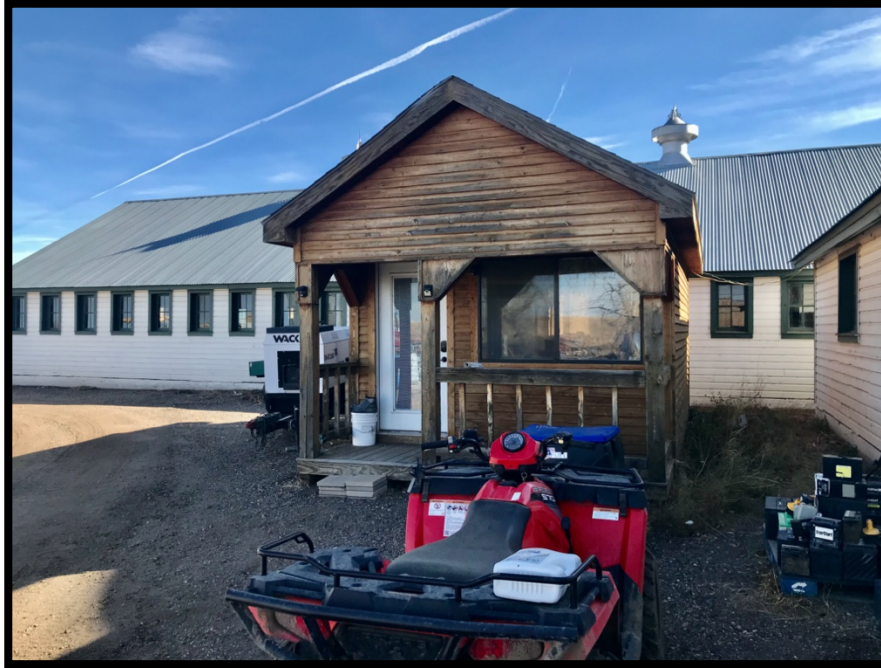
Photo 47

Small Office (Non-Contributing) Adjacent to Milking Barn Annex. View to the Southeast.

Small Office, 2015 (photo 47): This small non-historic one-story wood frame building is located west of the milking barn and north of the milking barn annex, occupying the inner angle formed by these two connected buildings. It was placed there in 2015, apparently to be used as an office. Facing northwest, the building rests on piers, its walls are finished with natural clapboard siding, and it has a front-gabled roof with boxed eaves and composition shingles. The façade features an open porch with an open rail. The entry holds a glass door and a single two-light sliding window is found on each of the northwest, northeast and southeast walls.

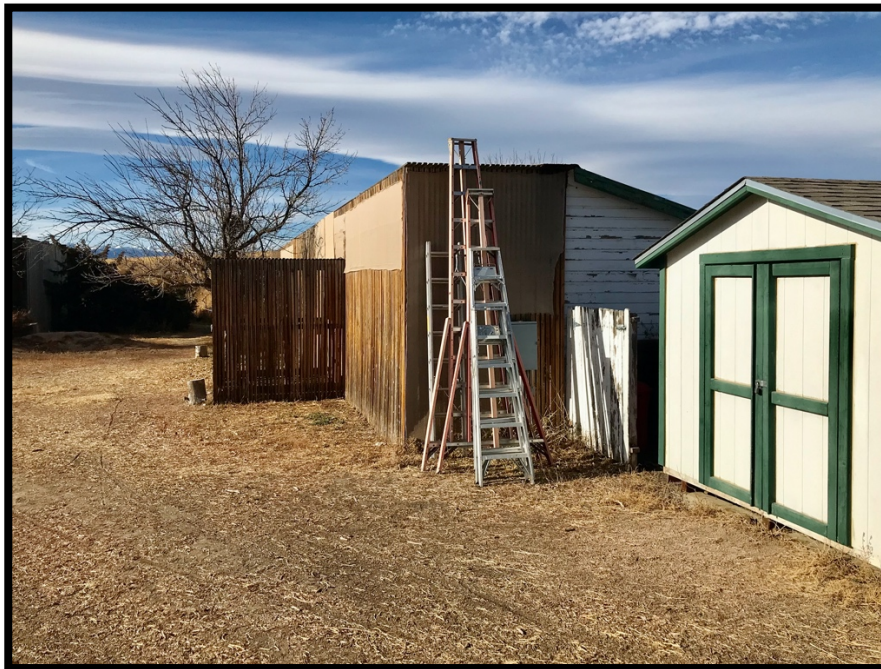
Photo 48

South Loafing Shed (Non-Contributing) in Raptor Area. View to the Northwest.

South Loafing Shed, circa 1933 (photo 48): This historic one-story wood frame loafing shed is located in the southwest area of the farmstead, west of the house and within the fenced compound now used as a raptor rehabilitation center. Facing toward the southwest, its rectangular plan measures 16' x 100'. The building rests upon a low concrete foundation and has an earthen floor. Its original exterior walls are clad in weatherboard siding and it was open to the southwest. The building has a saltbox roof finished with corrugated metal panels.

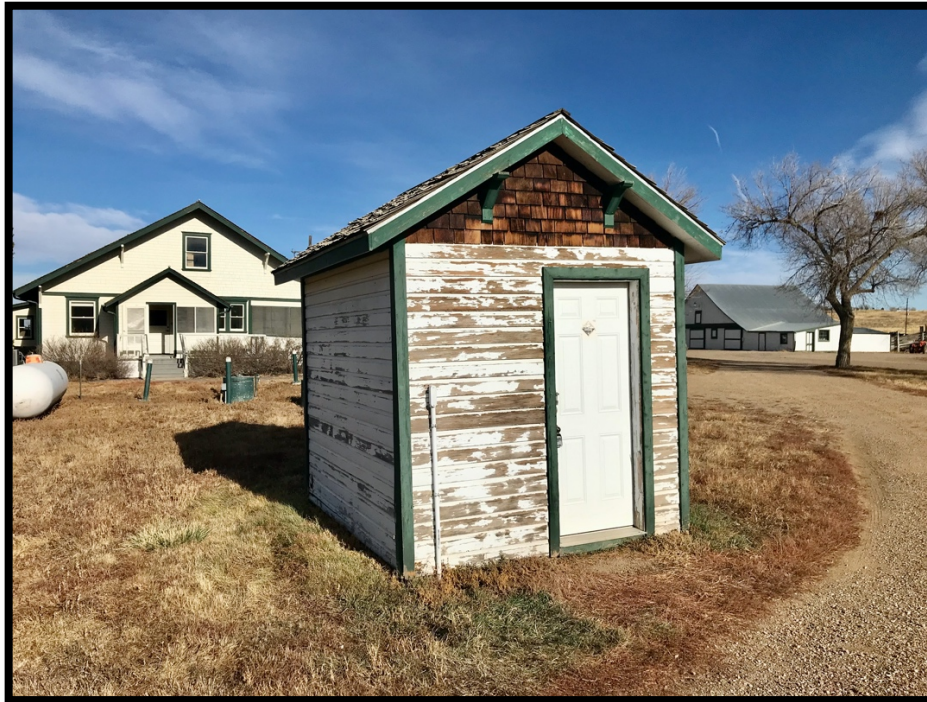
Photo 49

New Well House (Non-Contributing) Southwest of the House. View to the Northeast.

Circa 1985 Well House (photo 49): This small one-story wood frame building is in the yard southwest of the farmhouse. Facing southwest, it rests upon a concrete foundation and has a rectangular plan measuring 8' x 10'. The exterior walls are clad in what appears to be historic weatherboard siding that might have been repurposed from elsewhere on the property. The gabled roof is finished with boxed eaves and wood shingles. Square butt wood shingles are on the gable end walls. The southwest façade holds a non-historic panel door and there are no windows on the building.

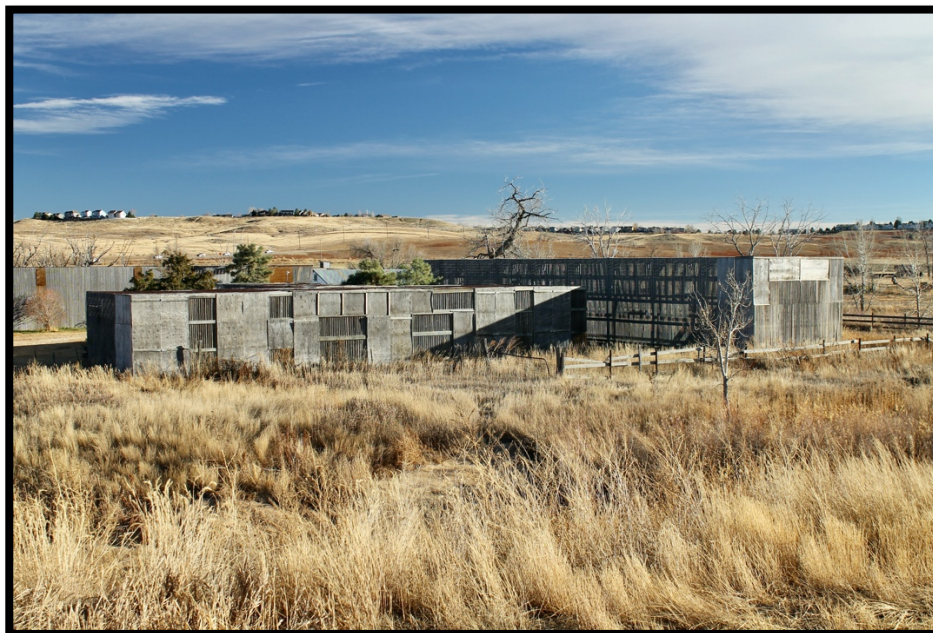
Photo 50

Raptor Rehabilitation Enclosures, 1988-1989 (photo 50): Standing in a fenced area southwest of the farmhouse are four non-historic rectangular wood frame structures. Together with the former loafing shed described above, these serve as flight enclosures that have been used since the

Raptor Rehabilitation Enclosures (Non-Contributing). View to the Southeast.

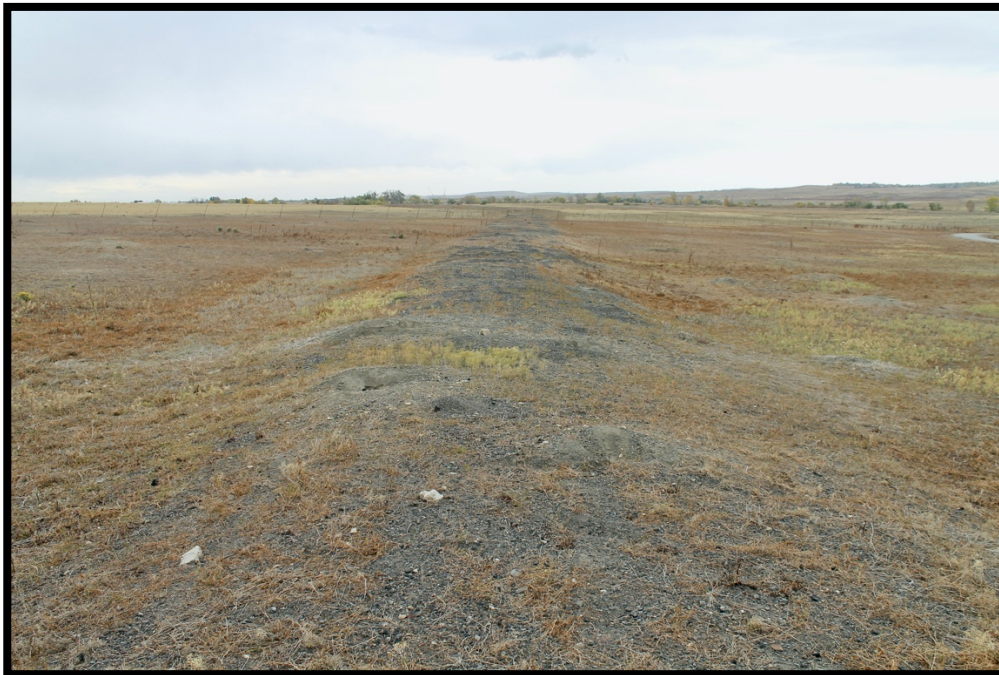
(5BL.400 & 5BL.400.13 & 5BF.70.7), 1873-1906 (photo 52): The east half of Section 28 in the southwest area of the nominated property holds an abandoned north-south rail segment that arcs through the fields just east of Brainard Drive. This was constructed in 1873 by the Colorado Central Railroad (CC) to Boulder and Longmont. In 1877, traffic extended all the way to Fort Collins and Cheyenne, Wyoming. Over the years, the CC was also acquired by a series of subsequent owners.

Photo 52
Colorado Central Railroad Segment. View to the Northeast.

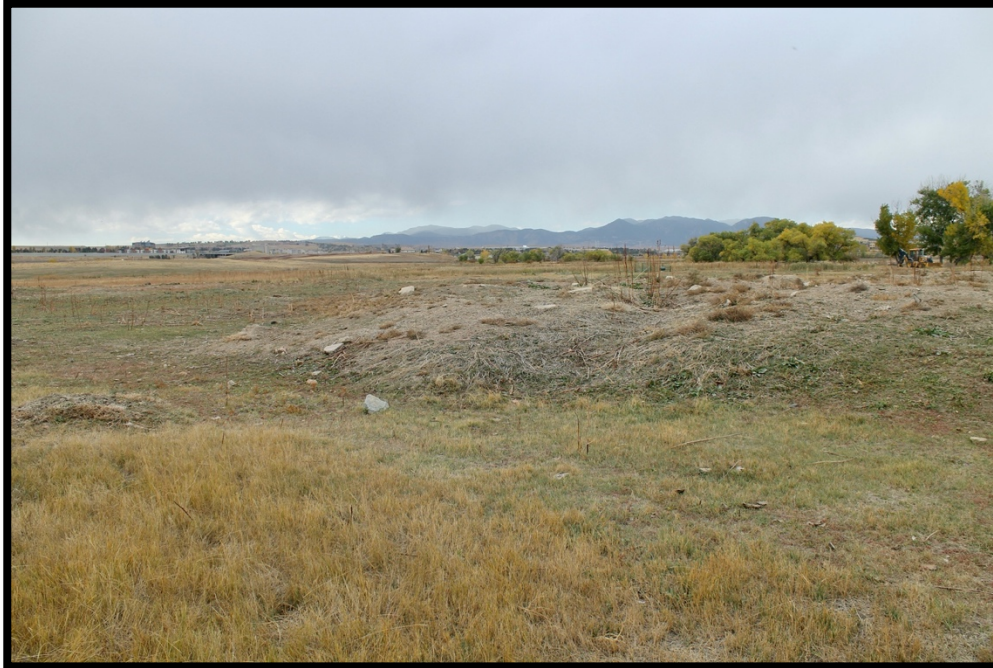
Photo 53

Sunnyside Coal Mine, 1900-1921 (photo 53): Located near the southwest boundary of Rock Creek Farm, the Sunnyside Coal Mine occupied much of the northeast quarter of Section 28 south of Rock Creek and east of Brainard Drive. Encompassing a surface area of around 235 acres, the mine might have also crossed the section line to occupy a small part of the northwest quarter of Section 27. Its underground workings were accessed by way of two shafts. During its two decades of operation, the site included not only what was below ground, but also various surface buildings and structures as well as a rail spur.

Vicinity of the Sunnyside Coal Mine. View to the Southwest.

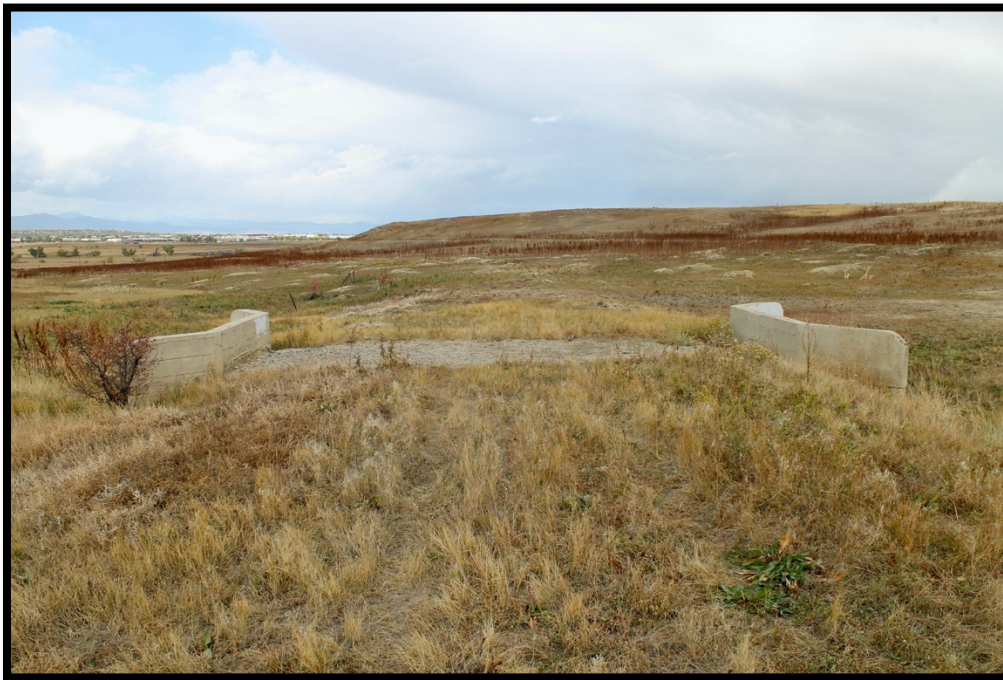
Photo 54

Lincoln Highway / Colorado Route 1 Road Segment & Bridge, 1910s-1920s (photo 54): By the mid-1910s, an unpaved automobile road ran through and along the east edge of Rock Creek Farm. Where it had to negotiate the bluffs and washes in the southeast quarter of Section 22 and northeast quarter of Section 27, a half-mile-long segment of the road diverged from the east section lines and curved westward into the property. It remained southeast of the CB&Q line before returning to the east section lines.

Colorado Route 1 Bridge and Road Segment. View to the Northwest.

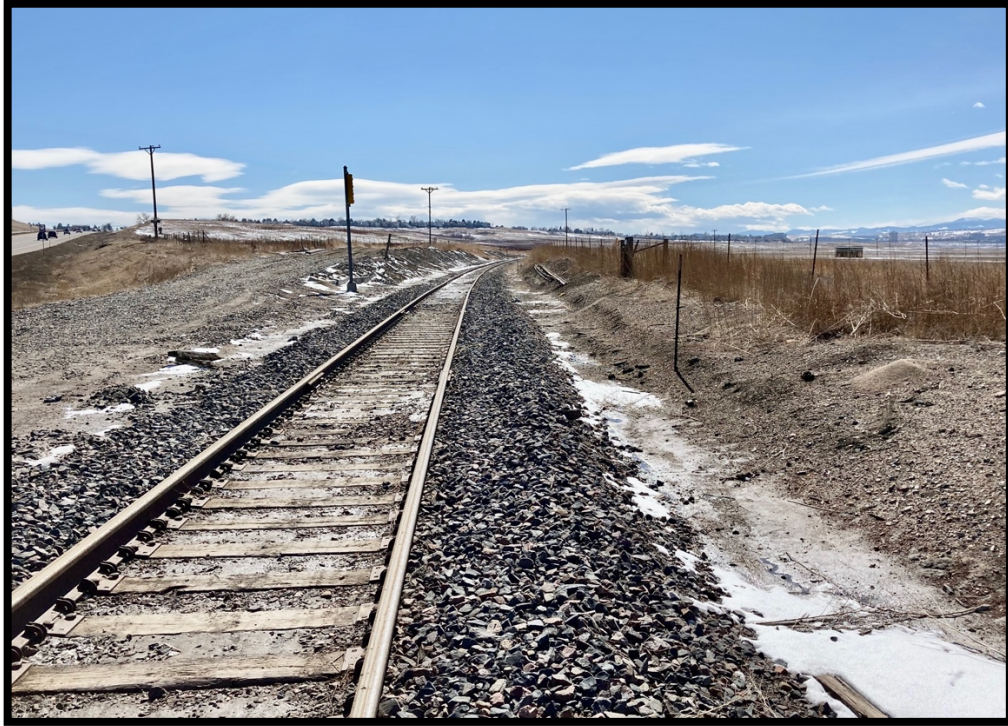
Photo 55

Denver, Utah & Pacific Railroad Segment. View to the Southwest.

Denver, Western & Pacific Railroad / Denver, Utah & Pacific Railroad / Chicago, Burlington & Quincy Railroad / Burlington Northern Santa Fe Railroad Segment (5BL.374 & 5BL.374.11), 1881-1889 (photo 55): The rail line that runs on a diagonal through Sections 22 and 27 was completed in 1889 by the Denver, Utah & Pacific Railroad (DU&P) to connect Denver with Longmont and Lyons. To the south at Burns Junction, just southeast of the nominated property's southernmost point along the north side of today's Industrial Lane, the route diverged from the main line of the Denver, Marshall & Boulder Railroad (DM&B), a subsidiary of the Union Pacific.

Between Burns Junction and Erie nine miles to the northeast, the DU&P line was built on a grade that had been constructed in 1881, but never completed with ties and rails, by the Denver, Western & Pacific Railroad. Today it is operated by the Burlington Northern Santa Fe Railroad (BNSF) but no longer reaches Longmont. The route is now truncated on the southeast edge of Lafayette southwest of the intersection of South Boulder Road and 120th Street, where it continues to serve two large lumberyard and building materials facilities.
