National Register of Historic Places Registration Form

3. State/Federal Agency Certification	
Not for Publication: Vicinity:	
	ounty: Chaffee
2. Location Street & Number: 18101 Mountain View Drive	
Other Names/Site Number: Morrison Homestead/5CF3573 Name of related multiple property listing: N/A	
Historic Name: McFadden Brothers Ranch East Headquarters

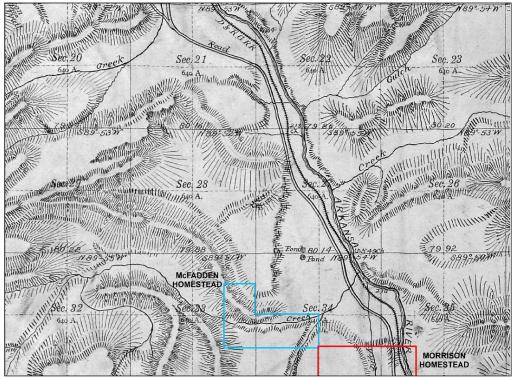
Figure 1. The boundary of the 1881 McFadden homestead is displayed here over the 1880 US Surveyor General's original township survey plat. The McFaddens later acquired the 1876 Morrison homestead to the southeast and built the 1920s headquarters (the subject of this nomination). The base map shows the location of the wagon road and Denver & Rio Grande Railroad tracks on the west bank of the Arkansas River. SOURCE: extract of US Surveyor General, original survey plat, Township 12 South, Range 79 West, 6th Principal Meridian, November 3, 1880.

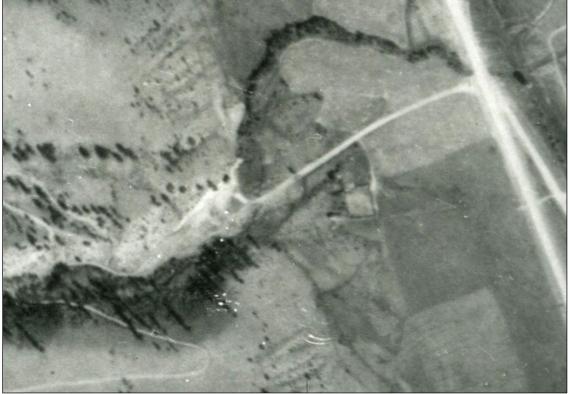
Figure 3. This 1938 aerial photograph shows the east headquarters area, with US 24 to the upper right and a road (now Mountain View Drive) extending southwesterly from the highway. The house and barn are present on the north side of the access road. The corral stands on the south side of the road with the gambrel roof building (not yet in its current location) and at least one other building to the west. The center pivot sprinklers have not yet been installed. SOURCE: Aerial photograph, September 30, 1938, BOV 30-81.

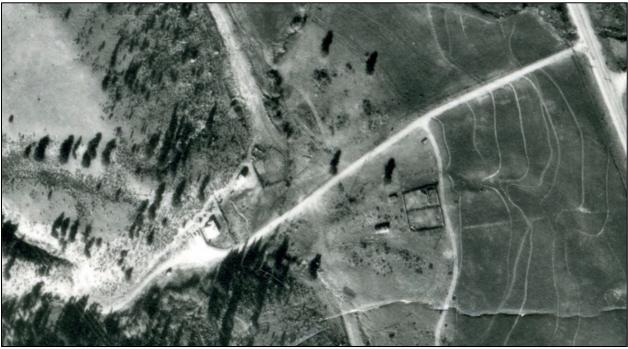
Figure 5. This 1972 extract of an aerial photograph shows the east headquarters area with approximately the same extent as the previous aerial photograph. The house and barn are present on the north side of the access road. The corral stands on the south side of the road with the gambrel roof building (not yet in its current location) and one other building to the west. The center pivot sprinklers have not yet been installed. SOURCE: Aerial photograph, October 25, 1972, 90576 CE 1421 1-03.
