National Register of Historic Places Registration Form

historic name Glassier Farmstead

other names/site number 5EA.3988

city or town Basalt

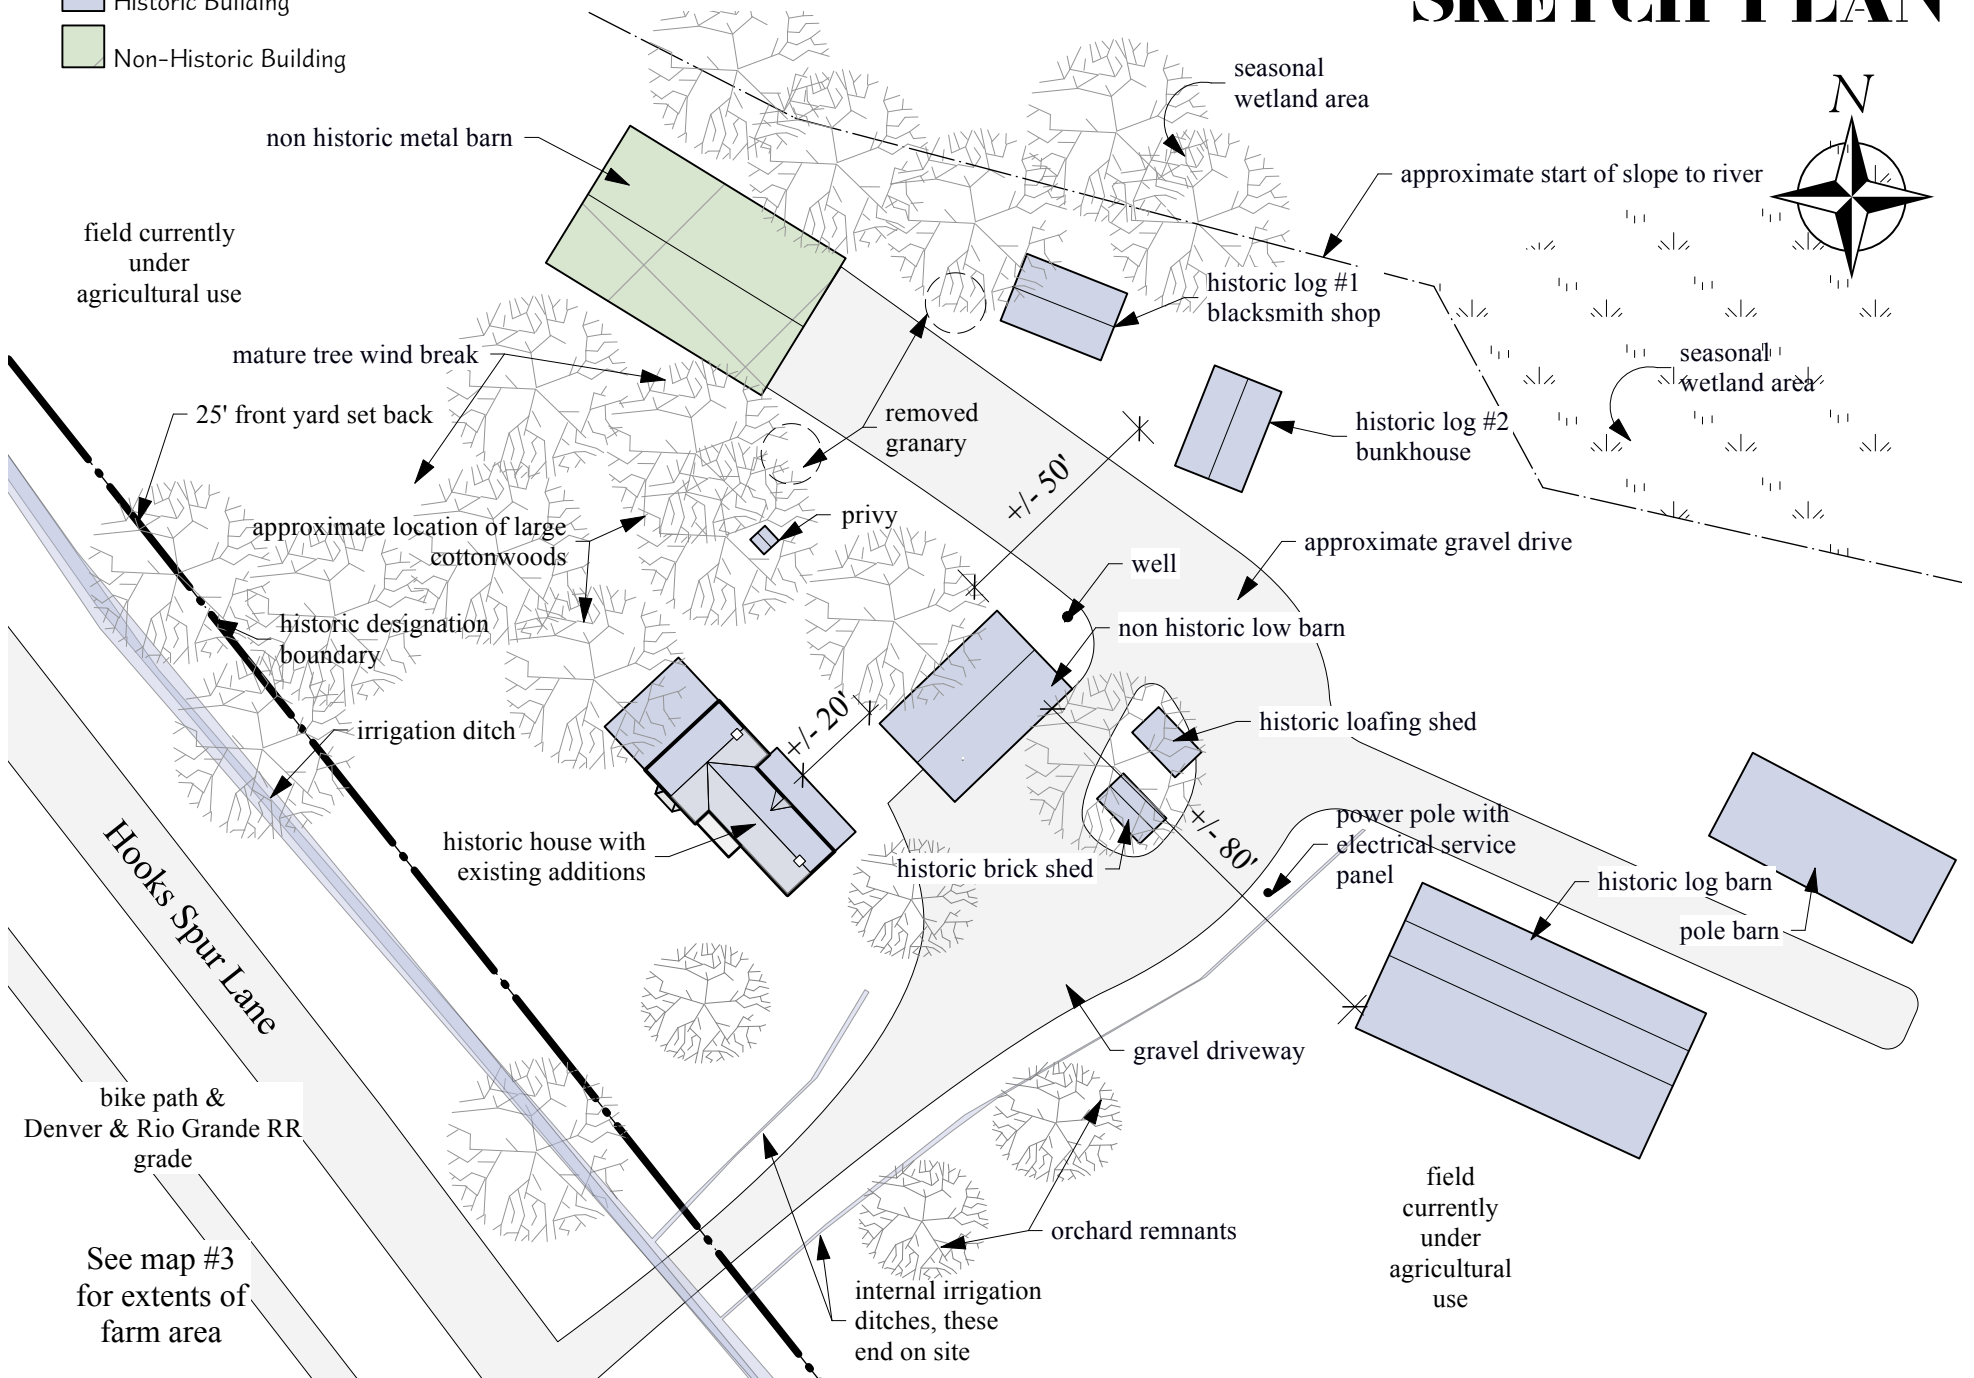
Map #3 • Historic Glassier Farmstead • Sketch Plan

SKETCH PLAN

- Historic Building
- Non-Historic Building

all locations and sizes are approximate

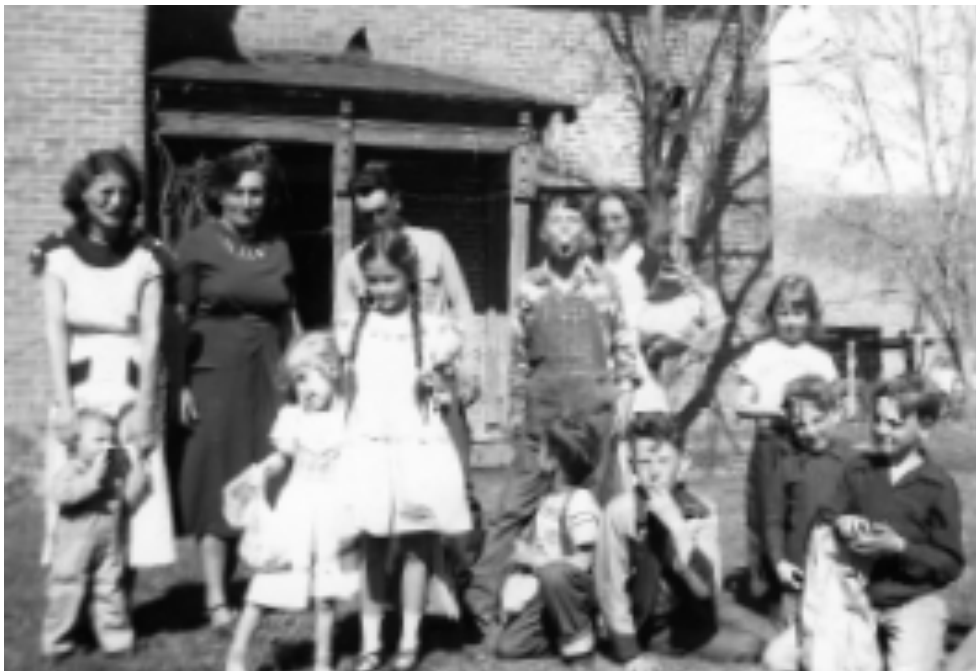
Note: Porch woodwork and decorative details are intact, however altered window to the right of the porch can be seen. The original window opening can still be seen in the brick wall.

Concurrent with these additions, two other vertically proportioned double hung windows were removed. These openings were altered to allow for a picture window on the southwest, adjacent to the entry porch and a horizontally proportioned slider window on the southeast façade, both on the main level of the house (the slider probably replaced an older fixed window). The original segmental arches remain in the brick wall, indicating the size and location of the original window openings. Finally, based on historic photos the original central porch post was removed, around or after 1950s, and the original porch floor was replaced with concrete.

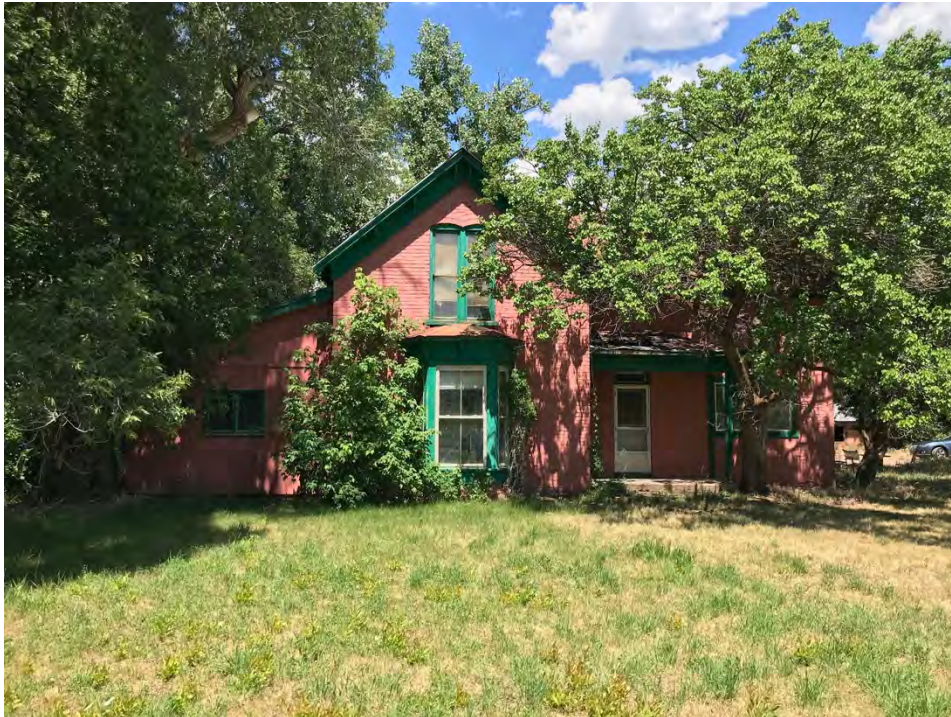
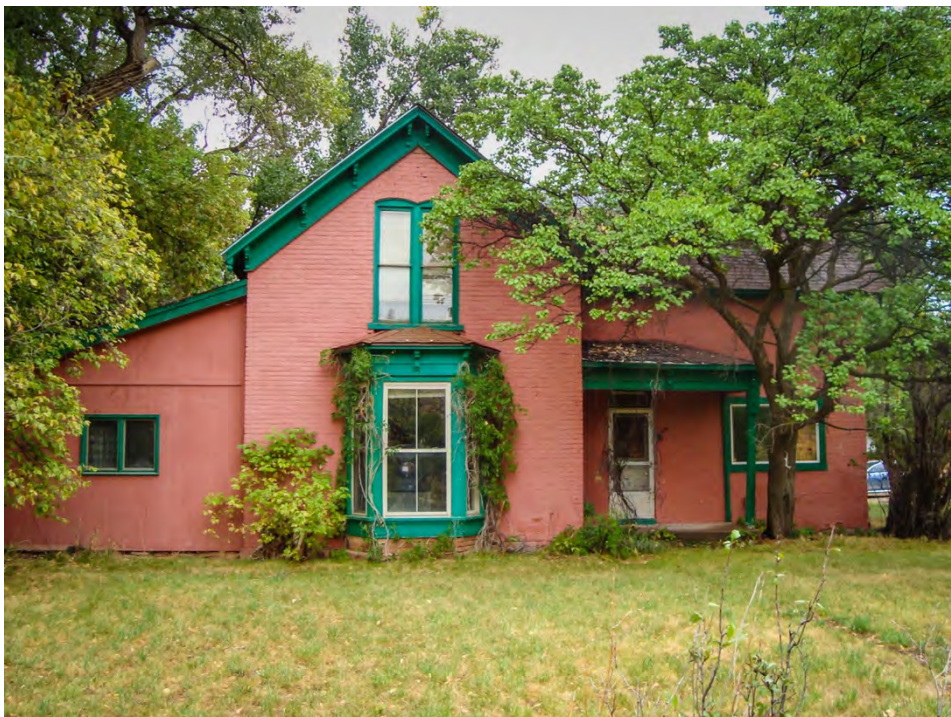
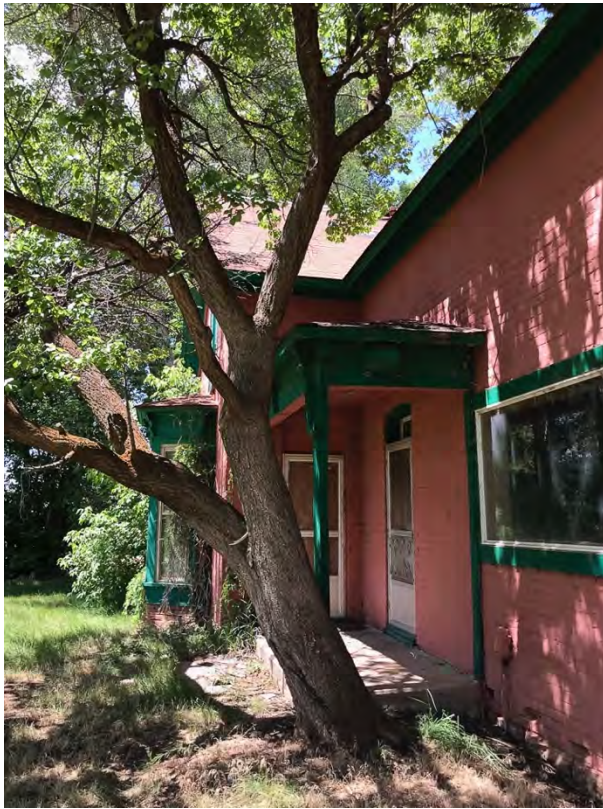
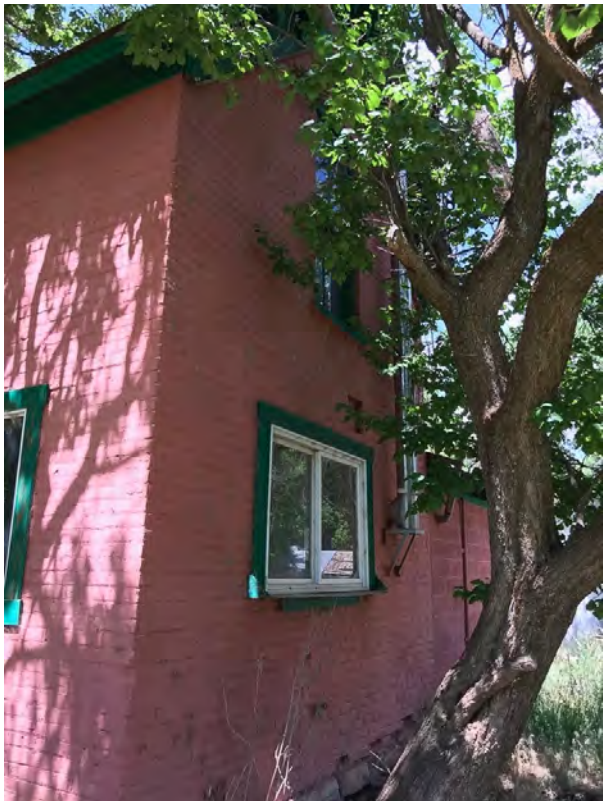
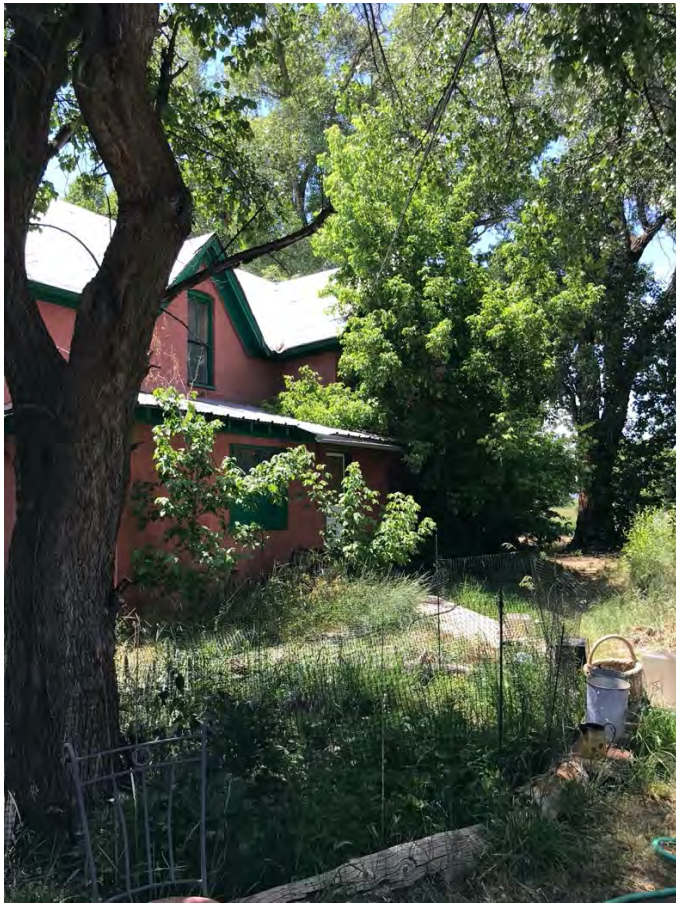
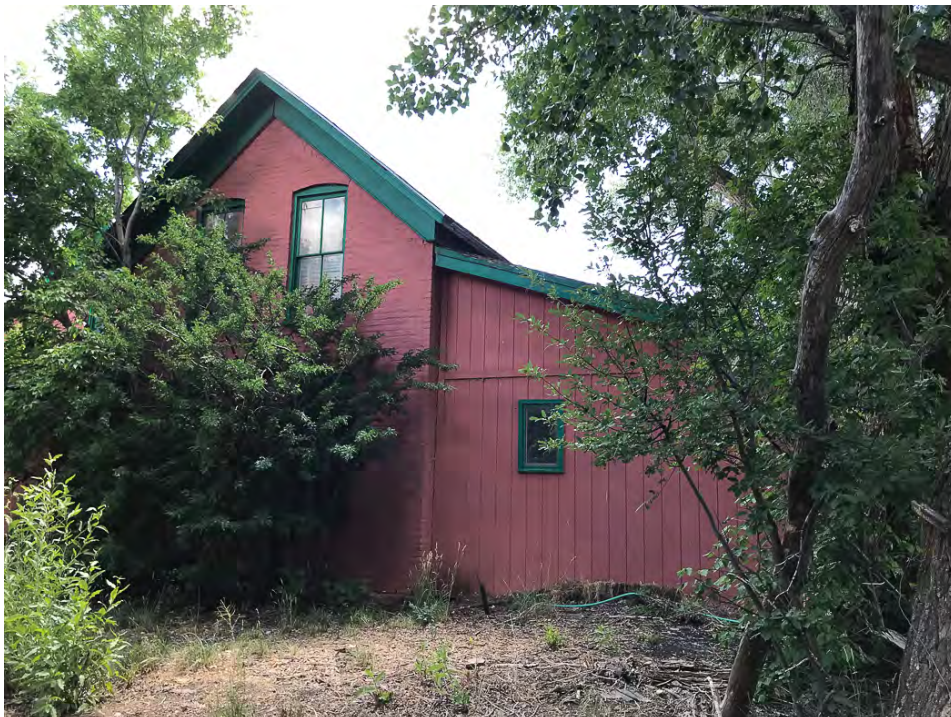
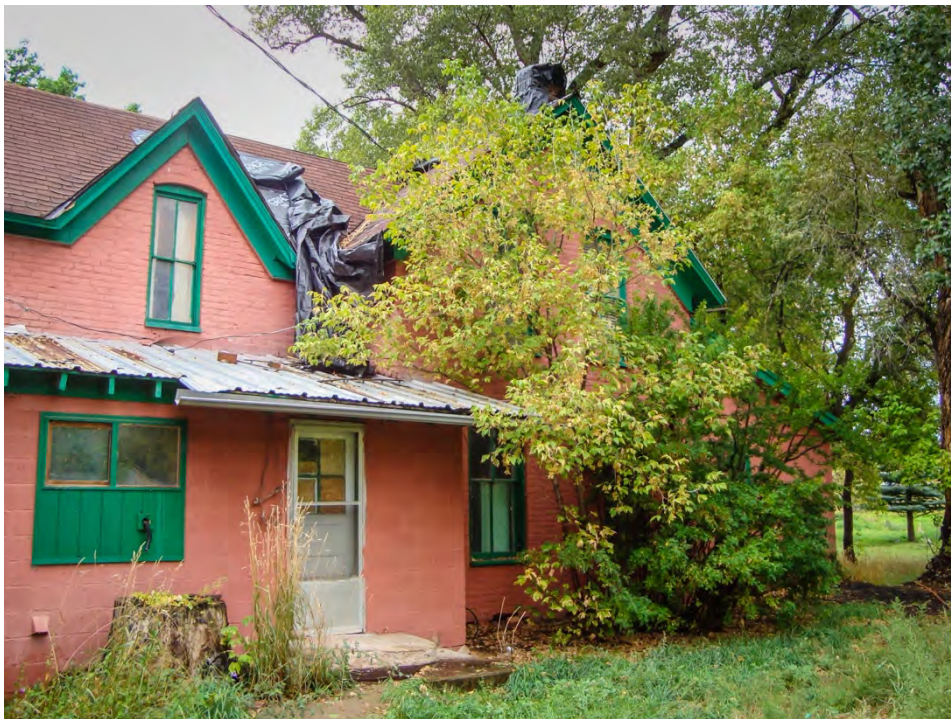
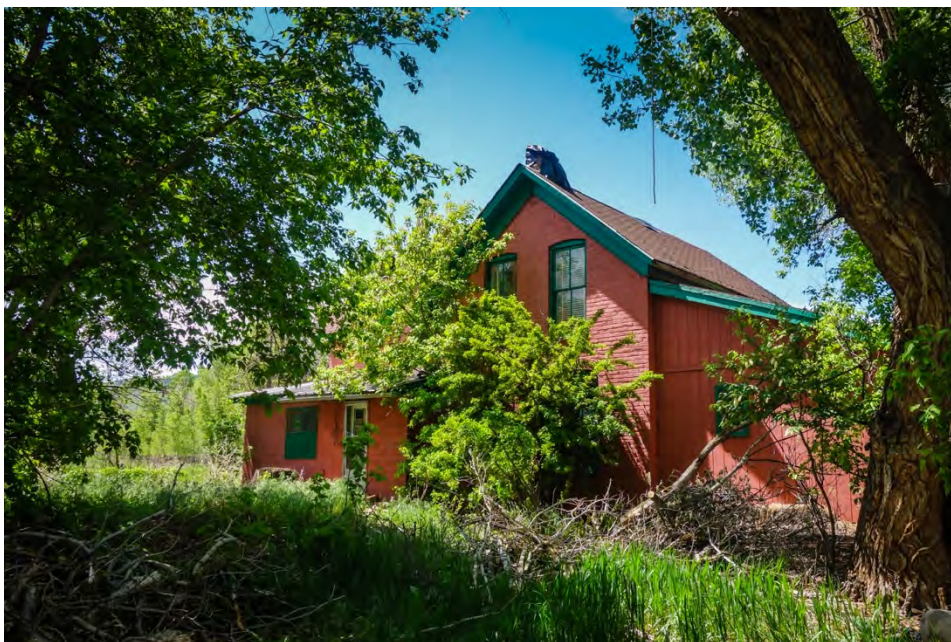
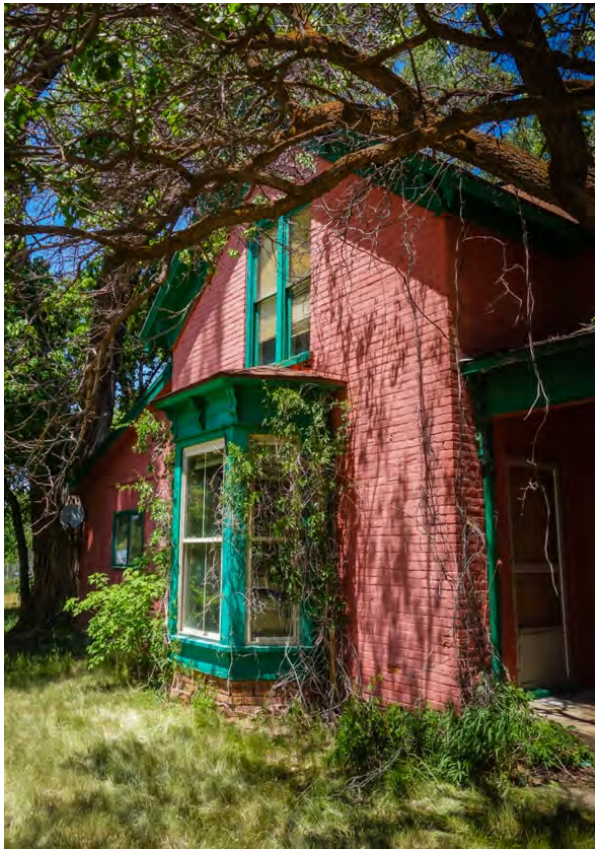
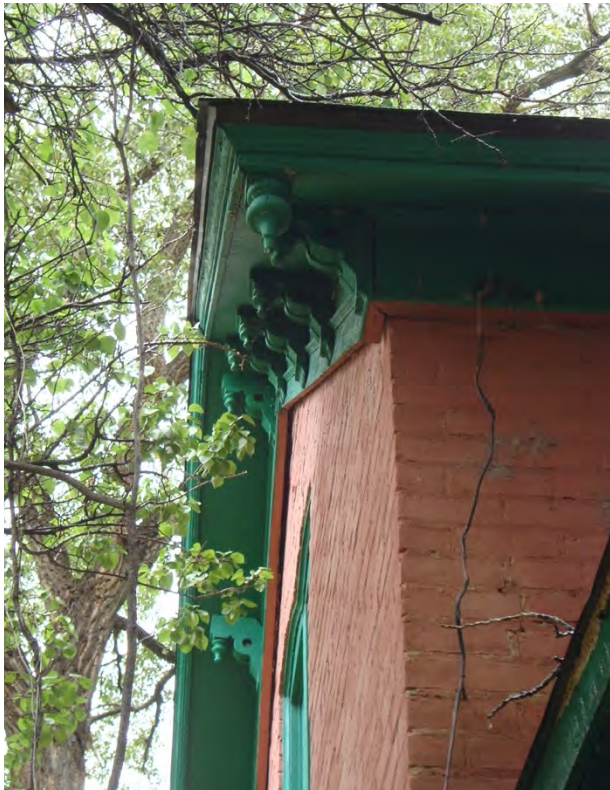
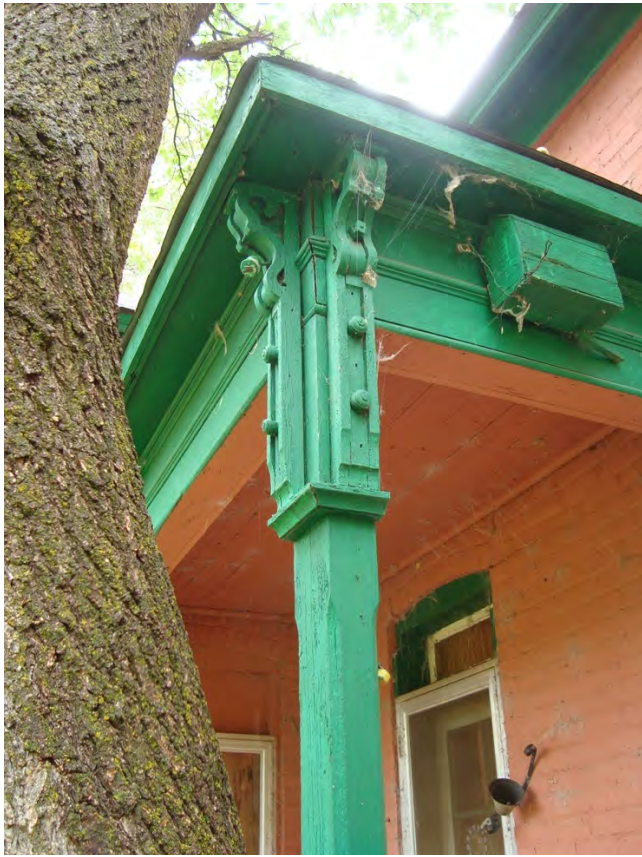
Photos 1 – 11 (exterior) and 44 & 45 (interior)

The Glassier farmstead house is a one and one half story painted brick house with a cross gabled roof. The brick portion of the house has a rubble sandstone foundation with a maximum of two courses exposed at the base of the masonry wall. The brick is running bond up to the full height of the walls. Two volumes have been added to the core brick house. A one-story wood frame addition is attached to the northwest of the house and sits on concrete sonotube supports. A one-story concrete masonry unit (CMU) addition to the northeast side of the house has a CMU foundation. The main roofs, the porch and bay have asphalt shingles. The one story CMU volume has a metal panel roof. Two masonry chimneys sit near the ridgelines of the main gables. A metal flue is located on the east end of the side wing, penetrating the roof overhang.

The building plan is T-shaped with a front gable running northeast to southwest, and a lower side wing extending to the southeast. A shallow hipped roof bay centers on the front gable on the main level, with a decorative cornice and scroll brackets under the eave. A single vertically proportioned vinyl double hung window with a vertical muntin is set in the face of the bay, with two narrow vinyl double-hung window on the 45° sides. A pair of vertically proportioned wood double hung windows, one over one, are set just above the bay roof on the upper level. Each narrow window has its own segmental arch with a central wood mullion. Immediately southwest of the front gable, a shallow hipped roof porch sits in the ell and extends about half the length of the side wing. Two entry doors, with aluminum storms, are located under the porch, one on the side wing and one on the side of the front gable (now infilled with a blank panel). Both doors sit in wood frames set in segmentally arched masonry openings with transoms above the door. A single turned post at the outer corner and two pilasters against each wall supports the porch roof. The porch has a decorative cornice with elaborate wood brackets. A single horizontal vinyl fixed window is located on the remainder of the side wing wall to the southwest of the porch. The main front gable has a deep trim board running along the eave at the wall plane with a series of small brackets supporting the overhang. Both eave ends have a large drop finial at the outer edge of the overhang. A one story wood frame shed roofed volume sits northwest of the front gable, set back slightly from the face of the masonry wall. This volume has a single horizontally proportioned wood double casement window centered on the plywood sided wall. The asphalt roof extends off the northwest wall of the front gable and has a moderate pitch with a small overhang.

The southeast side is the gable end of the side wing, with a large vinyl horizontally proportioned slider window near centered on the main level and a single vertically proportioned wood double hung with a single vertical muntin in each sash in a segmentally arched opening on the upper level. This gable end, which faces the driveway, has the same decorative features and the main front gable. A one story hipped roof volume, CMU extends off the northeast side of the brick house with no fenestration on its southeast side. Short lengths of the front gable volume are visible to either side of the side wing gable.

The northeast side retains the same front gable and side wing configuration as the southwest. Two vertically proportioned wood double hung windows with a single vertical muntin in each sash are equally spaced on both levels of the front gable volume. The one story CMU volume runs the length of the side wing, with a wood door (with aluminum storm door) located to the northwest and a square opening centered to the southeast. This opening is partially infilled with wood siding and has two small, fixed wood windows in the upper half. A gable dormer is located at the center of the side wing wall above the CMU addition, with a narrow vertically proportioned two-over-two double-hung window in its center. The wood shed roof addition extends to the northwest, with a single small window inset off center. The decorative brackets and finial are not included on this side.

The northwest side has the one story wood frame /wood sided volume on the lower level and the slope of the front gable roof on the upper level. A single horizontally proportioned wood casement style window is located on the first level.

The brick Glassier House has two additions that were added during the period of significance in the 1950s to improve the functionality of the house. The rear one-story addition is CMU construction and houses a bathroom, laundry, and mechanical equipment. The addition covers an original double hung window opening, converted to a doorway into the new bathroom. It also covers the original rear entry door, which is accessed through a new entry vestibule. The second addition is the one story wood frame addition on the northwest; this addition contains a bedroom, bathroom and closet. An original northwest facing double hung window opening was enlarged to create a doorway and a second double hung window was enclosed with wall finish from the addition side.

The brick Glassier House has been painted, which may conceal inappropriate repairs, but for the most part the brick walls and stone foundation remain throughout and most of the original wood windows remain in relatively good condition. A few modern window units have been added which does detract from the materials aspect of integrity, but overall, the site retains integrity of *materials*. The Log Barn, Log #1 and Log #2 retain their log construction in full. There has been some deterioration to the logs at the base of the wall and loss of chinking materials, but enough chinking material remains to determine its composition. The areas of wood framing and siding on the gable ends and the roof eave details are generally unaltered. Log #1 and Log #2 have concrete floors that were poured inside the perimeter of the log walls. The logs still rest on the ground. The materials of the Low Barn's internal structure are consistent with an earlier construction date; however, the exterior roofing and siding completely alter the impression of this building. No photographic evidence shows the original roofing or siding materials.

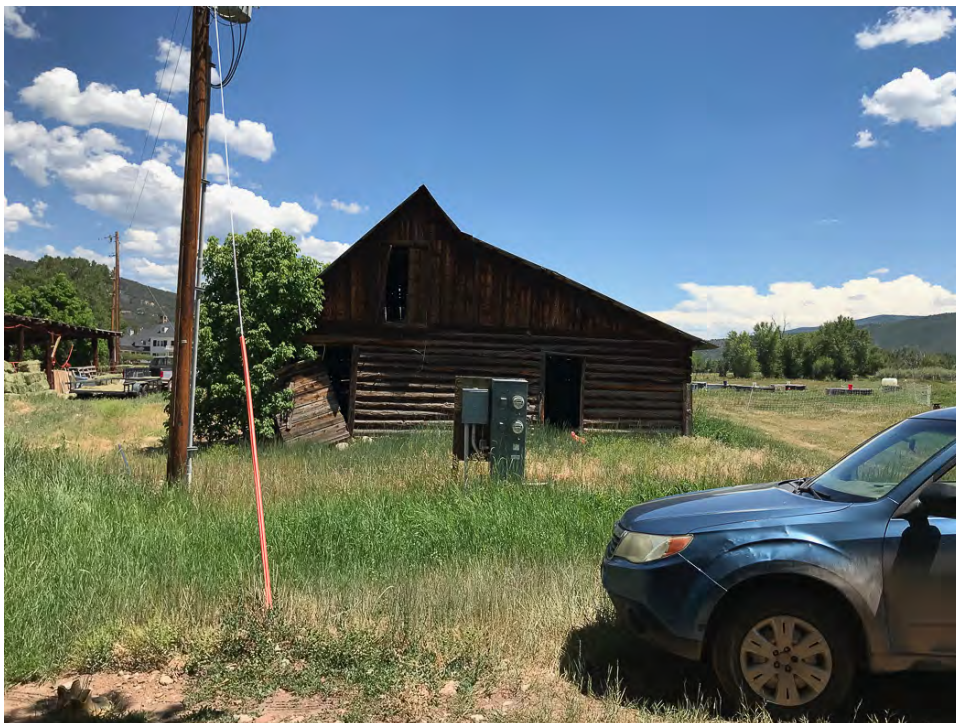
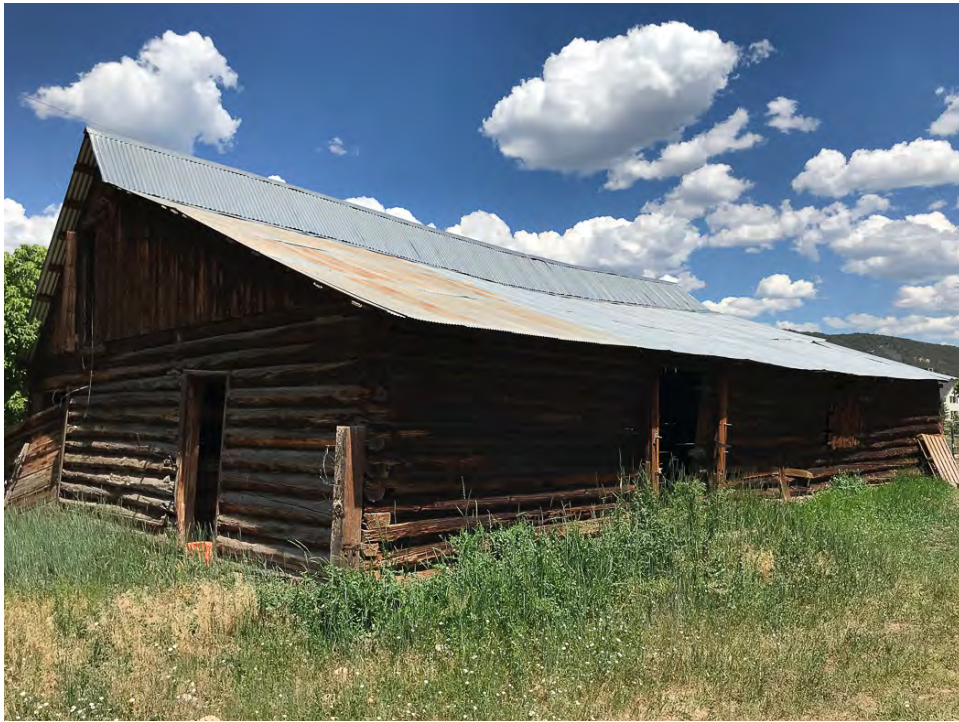
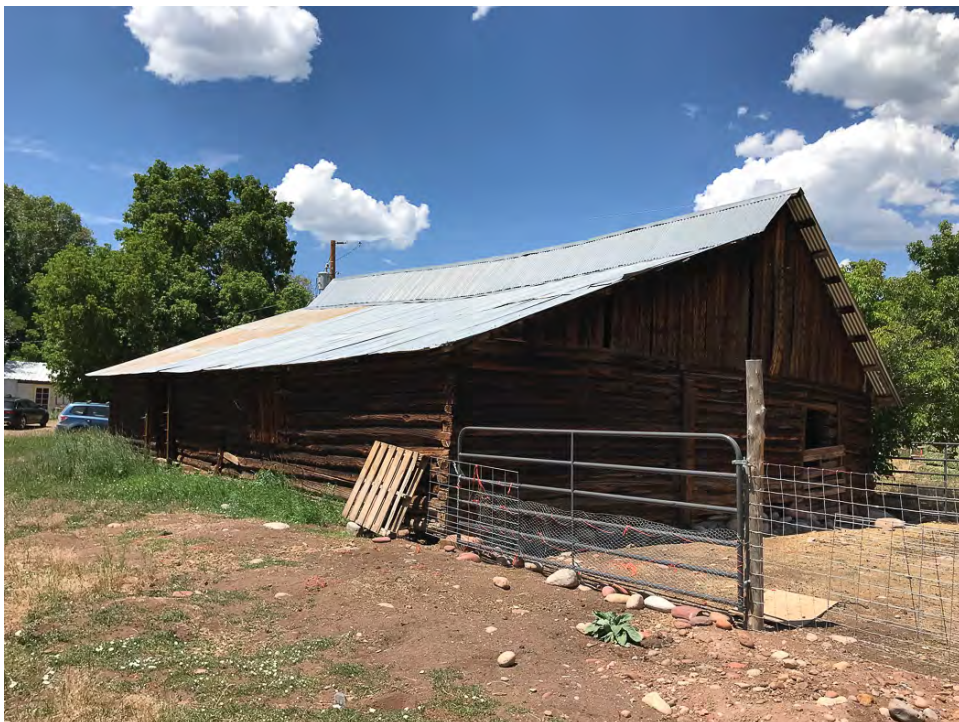
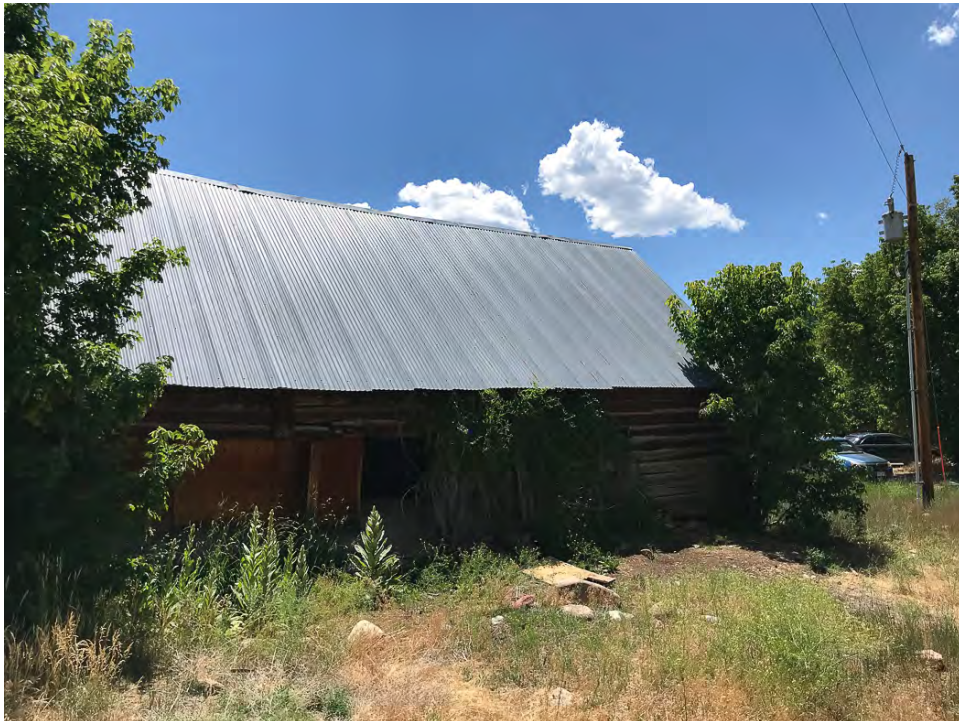
Photos 12 - 15

Across the driveway to the southeast sits the large log and wood frame barn. The barn has a gable roof with a shed roof extending to the southwest off the slope of the gable. The main ridge runs northwest to southeast with the principal façade facing the building group on the northwest. The round log structural elements run up to the level of the shared gable and shed roof plate height around the perimeter of the building. The logs run the length of the main façade and are generally consistent in diameter. The corners are half lapped and do not extend beyond the wall plane. There are some remnants of both wood and cementitious chinking. The remainder of the wall is wood frame with vertical wood plank siding. The principal façade has two door openings: one to the northeast of the ridge line and one to the southwest under the shed roof section in the log wall. Both openings have wood frames, but no glazing or other closure at this time. A large double leafed hayloft door sits under the front gable in the wood frame area of the wall. The door is built of the same vertical wood plank as the surrounding wall. A single central door opening is located under the eave on the southwest wall, with an additional shuttered opening further along the log wall to the right. The rear of the barn has a single door opening to the right, which accesses a fenced animal pen. The northeast wall has a single central wide door opening. The interior of the barn is divided into a main section under the gable and a secondary section under the shed roof. The main section is defined by a low log wall, which is located approximately along the line of the gable roof eave, had it extended the full width of the interior. A loft is located above this main section. The side section is roughly divided into two areas. One smaller section closer to the front and a long section at back. The floor is dirt throughout, and the metal roofing is supported by log rafters with widely spaced planks. The building may predate the brick house and date from the 1891 settlement of the farm.

The log barn has a corrugated metal roof that is in good condition, indicating that materials have been replaced at some point. Based on the historic photos, metal was the original roofing material. Some wood support posts have been added to the interior to stabilize the roof structure. This work was carried out over time.

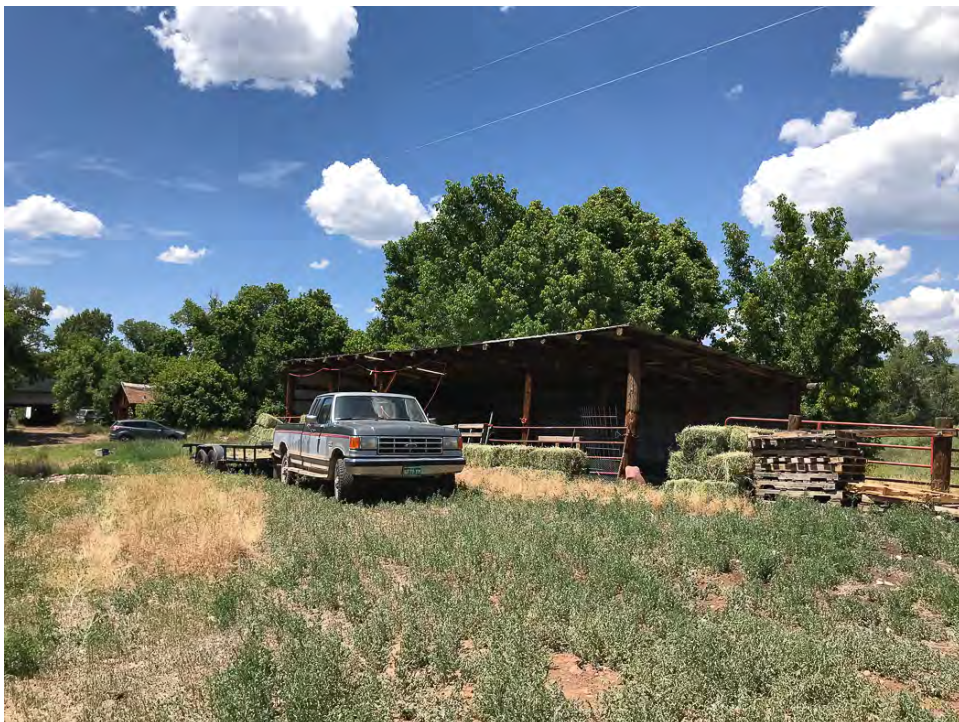
This two sided shelter is located to the north east of the Log Barn, across a gravel drive. The barn has a low pitched shed roof supported by five log posts on the ridge side, facing the Log Barn. This side is open as is the northeast side. The southwest side and the back have vertical metal panels, matching the roof material, enclosing the volume. Materials and construction suggest it dates from the period of active farm operations, with many repairs and reconstruction over time.

Photo 16 • Pole Barn looking northwest. July 2022

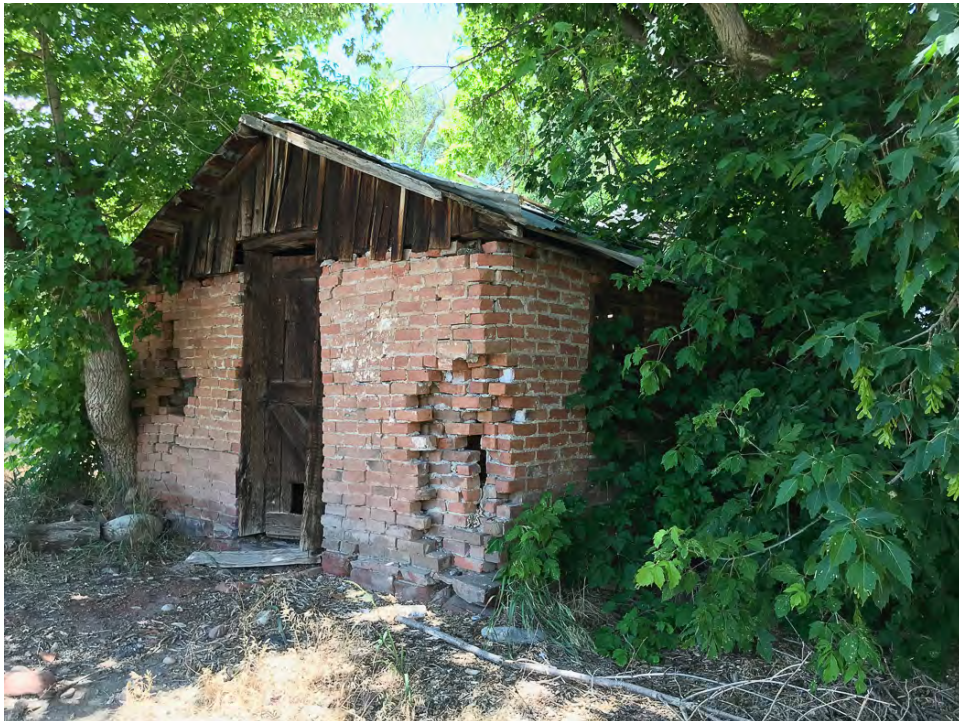
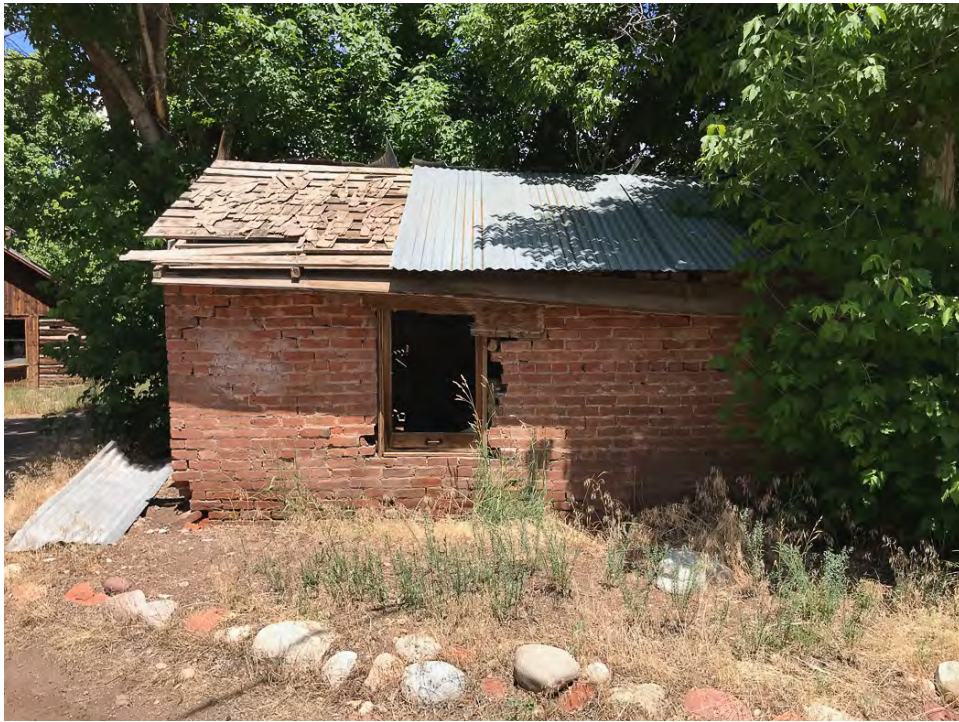
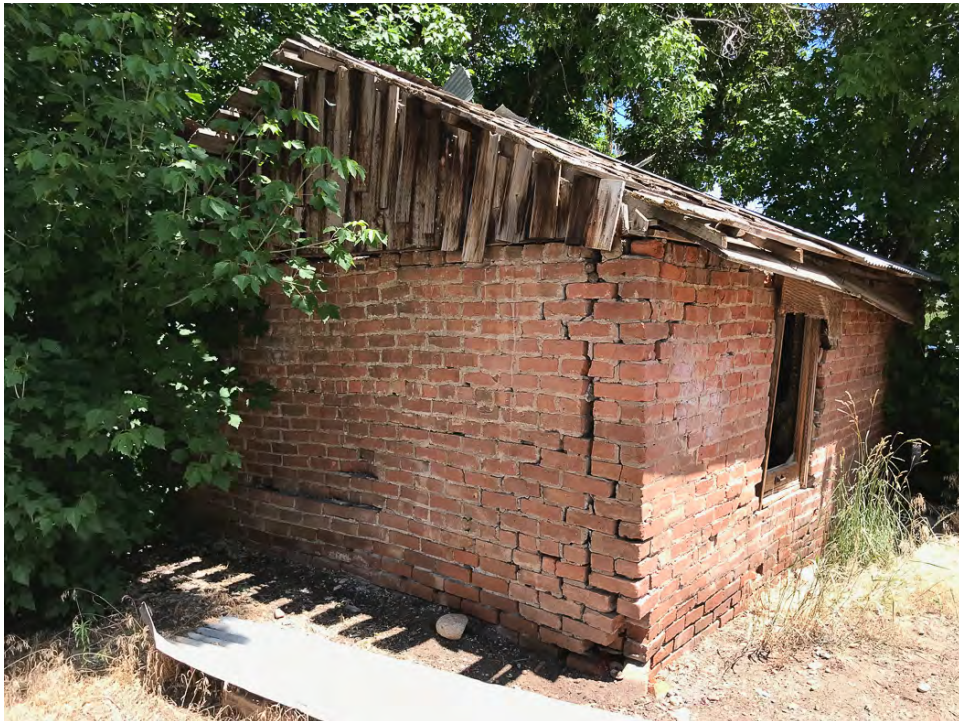
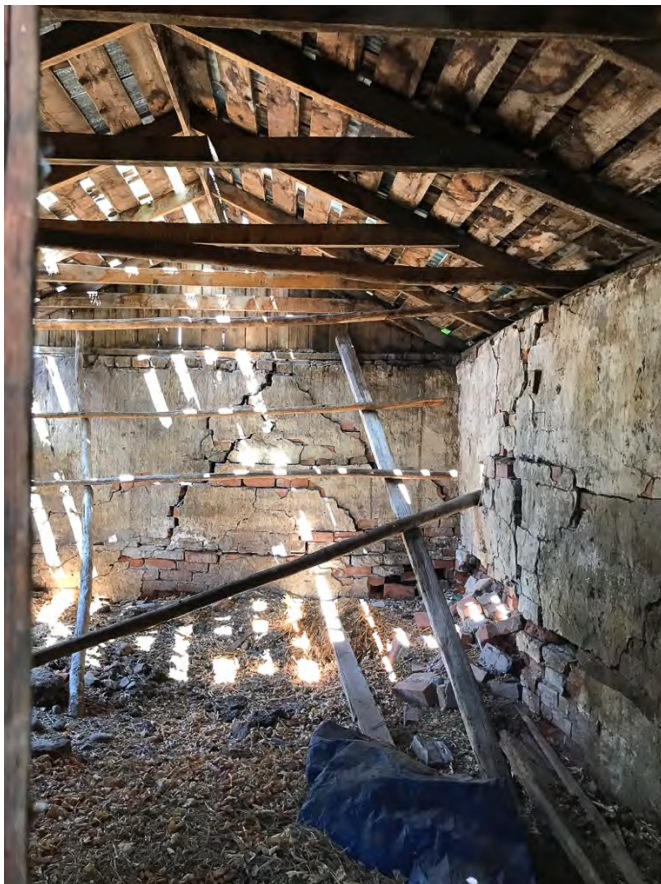
Photos 18 - 21

Just adjacent to the Low Barn is a small front gable brick building that may have served as a chicken coop or other animal shelter. The ridge of the low pitched gable runs northwest to southeast with the front façade facing southeast along the driveway. The shed has a red sandstone foundation and two wythe brick walls that run to the height of the eave. The gable ends are wood framed and sided with vertical wood planks. A single door sits in the center of the main façade, a single wood framed opening is located near the center of the wall on the southwest side, a similar opening is located on the northeast side. Both of these openings have no existing infill, but they both have arched wood tops that sit near the top two courses of brick. The rear of the building has no openings. The interior of the shed has parging on the brick walls with exposed wood rafters, wood skip sheathing and wood shingle roofing covered with metal in some areas. This building likely dates to ca. 1904, the date of the house construction based on materials and construction.

Overall, the farmstead buildings continue to display the level of *workmanship* appropriate to the various building types. The original materials of the Brick Shed and the Privy remain, however are suffering from significant deterioration. It should be noted that the Privy continued in use until the construction of the addition on the main house. This could indicate that materials were replaced over time, though apparently in kind. The level of detail and methods of construction are appropriate to the original workmanship of the working farm. The Glassier House continues to convey the high level of workmanship and detail that conveys the significant investment that the brick house represented to the family. The Log Barn, Log #1 and Log #2 retain their log exterior wall construction giving clues to their age based on construction techniques.

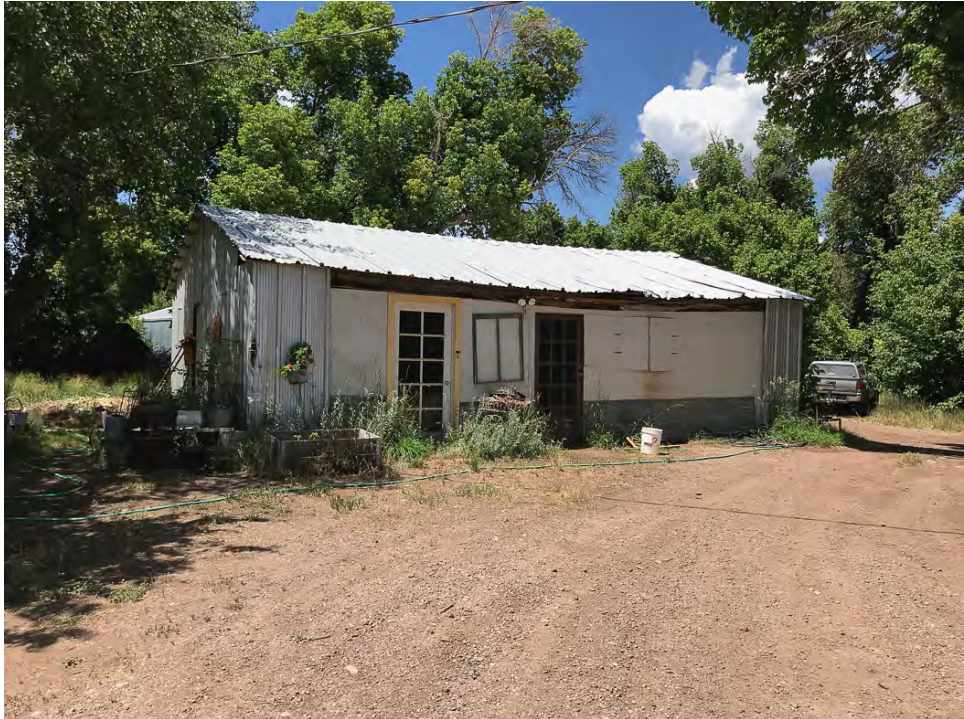
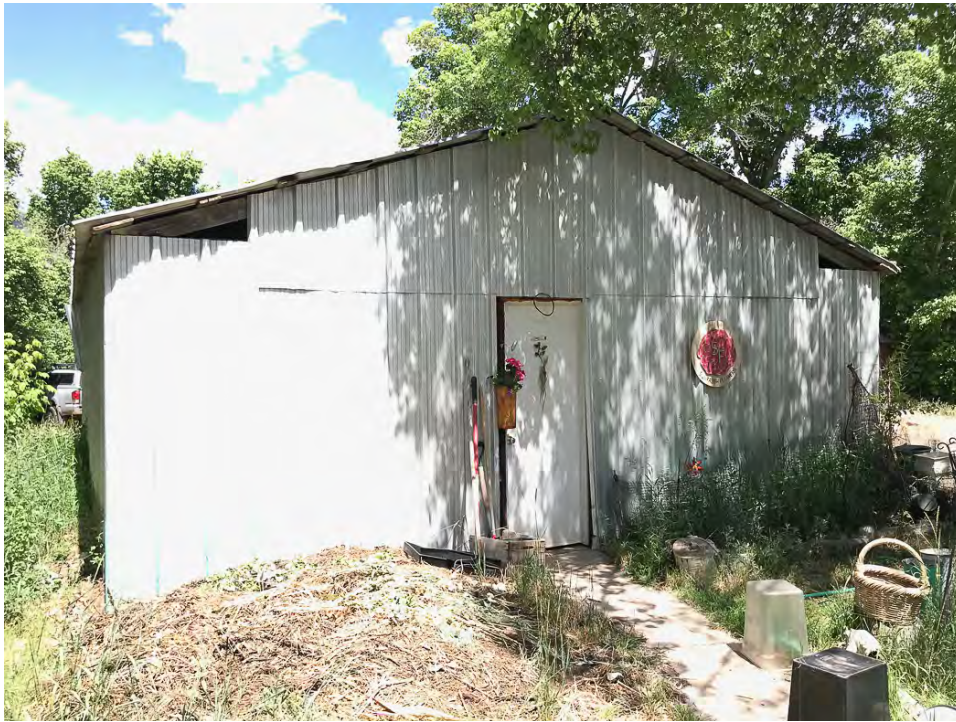
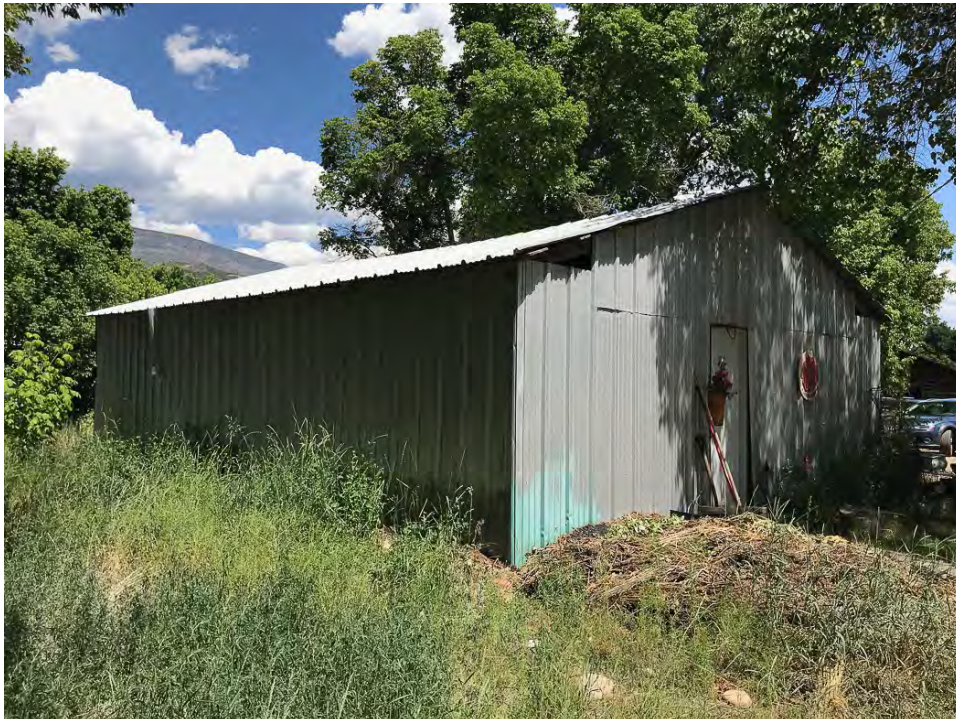
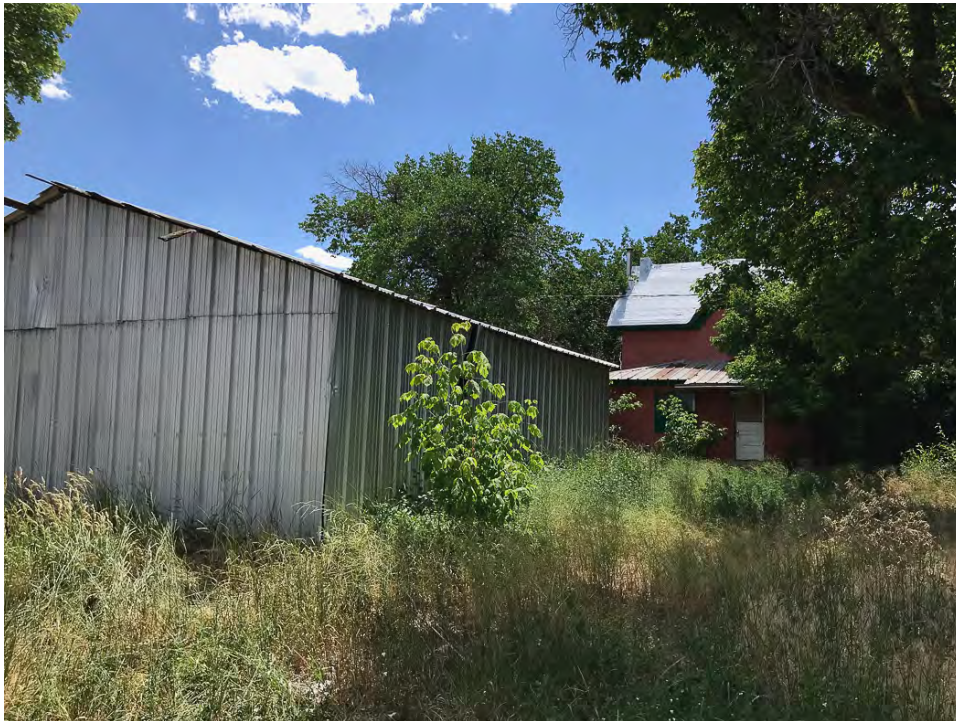
Photos 22 - 25

Just behind the farmhouse, a one story wood frame barn/garage sits in the center of the building group, probably constructed in the 1950s. This barn has a low pitched gable roof whose ridge runs northeast to southwest. The barn roof is metal panels on widely spaced wood planks. The walls have similar widely space studs with wood planks supporting the same metal panels of the wall planes. A single wood door is centered on the southwest façade. The southeast has metal panel wall covering at either end, with a central area of wood panel wall with wood doors and a single window, behind shutters. The northeast and northwest walls are metal panel with no openings. The wood paneling and doors infill were added to the previously open area after 2015. This building likely dates from the 1950s.

The low barn has been resided with sheet metal roofing panels, which match the roof material. The once open bays of the southeast façade have been infilled with a variety of wood panels and salvaged doors. Date of the infill is 2000s, date of the metal roof and siding is unknown, but late 20th century based on the material type and condition.
