National Register of Historic Places Registration Form

historic name Glassier Farmstead

other names/site number 5EA.3988

city or town Basalt

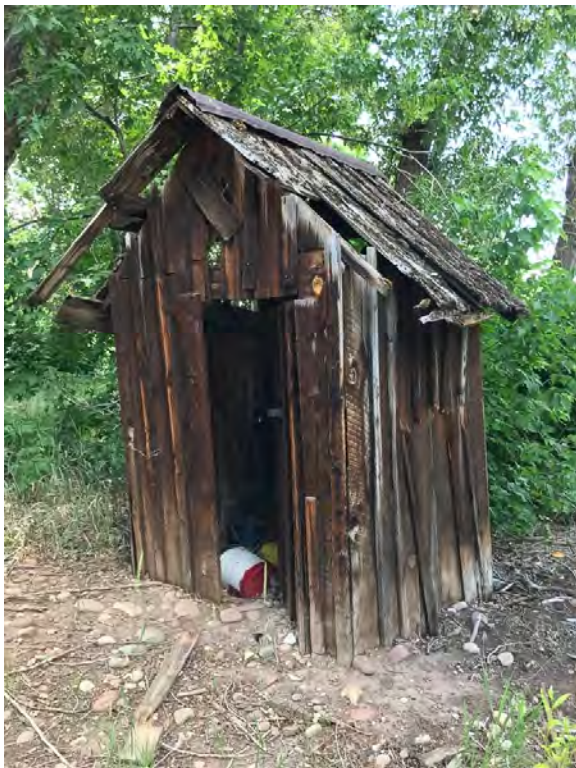
Photo 26 • Privy, southeast facade. Looking northwest, July 2022

A wood frame privy sits between the large Metal Barn and the Brick House. The small square plan building is comprised of vertical wood planks with battens. The privy has a steep gable roof, running northwest to southeast and the only opening is a door centered on the gable facing southeast. The privy has a dirt floor and the remnant of a wood seat is still located inside. The privy sits in the trees to the north of the Brick House and is in a deteriorated state.

Overall, the farmstead buildings continue to display the level of *workmanship* appropriate to the various building types. The original materials of the Brick Shed and the Privy remain, however are suffering from significant deterioration. It should be noted that the Privy continued in use until the construction of the addition on the main house. This could indicate that materials were replaced over time, though apparently in kind. The level of detail and methods of construction are appropriate to the original workmanship of the working farm. The Glassier House continues to convey the high level of workmanship and detail that conveys the significant investment that the brick house represented to the family. The Log Barn, Log #1 and Log #2 retain their log exterior wall construction giving clues to their age based on construction techniques.

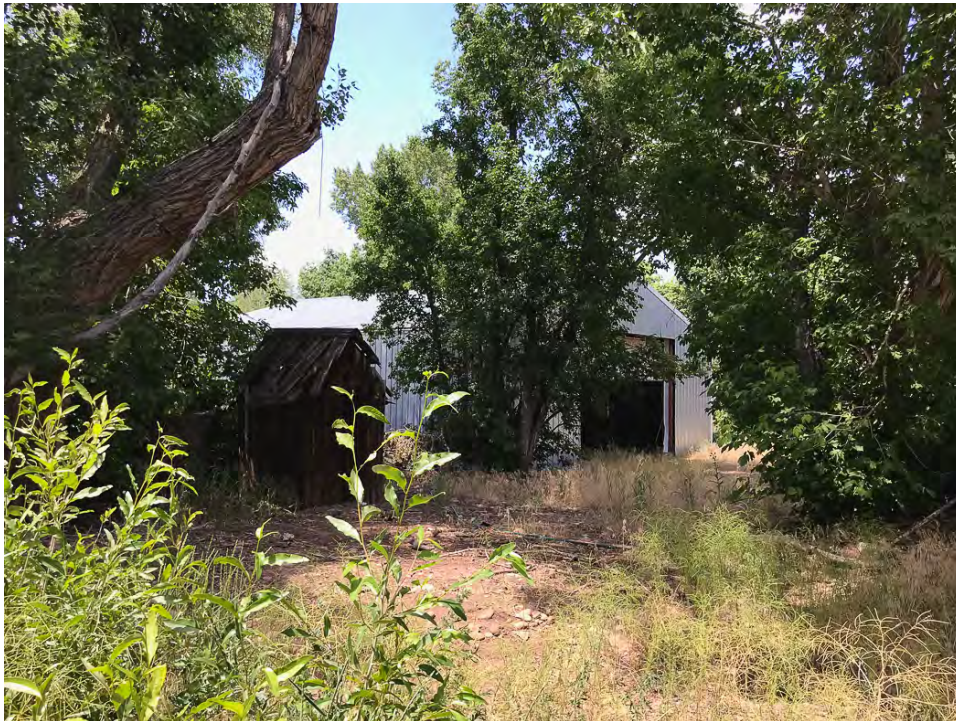
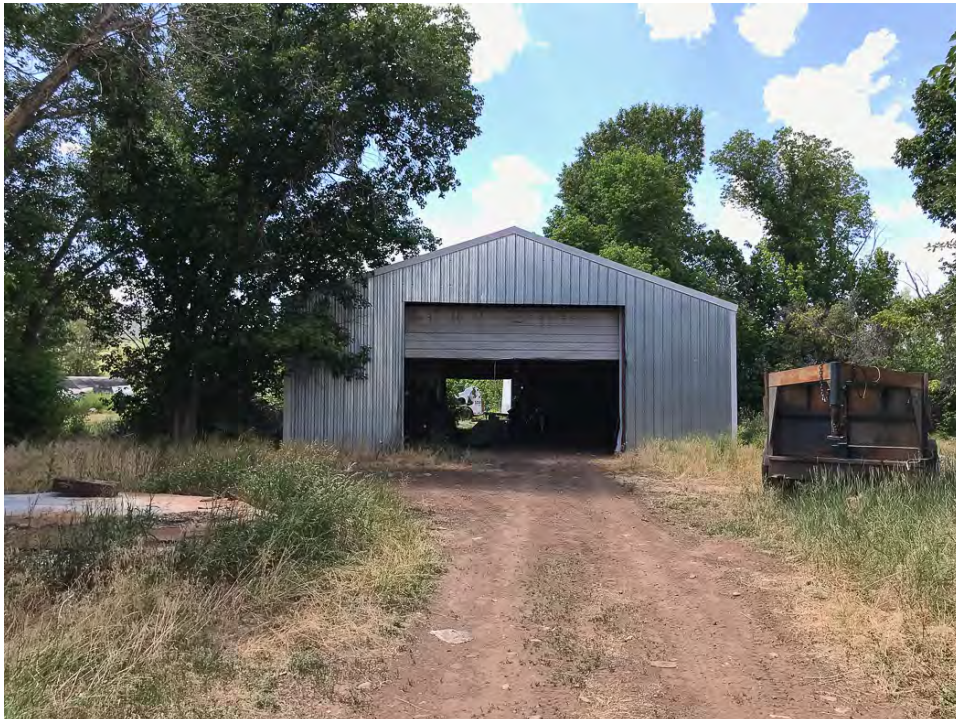
Photos 27 & 28

On the northern edge of the building group is a large metal barn with a light steel frame and metal roofing and wall cladding, aka a Butler Building. The barn is a front gable with the ridgeline running northwest to southeast. The principal façade faces southeast. A large opening is centered on that façade and a narrow opening accesses the fields to the northwest, both have metal overhead doors closing the envelope. There are no other openings in the building. The building is a shell with no interior partitions and a dirt/gravel floor. This building dates from the 1980s.

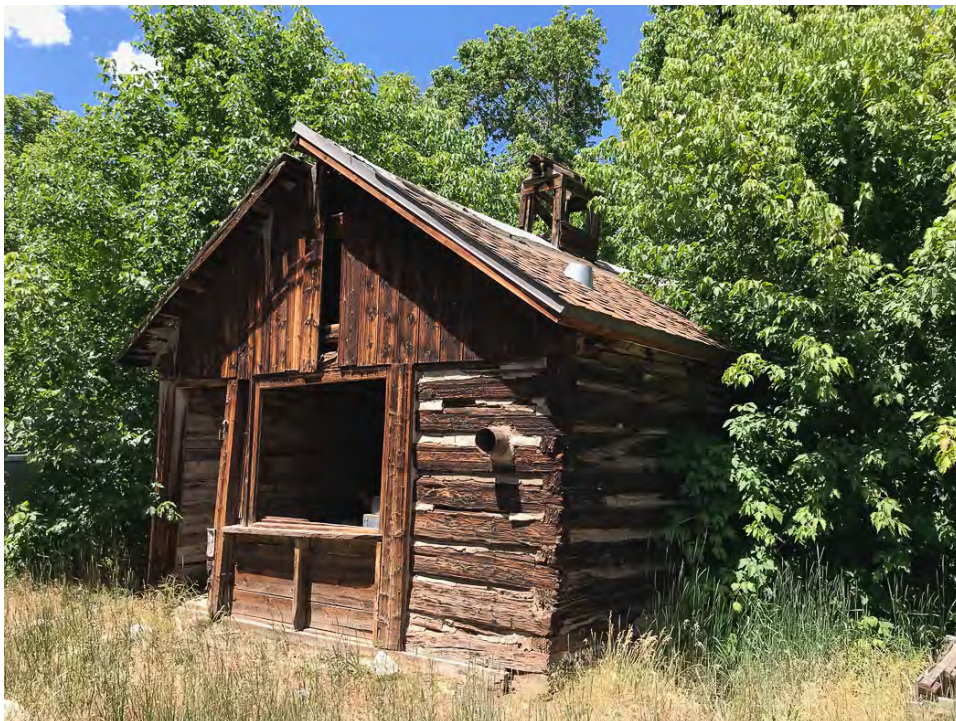
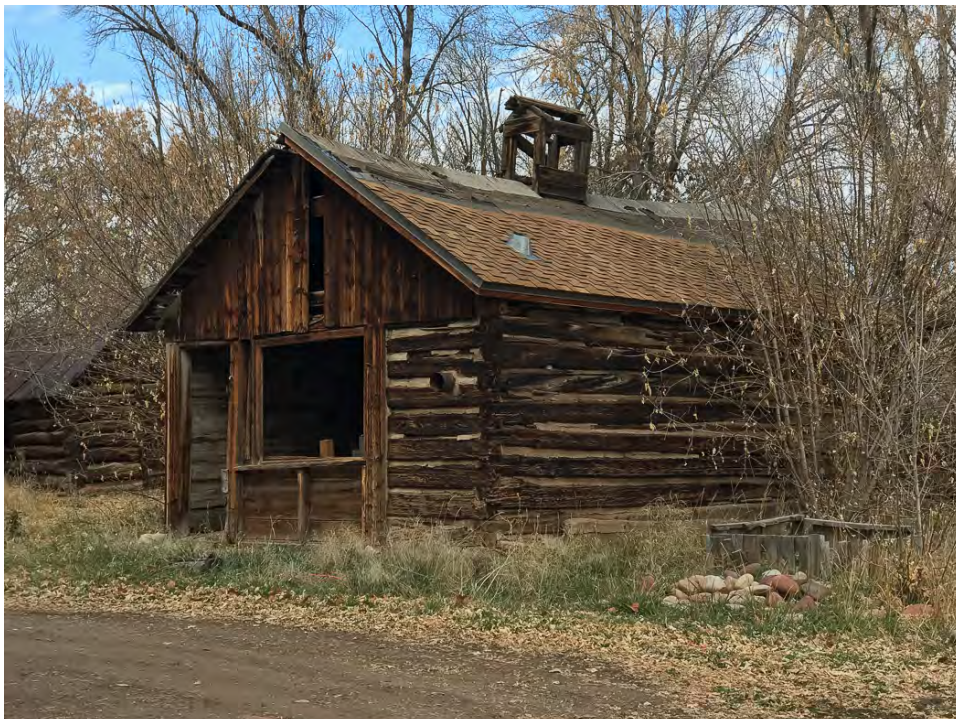
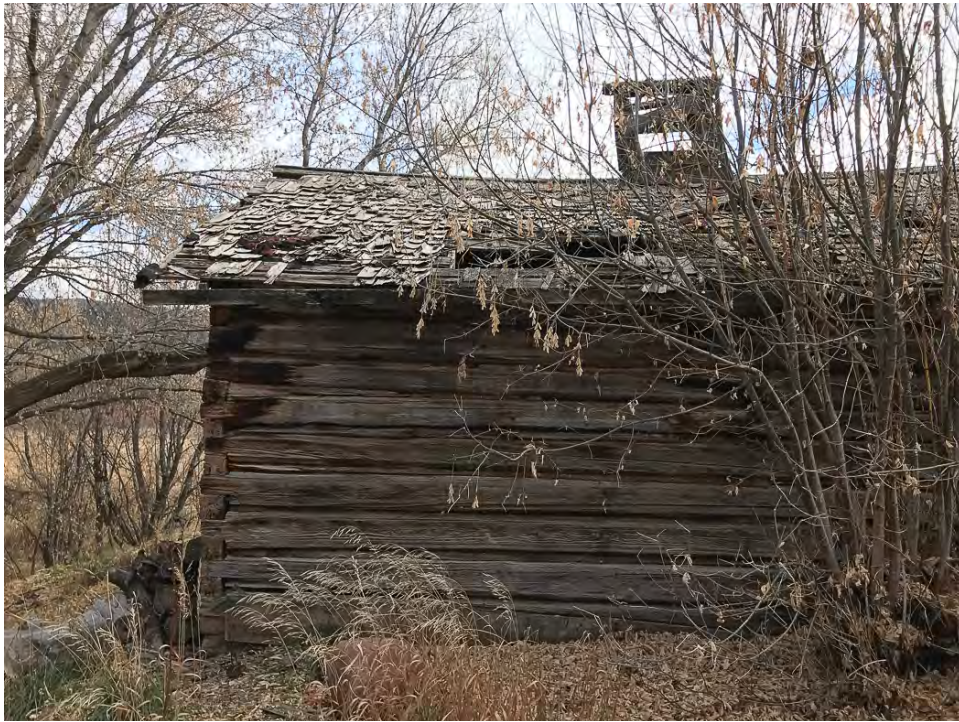
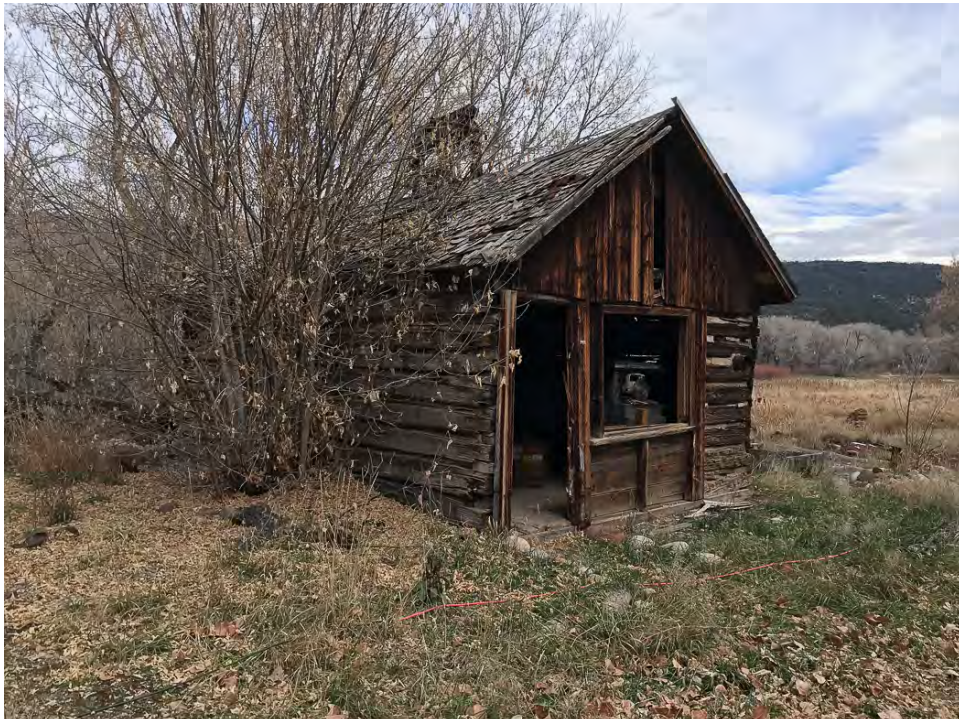
Photos 29 - 32

Opposite the Low Barn, at the back of the site sits a one-story log building reportedly used as a bunkhouse. The rectangular plan building has a front gable roof that faces into the building group. The building ridge runs northeast to southwest, and the principal façade faces southwest. The walls are large square cut logs with square-notched corners. Wood and cementitious chinking infill the narrow gaps. The log walls extend to the eave height and wood framing infills the gable ends. The façade has a large opening cut into the logs with a doorframe on the left side and rectangular frame opening with wood panels below occupying the center of the wall. There are no other openings on the building. The gable ends have vertical wood siding. The remains of a wood frame cupola sit on the ridgeline near the center of its length. It is open on all four sides and has a gable roof that aligns with the main roof. The interior of the building has some remnants of mud and straw chinking along with the wood strips. A wood plank ceiling separates the single main space from the attic; there is no apparent connection to the attic. The floor of the main room is a concrete slab, and the roof is rusted corrugated metal. This building may predate the construction of the main house and be associated with the early settlement of the farm in 1891.

Log #1 and Log #2 have concrete floors that were poured within perimeter of the log walls. Log #2 has some likely alteration to the façade, dates and original configuration is unknown. No changes are apparent in the Brick Shed, the Loafing Shed or the Pole Barn

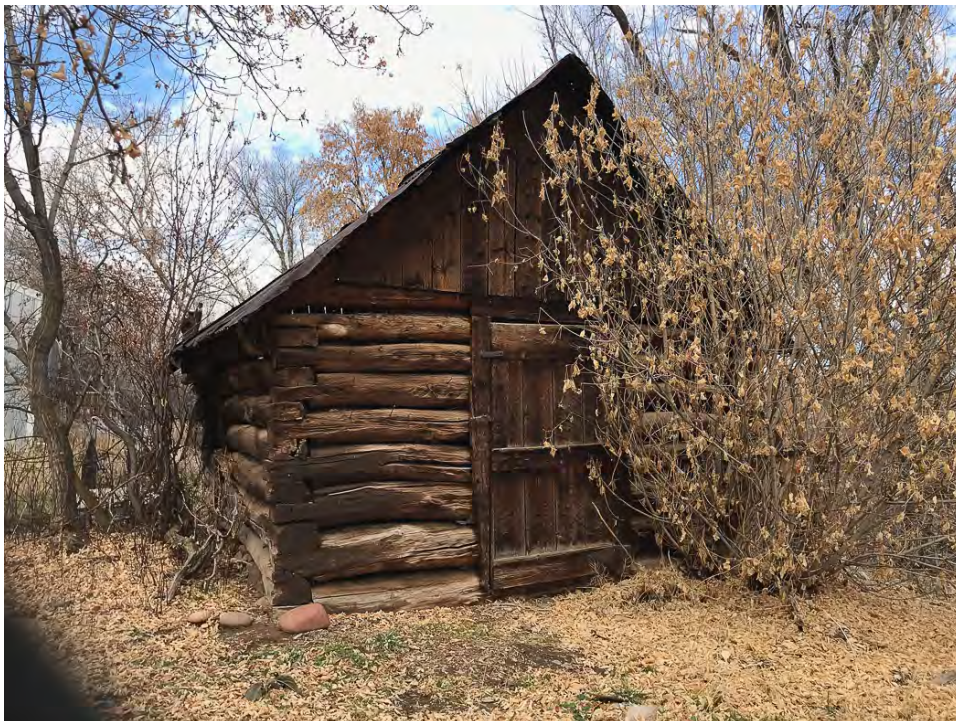
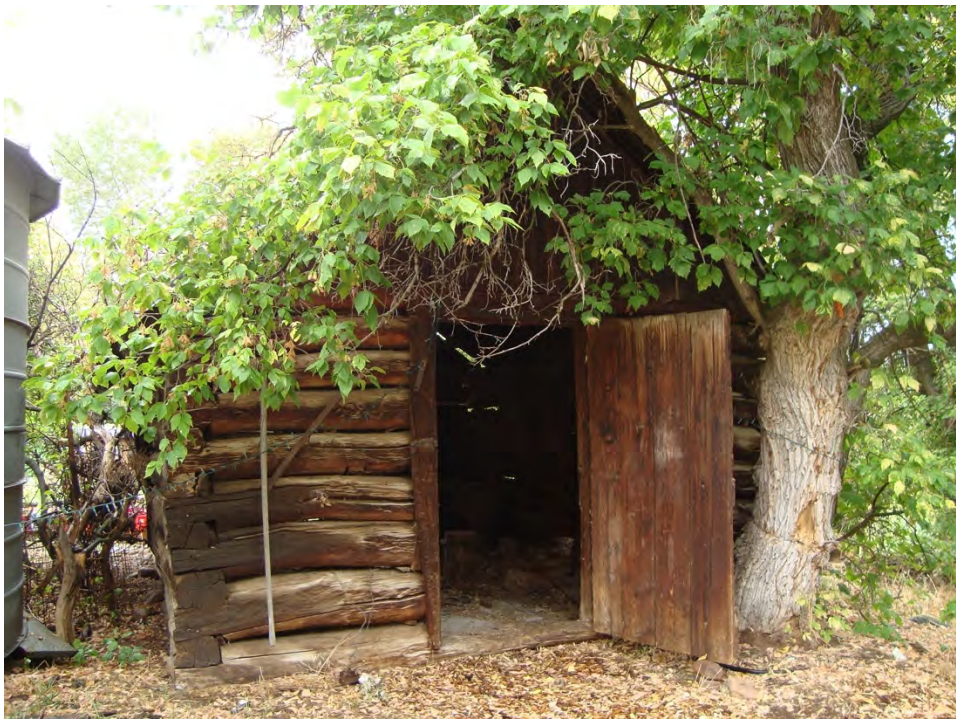
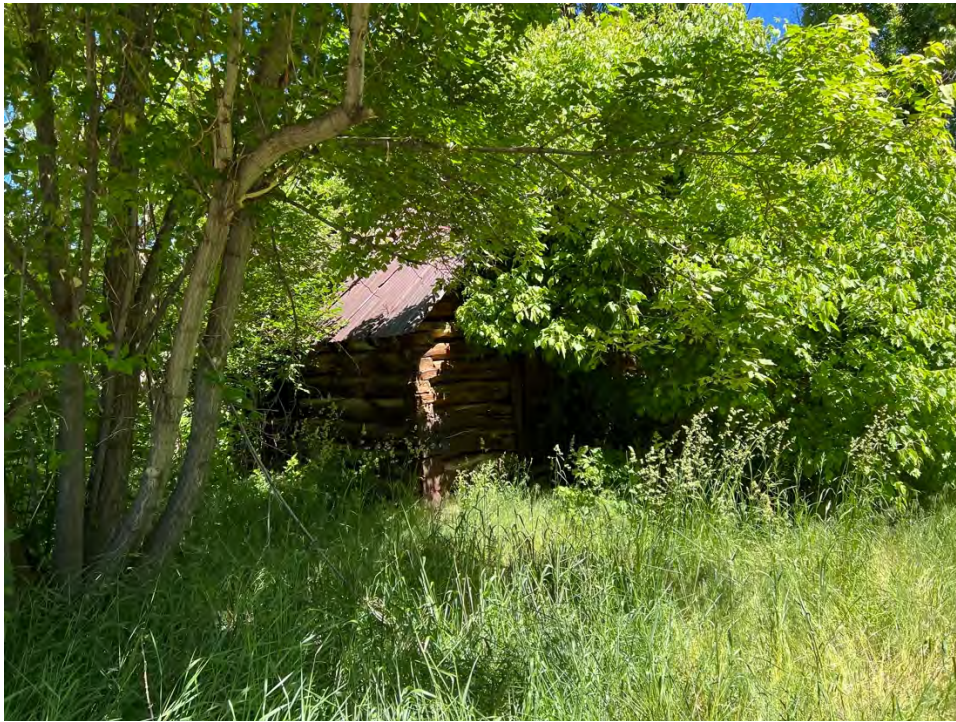
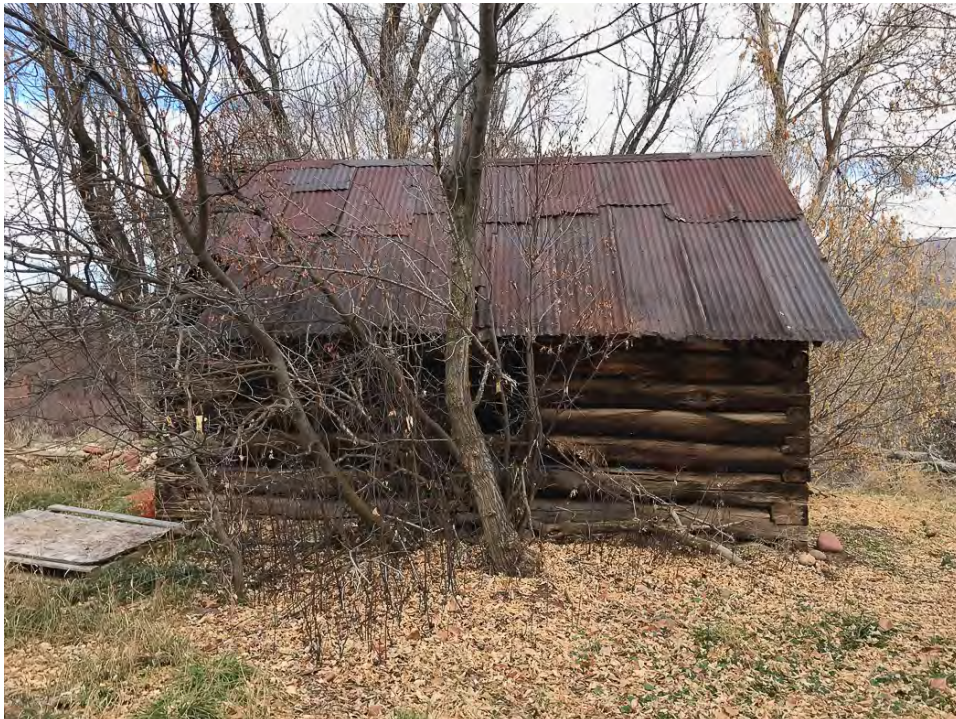
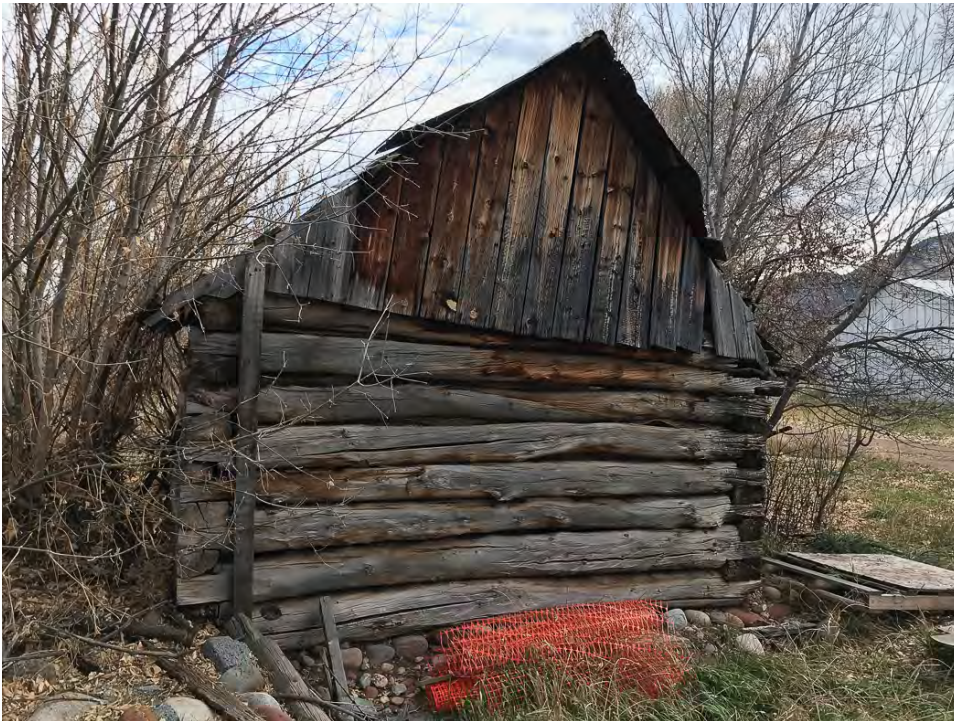
Photos 33 -37

To the northwest of the Bunk House is another similarly sized log building. This building is a front gable building situated on the edge of the bank that runs down to the river. The ridgeline runs northwest to southeast, and the principal façade faces southeast. The walls are made of mostly round logs, with some flat surfaces. The logs vary in size with large diameters on the bottom and smaller near the top. The logs run to the eave height with wood framing infilling the gable ends. The corners are square-notched with some areas of wood chinking. The principal façade faces southeast and has a large wood door centered on the façade. The door is made of wood planks similar to the gable end siding. There are no other openings. The building has a corrugated metal roof. The small rectangular space is open to the gable and the floor is dirt. There is a makeshift brick forge in the northwest corner. This building may be associated with the early settlement of the farm in 1891.

Photo 34 • Log building #1 forge remnants can be seen inside. Looking west, September 2015

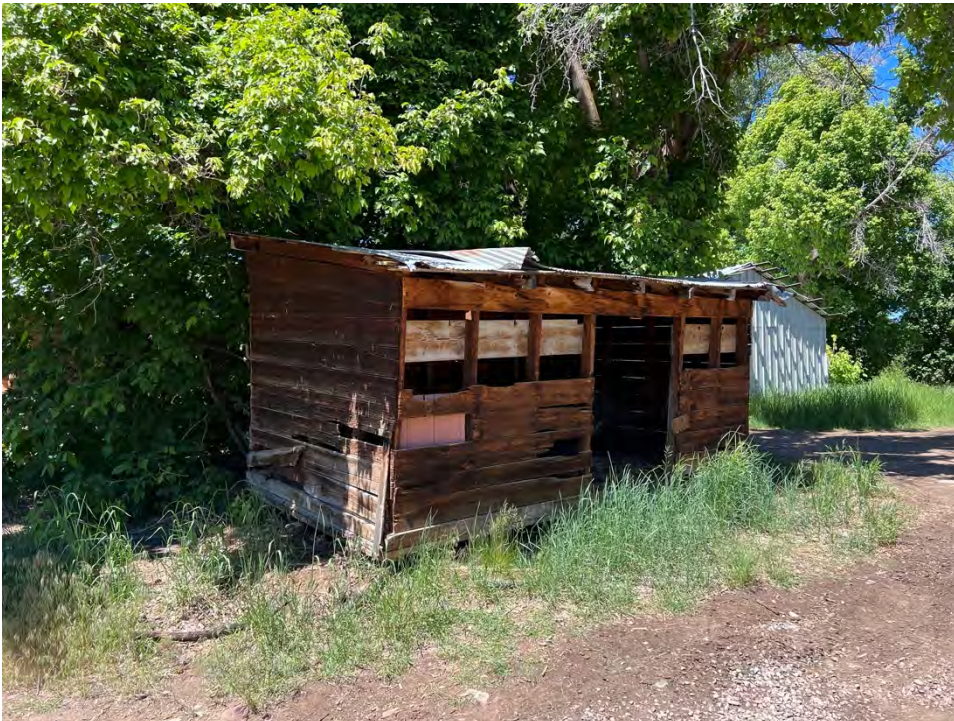
Photo 38

A wood frame shed sits behind the Brick Shed to the northeast. This is a shed roofed structure made of wood framing and horizontal wood plank siding. The roof is corrugated metal. The shed does not have a foundation and is a movable structure used as needed in the fields. This is a common building type in this area, the construction date is unknown but it has materials that are consistent with other wood frame construction from the period of farming operations on the site.

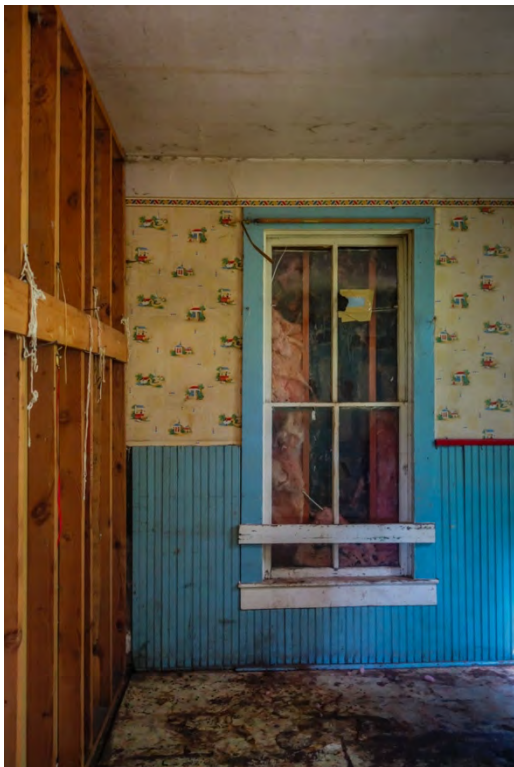
Photo 44 • Glassier House, main floor interior. Image shows original exterior window enclosed by frame addition. Looking northwest, June 2017 – (unchanged as of 2023)

The brick Glassier House has two additions that were added during the period of significance in the 1950s to improve the functionality of the house. The rear one-story addition is CMU construction and houses a bathroom, laundry, and mechanical equipment. The addition covers an original double hung window opening, converted to a doorway into the new bathroom. It also covers the original rear entry door, which is accessed through a new entry vestibule. The second addition is the one story wood frame addition on the northwest; this addition contains a bedroom, bathroom and closet. An original northwest facing double hung window opening was enlarged to create a doorway and a second double hung window was enclosed with wall finish from the addition side.
