National Register of Historic Places Registration Form

historic name First National Bank of Elizabeth
other names/site number 5EL.321

street & number 188 S. Main Street not for publication
city or town Elizabeth vicinity
state CO county Elbert zip code 80107

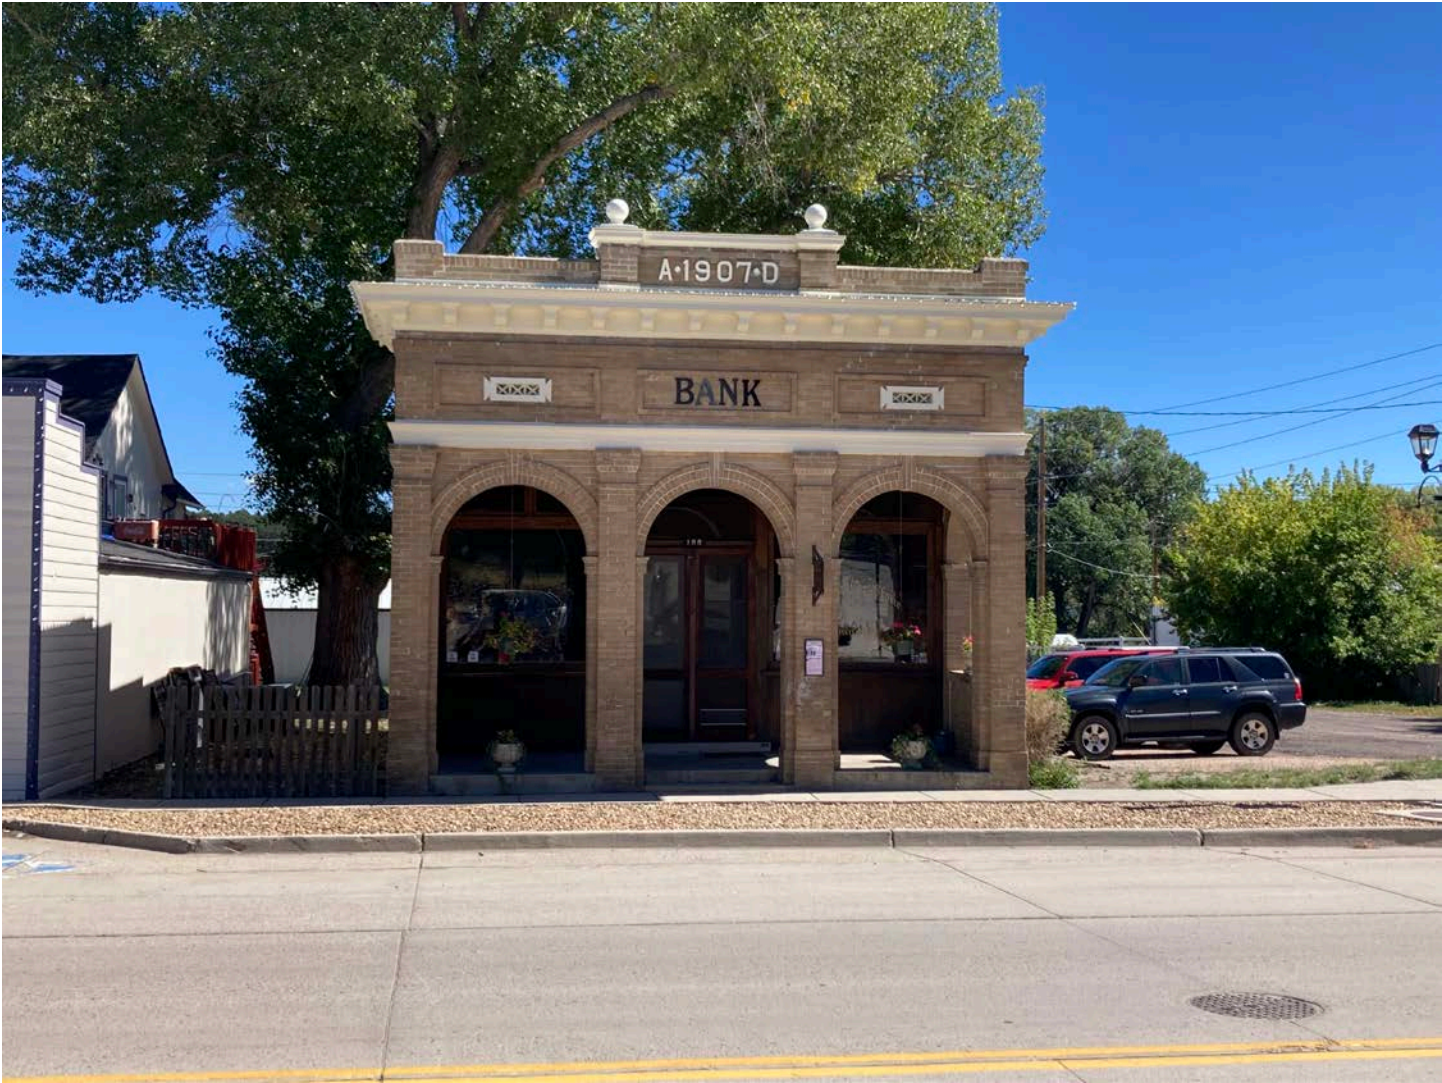
1 of 37.

Description of Photograph(s) and number: West (Main/Front) elevation.

The prominent features of this building are on its primary (west-facing/ street facing) facade and include an arcaded porch and bracketed cornice. Two bands of rowlock-coursed brick comprise the classical rounded arch (typical of three on the west elevation, one each on secondary north and south elevations where the porch returns to the massing of the building). The arches are well defined in the facades and stand proud of the field of brick masonry that comprises the mass of the wall that frames the porch. Keystones centered at the high point of each of the five arches are constructed of three brick rowlock courses, and stand proud of the finished face of the well-defined arches. There is a simple corbel detail comprised of three running-bond brick courses at the base of each arch, meeting the supporting brick columns. The bottom two courses of this detail are coplanar but corbel out from the plane of the column, the upper/ final course of this detail is cut as a special brick shape utilizing an ogee profile. The columns are topped level with the keystones at the top of the arch. Additional details at the top of the column include a course of special brick, shaped by egg and dart molding, and three more corbeled running bond courses. Pilasters articulate the columns and terminate at the cornice.

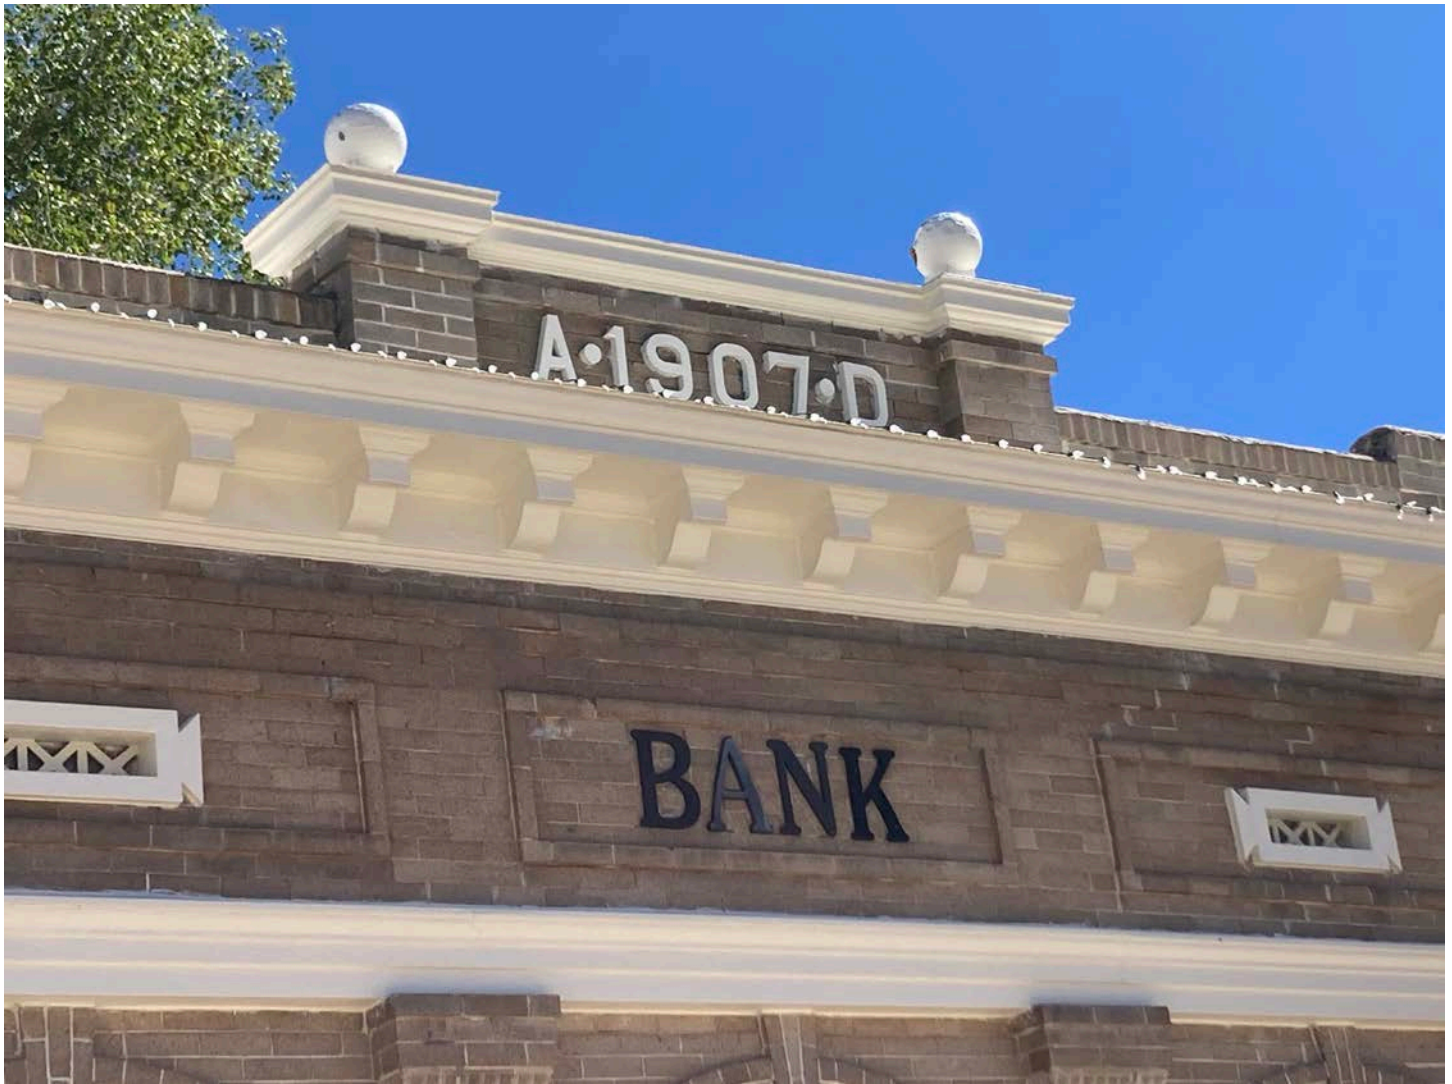
2 of 37.

Description of Photograph(s) and number: Detail of cornice and parapet, showing building construction date and building use. West (Main/Front) elevation.

The upper cornice returns to painted wood brackets on a flat fascia with the most predominate painted molding topping the brackets and indicating the top of the cornice. The masonry walls extend as a parapet approximately 3 - 4 additional brick courses above the cornice, and are articulated by symmetrical pilasters and crenellation, and capped by additional course of rowlock brick. The center section of the parapet is adorned with a band of corbeled brick below a cap of painted wood trim and cannonball finials, joining the two center crenelated pilasters and framing the date of 1907. The center date block protrudes slightly above the parapet. It is aligned to the center of the framed 'BANK' signage below. (Photo 2).

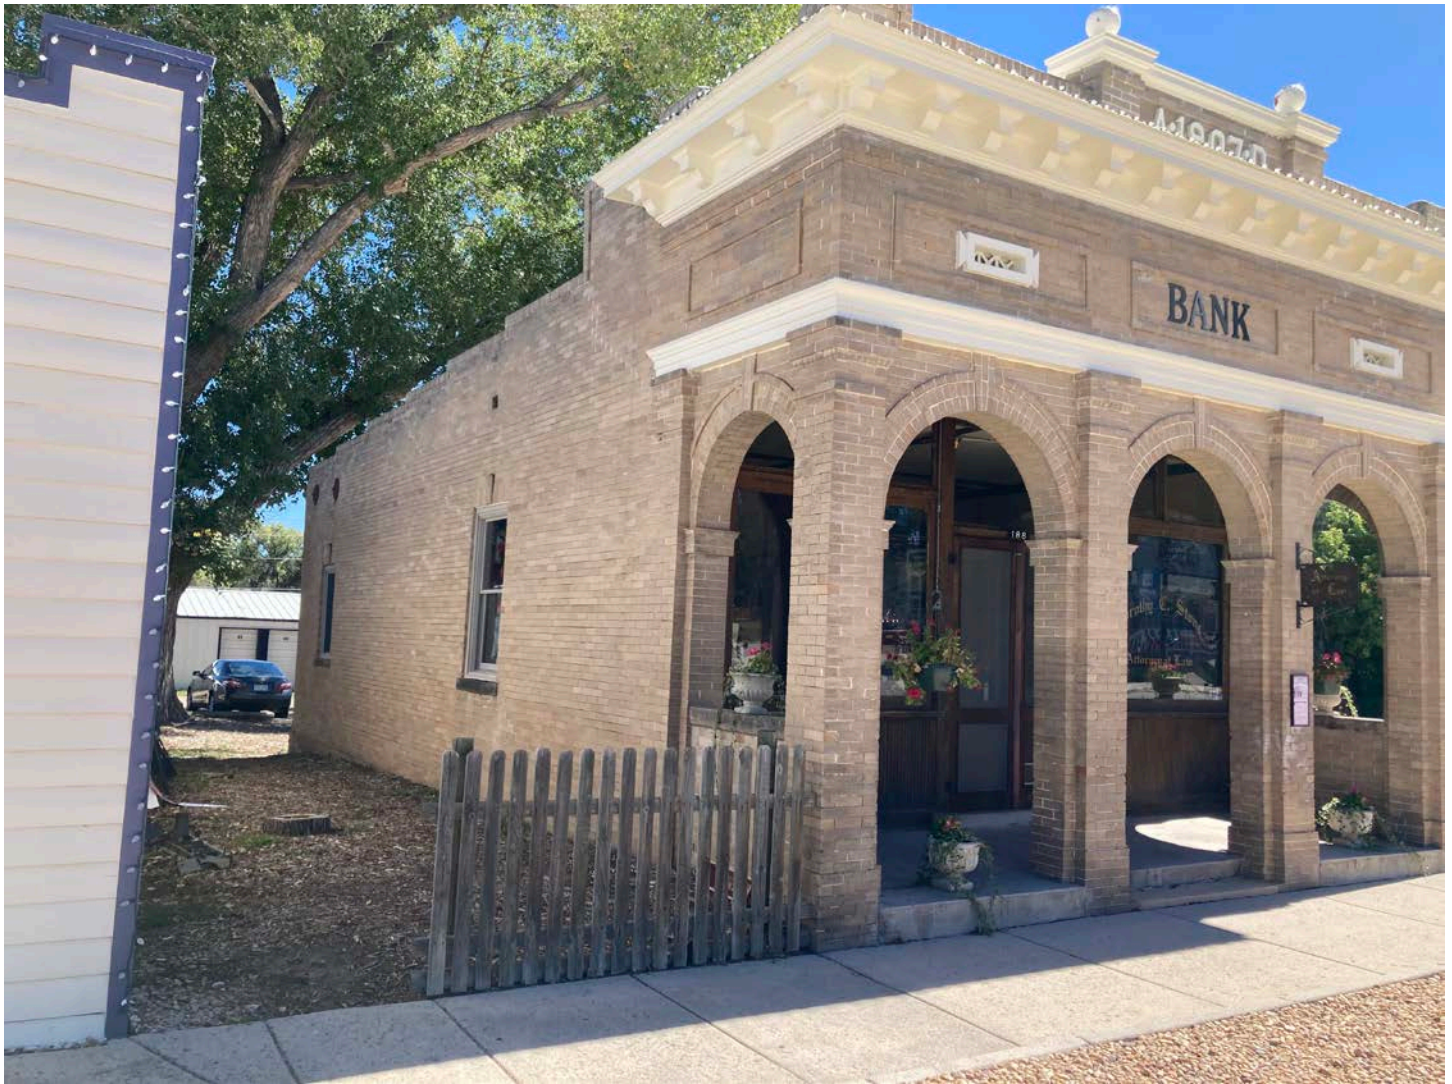
3 of 37.

Description of Photograph(s) and number: North (secondary) elevation and West (Main) elevation, looking southeast

The north side of the building is visible due to a small open space between 188 S. Main Street and the adjacent building to its north. The porch and cornice detailing wrap onto the northwest side of the north façade, in the same style of detailing as described for the primary façade and extending to the full depth of the porch. The parapet begins to step down from the primary elevation height as the roof slopes east to the rear of the building. It appears that a pair of stabilization cables have been installed above the east-most window along the north side of the building; exterior observations indicate some cracking in masonry mortar along the north façade (repaired between the west-most window and parapet) but appearing open between the east-most window and east corner of the building. The north facade of 188 S. Main Street features two windows, each rectangular in shape and vertically oriented, double-hung with a keystone in the flat arch of the masonry opening. The windows along the north, east, and south elevations utilize solid stone window sills that project slightly from the finished exterior plane of brick. The stone appears to match the stone used to construct the entry and secondary door thresholds and stoops. (Photos 3 and 6).

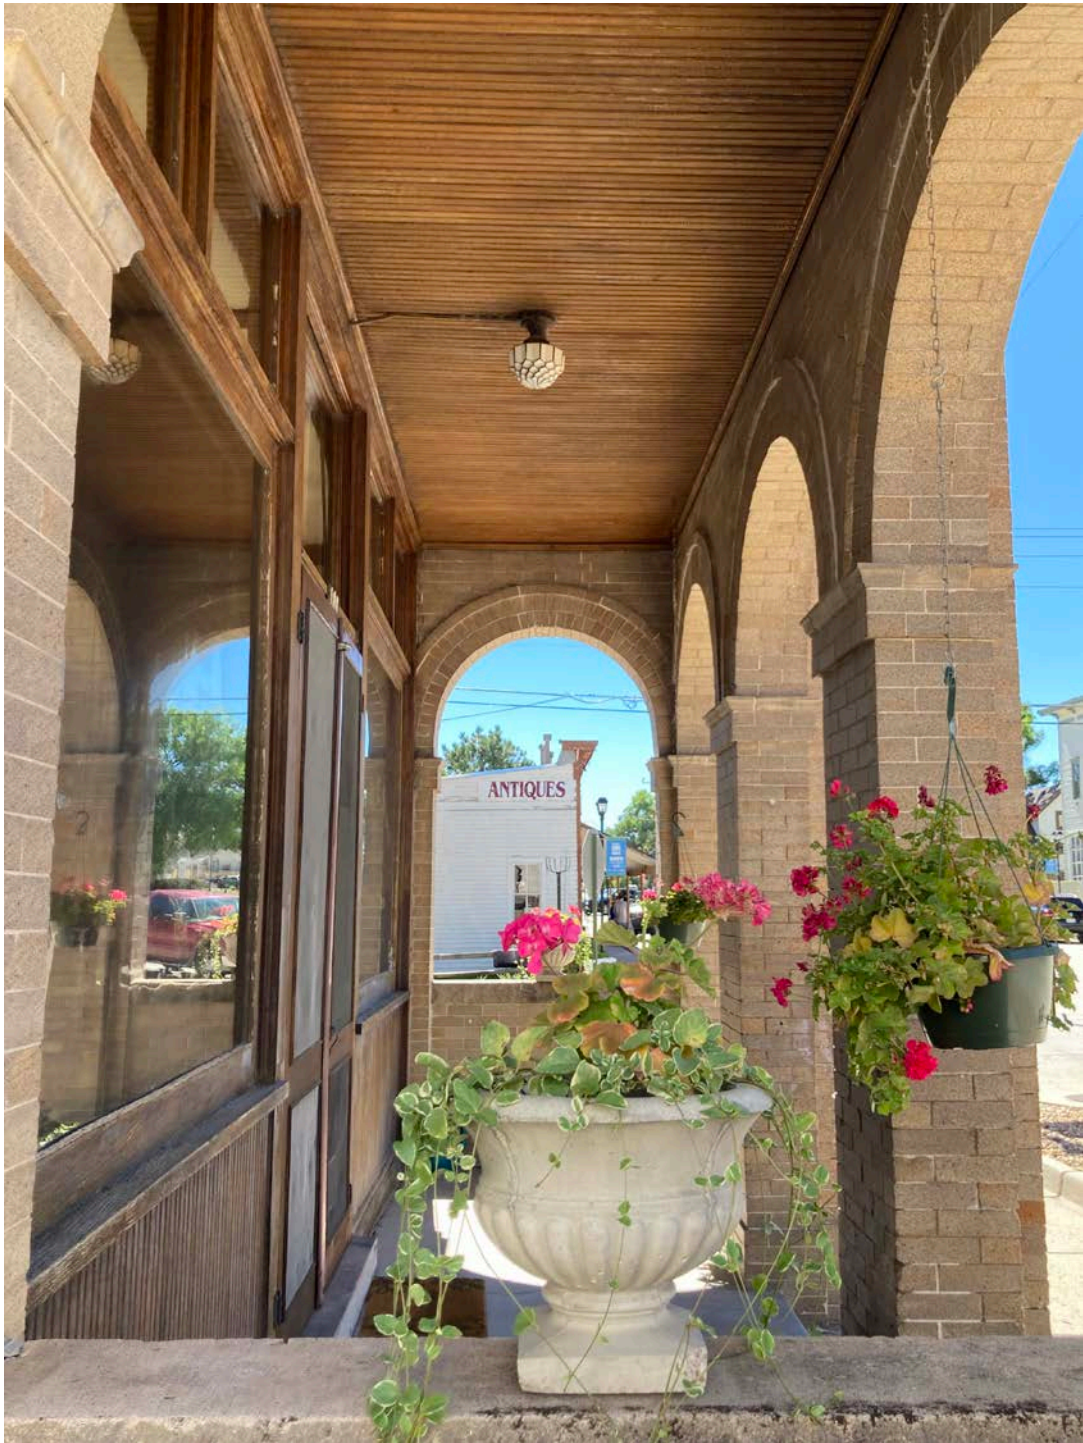
4 of 37.

Description of Photograph(s) and number: Porch arcade/portico on main facade, looking south. Note the detail in the brick arches, fixed-pane shopfront windows with transoms over wooden kick plates, and wooden ceiling.

The primary entry is recessed within the simple round-arch portico that features classical pilasters. The detailing of the brick where the arches meet the columns wraps into the 'interior' of the porch. Cut stone is used at the main entry's door jamb, lintel, and porch floor. The porch ceiling is a wood bead board, presumed to be original. A single, period-appropriate surface mounted light fixture hangs from the porch ceiling, centered over the main entry doors. It is unknown if this fixture is original to the building. The main entry is a wooden double door with rectangular, fixed pane lites in the top half of each leaf. Large, fixed-pane shopfront windows with wooden kick plates flank each side of this door. The main entry door and the shopfront windows all contain glazed transoms. (Photos 4 and 5).

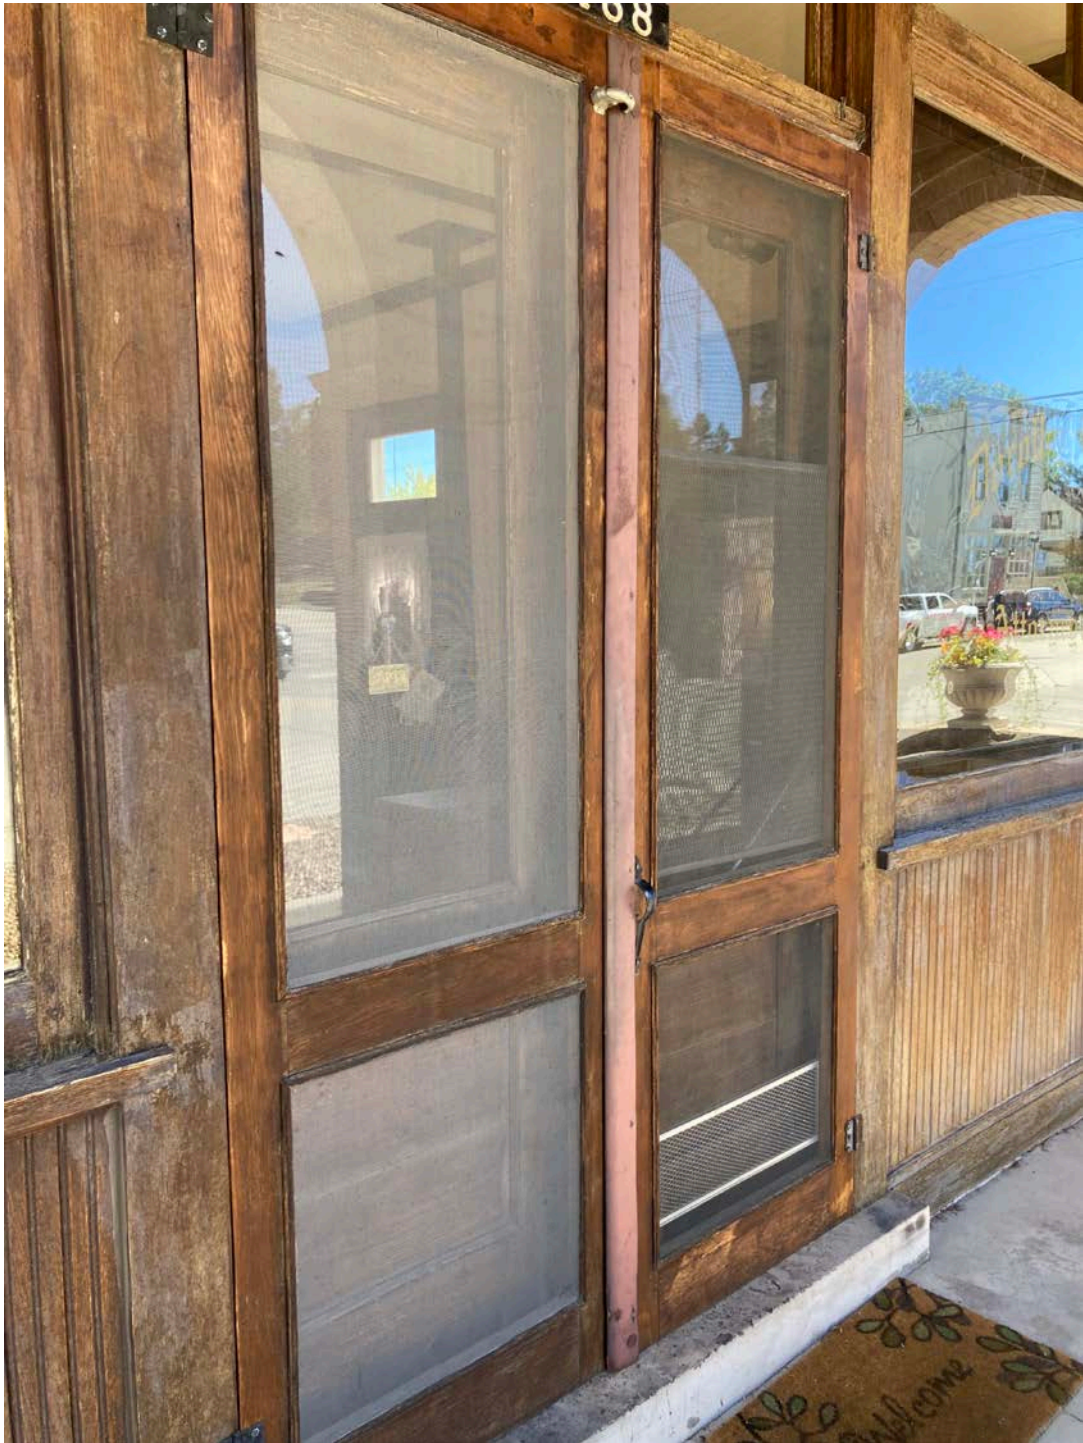
5 of 37.

Description of Photograph(s) and number: Main Entry Door and Sill, Fixed Pane Shop windows with wooden kick plates.

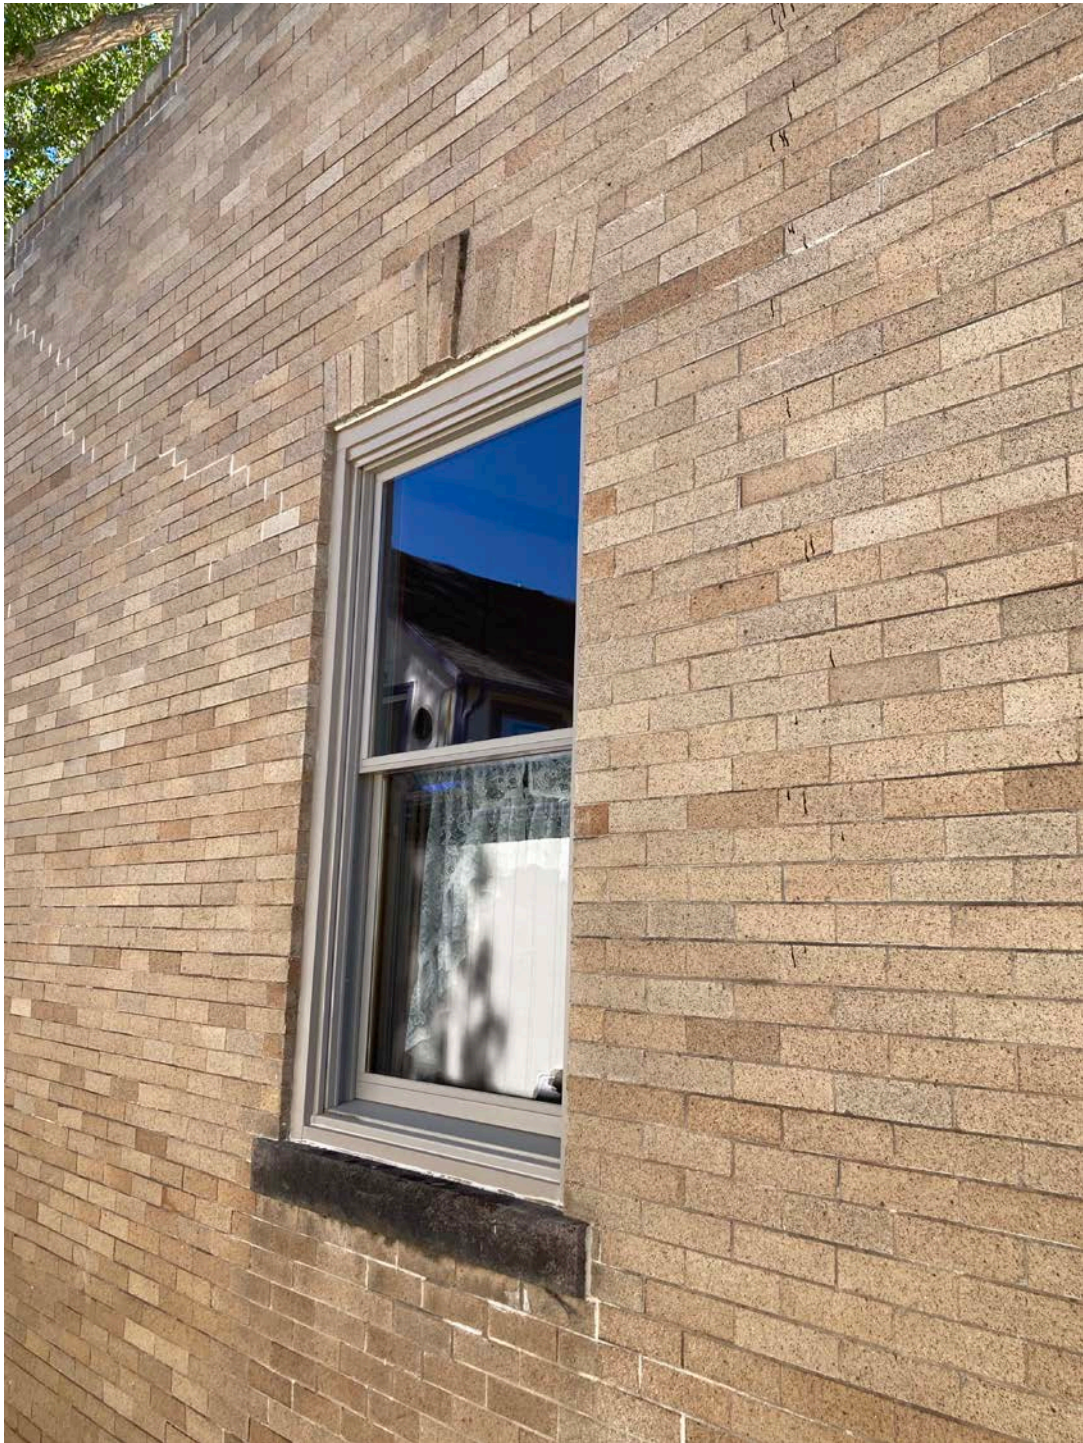
6 of 37.

Description of Photograph(s) and number: Typical Wood Single-Hung Window (original), secondary (north) elevation. Note the stone sill and brick keystone in the flat arch of the masonry opening.

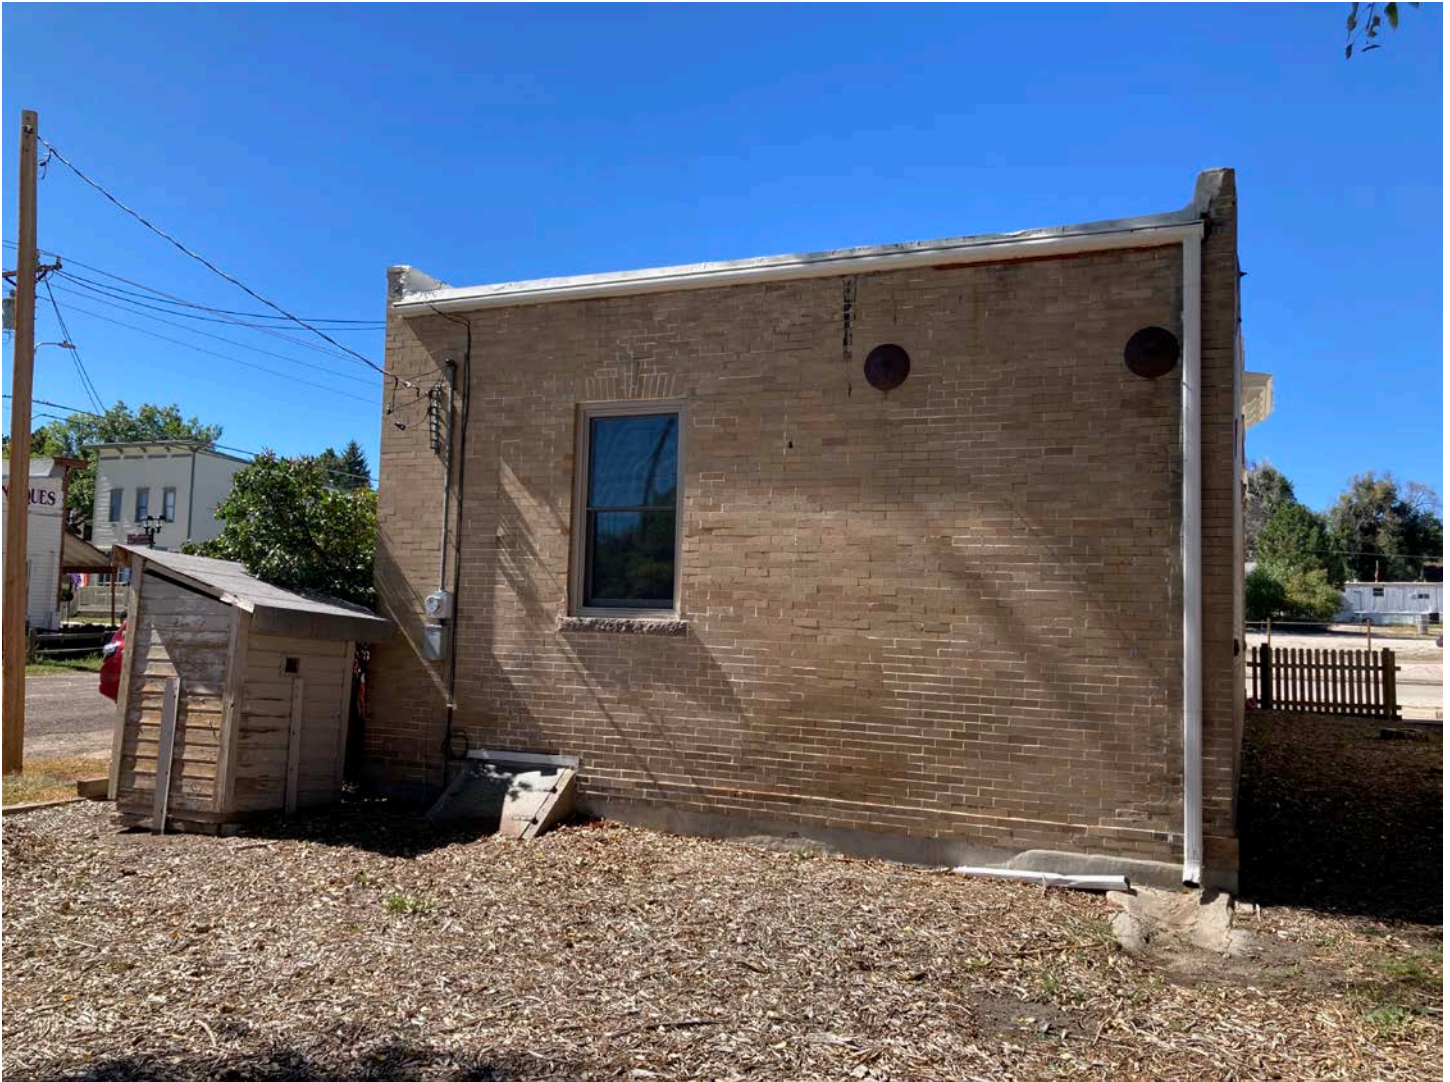
7 of 37.

Description of Photograph(s) and number: Rear (East) Elevation, note access to basement/crawl space and original wooden outhouse structure. This elevation would have faced the railroad.

The rear facade has no parapet but supports a gutter at the low-end of the flat roof for roof drainage to grade. There is a small door on the rear facade, offering basement/cellar access along the building's foundation. (Photo 8). A similar pair of stabilization cables can be seen at the adjacent corner to the cables noted on the north side of the building (northeast corner). South of the center line of the east side, there is one typical hung window, matching in materials, style, masonry opening, size, and sill as to the other single-hung windows on the secondary elevations. A wood-paneled hatch just above grade level provides access to a presumed crawl space or foundation; this hatch has not been accessed at the time of building survey and application to the National Register of Historic Places.

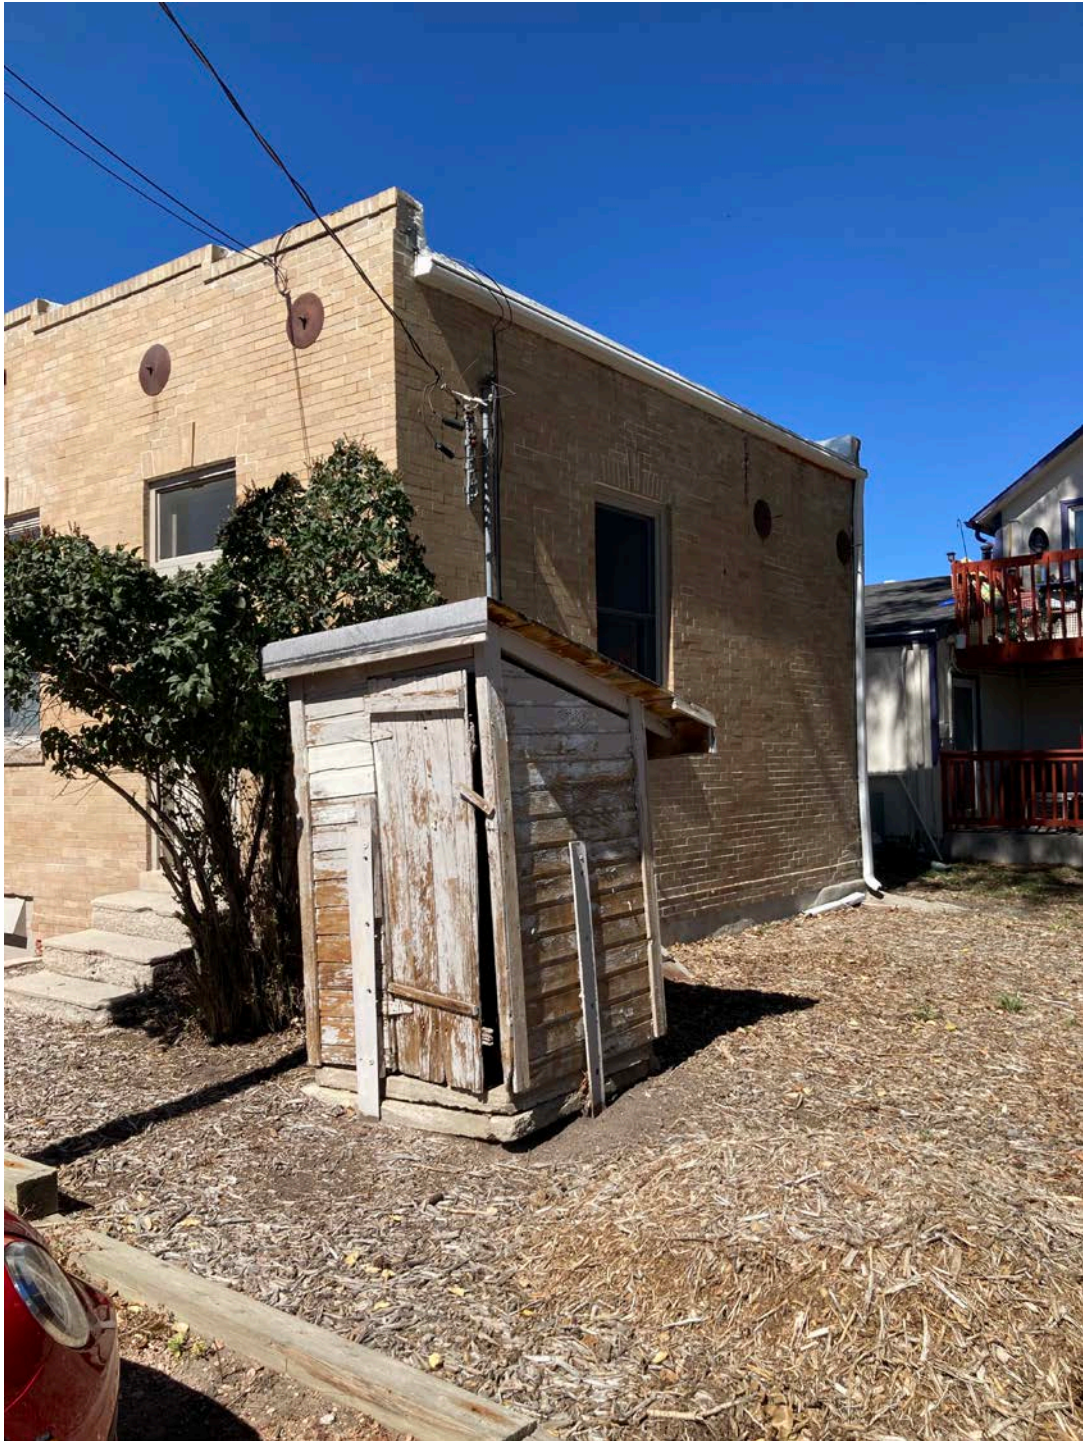
8 of 37.

Description of Photograph(s) and number: Rear (East) Elevation and partial Secondary (south) Elevation, looking northwest, original wooden outhouse.

A small, wooden outhouse structure is located on the southeast corner of the site. It is believed to be original to the building, as the building's current owners have noted that there is no indoor plumbing within the building. The structure is approximately 3 feet wide x 3 feet deep with a sloping wood roof. The high point of the roof is approximately 7'-6" above grade sloping north toward the masonry building to a low point of approximately 6 feet above grade. The wood siding is approximately 6-inch board siding and appears to have been painted a solid color (presumably white), however, the painted surfaces have not been maintained. The narrow entry door to the outhouse faces south. The structure appears to partially sit above a concrete or stone slab and is leaning slightly to the west. (Photo 8)

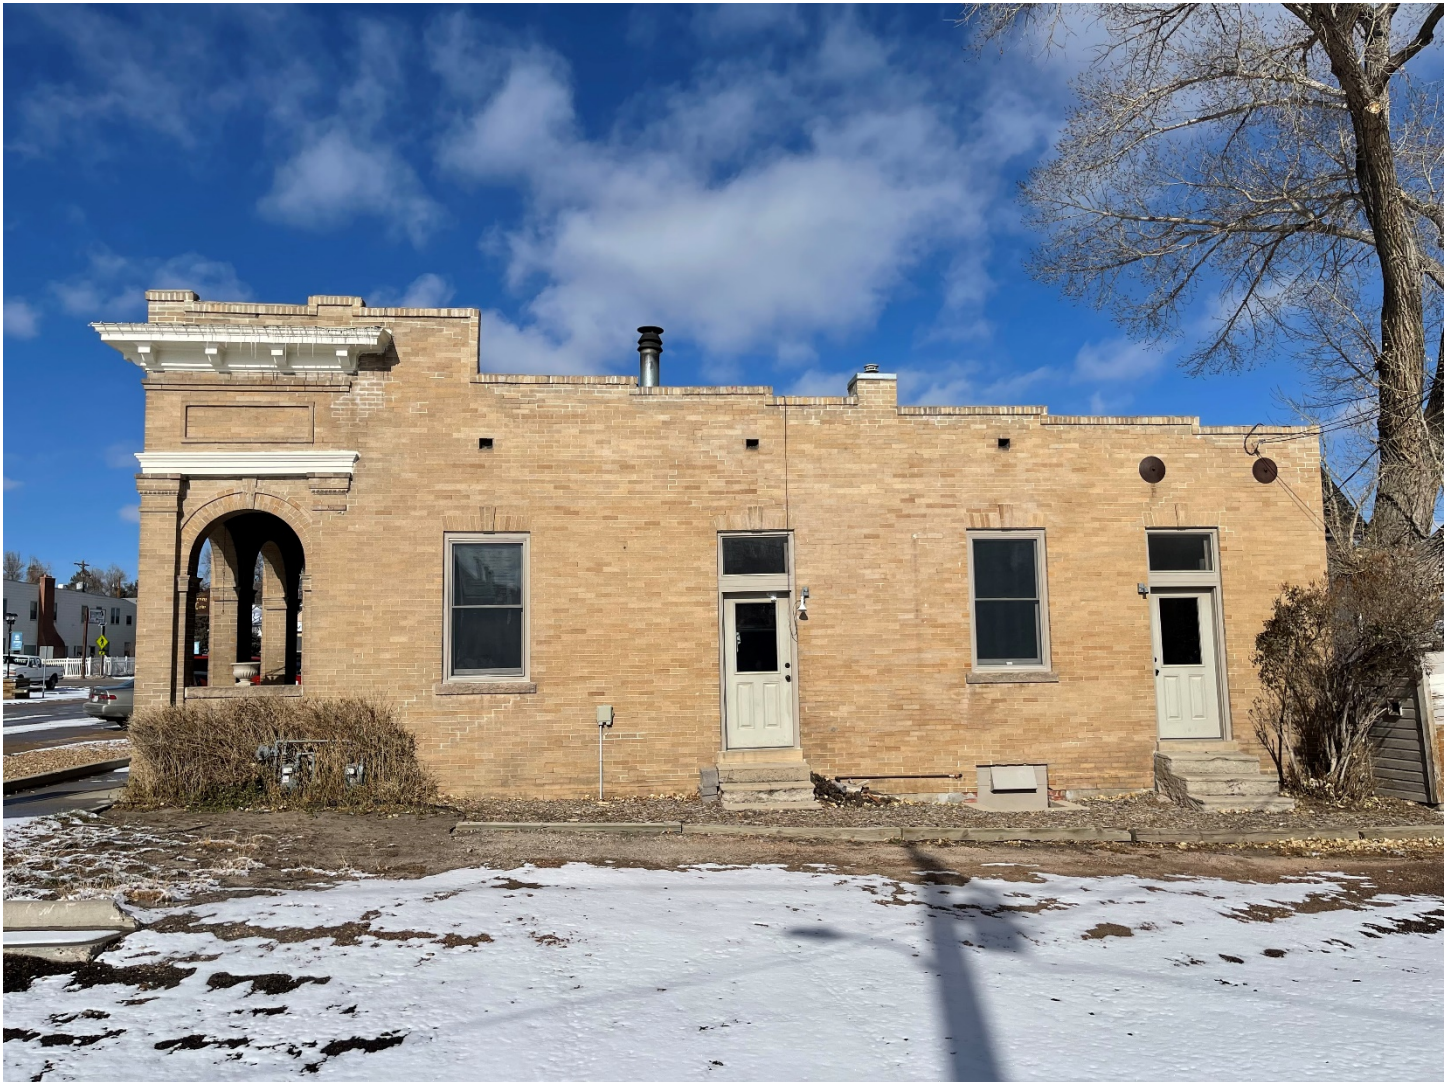
9 of 37.

Description of Photograph(s) and number: Secondary (south) Elevation, with two secondary entrances with transoms and two original wood windows. Wood window detail is same as on north elevation.

The south side of the building faces a small, unpaved parking lot. There are two secondary doors on the south side of the building which are single wood leafs with singular rectangular fixed pane lites, framed in wood. Working from east to west, the south side of the building mimics the organization of the north side, with the exception of the additional secondary entry doors. Two wood windows similar to those found on the north facade are also featured on the south facade. From the southeast corner working west, the organization of the south façade is as follows: brick wall segment, secondary entry door with transom, brick wall segment, typical window, brick wall segment, secondary entry door with transom, brick wall segment, typical window, brick wall segment, southern return (wrap) of entry porch. The entry porch detailing and stepped cornice on the south elevation match that of the north side of the building. Each of the two secondary entry doors are reached via stone slab steps. Both doors have glazed transoms above. Like the north and east sides of the building, stabilization cables have been installed in the upper south east corner of the structure, above the east-most door, with evidence of mortar repair/replacement in the general area. Stepped-brick parapets are visible on the secondary (north and south-facing facades). (Photos 9, 10, and 11). Through-parapet scuppers are visible centered in the masonry above both windows and the west-most door, approximately 11 brick courses above the top of the masonry opening's brick keystones. There appears to be an original masonry chimney, approximately 4 brick courses tall above the parapet with patina finish on metal flashing, located approximately midway across and flush with the south side of the building. The secondary facades and the rear (east- alley) facade are of the same tan brick masonry. From the south side photos, one can also see a metal-flue stove or fireplace penetration, extending to just below the height of the tallest (west side) parapet height. (Photo 9)

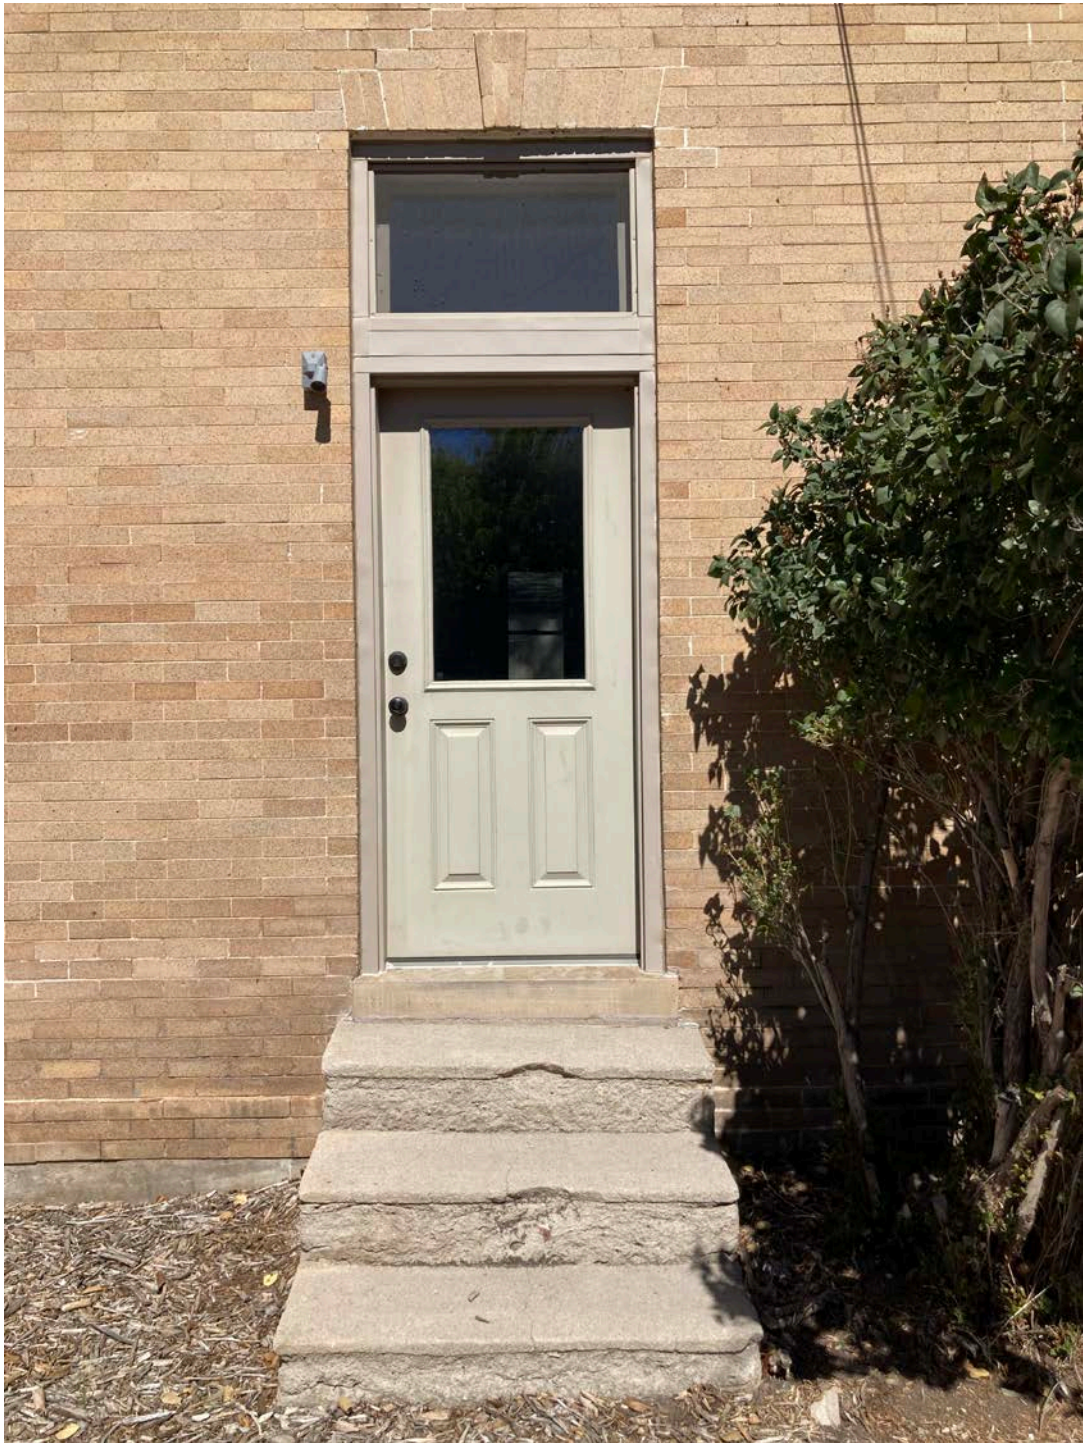
10 of 37.

Description of Photograph(s) and number: Detail of Secondary Entry Door from Secondary (south) Elevation. Not the stone stoop, wood frame and transom, and matching brick keystone in flat arch of masonry opening.

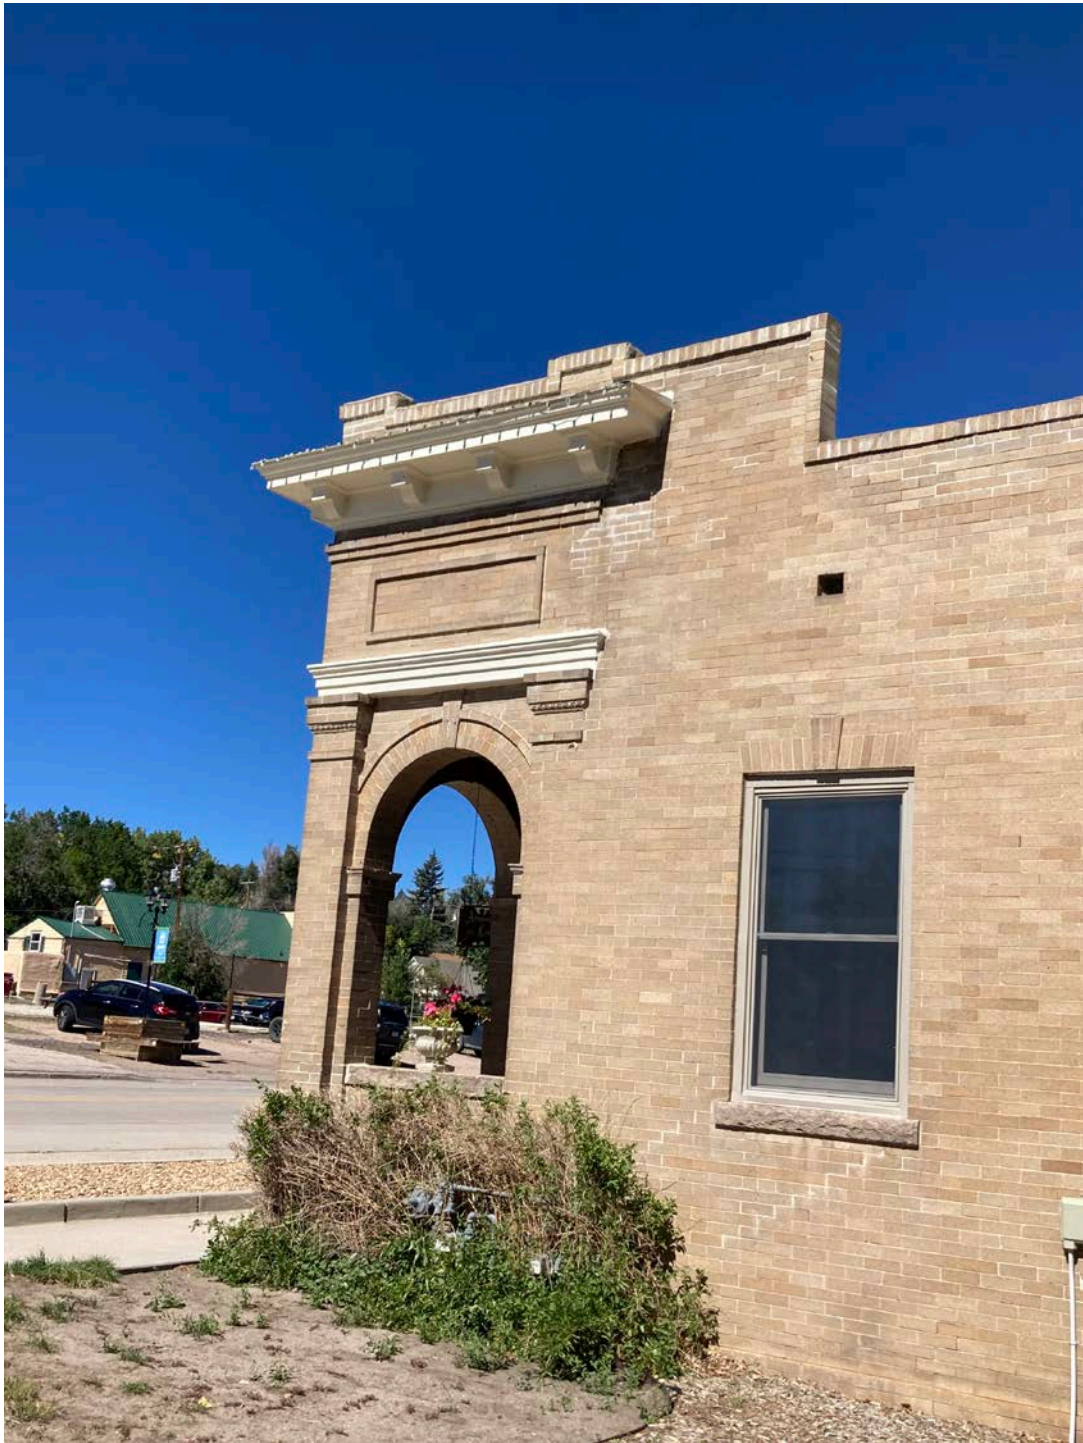
Description of Photograph(s) and number: Partial Secondary (South) Elevation looking northwest back to Main Street, arcade/portico/porch. Note the extent of the high parapet and cornice return matches the dimension of the porch before the parapet steps down along the length of the secondary elevation.

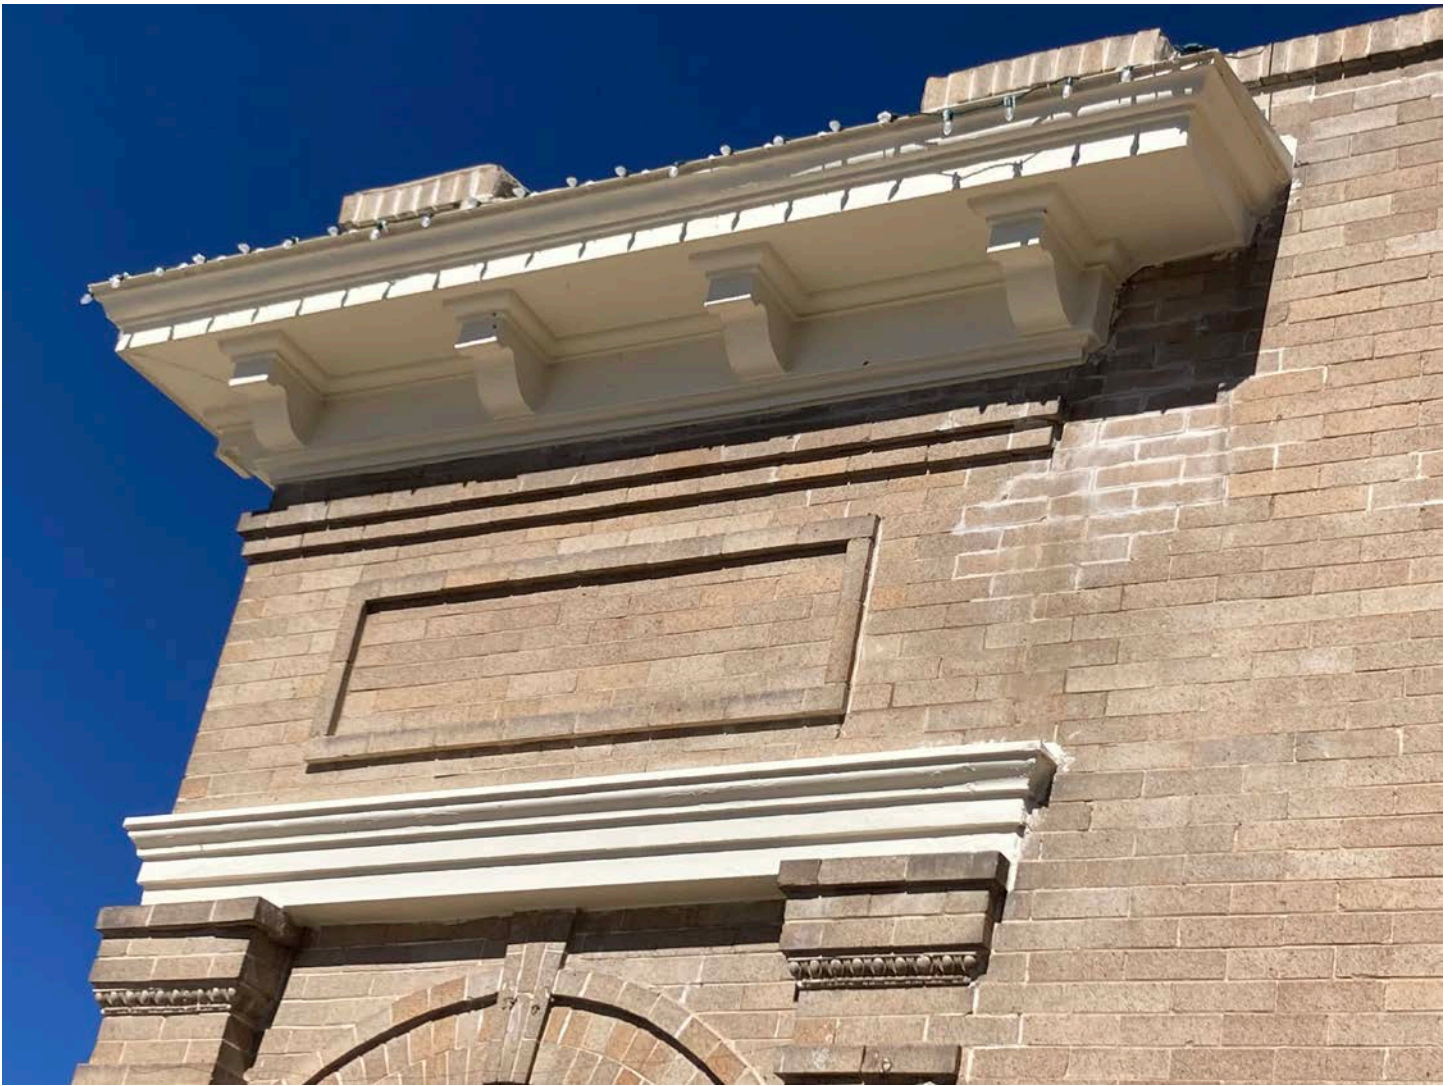
12 of 37.

Description of Photograph(s) and number: Detail of Cornice and Parapet from secondary (south) elevation. Note the brick keystone in the arch, the egg and dart detailing in the pilaster capitals, brick corbeling, and wood brackets and profiles.

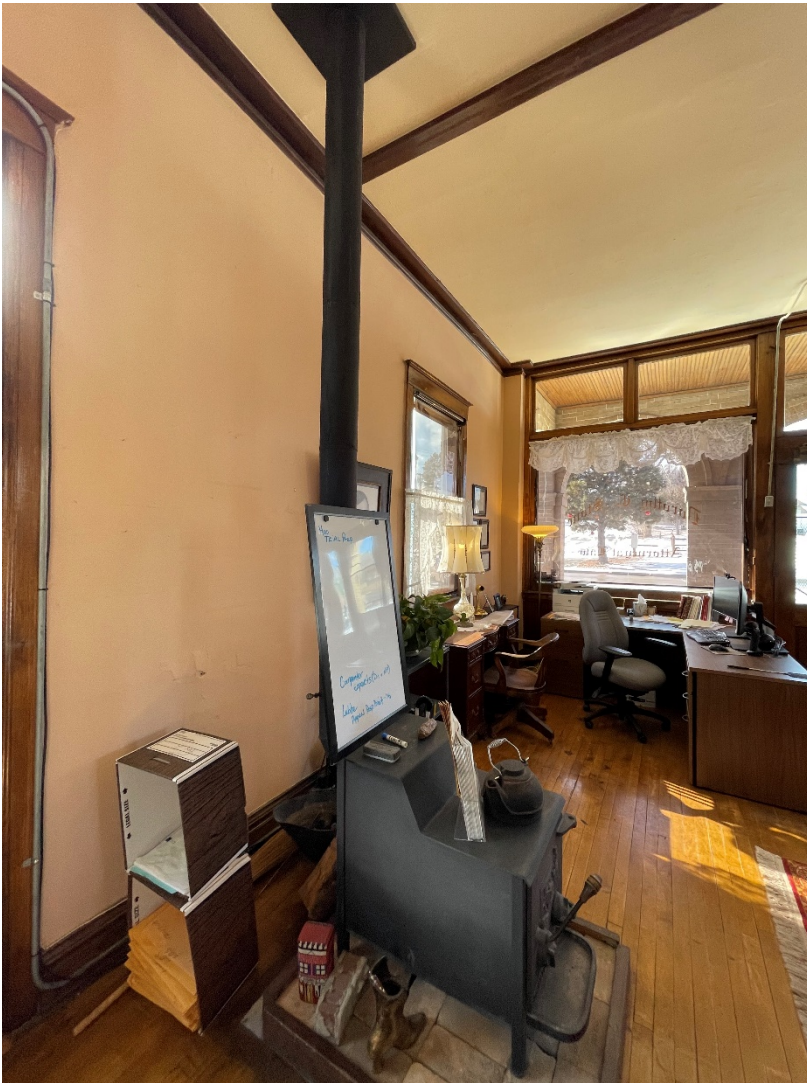
16 of 37.

Description of Photograph(s) and number: 188 S. Main Street, Main Level, primary public space, note iron stove and flue pipe.

Entering the building from the main doors along Main Street (west side), the primary level of the building opens into the largest interior room, approximately 23' x 23' square. This primary public space is street-fronting. Floor finishes are light-stained wood flooring, painted plaster walls, dark-stained wood crown molding, and painted plaster ceiling with a shallow wood beam dark stained to match the crown molding, bisecting the ceiling in the north-south direction and also crossing in the east-west direction, concealed by electrical conduit. Surface mounted wire mold/electrical conduit, painted dark brown to match the dark wood stain, crosses the ceiling in the east-west direction. This conduit appears to provide the electrical distribution to the pendant and surface-mounted light fixtures within the space. Most of the light fixtures are electrical and appear to be period-appropriate; ceiling fans and smoke detectors are also visible. Dark stain on wide wood trim finishes the window surrounds. The interior surface of the wood paneling beneath the entry windows is stained to match the dark stain of the crown molding and window trim. (Photos 14 and 15). There is an iron stove located on the south-east side of this room (Photo 16), the flue for this stove is visible from the south side of the building's exterior. There is no existing
