National Register of Historic Places Registration Form

historic name First National Bank of Elizabeth
other names/site number 5EL.321

street & number 188 S. Main Street not for publication
city or town Elizabeth vicinity
state CO county Elbert zip code 80107

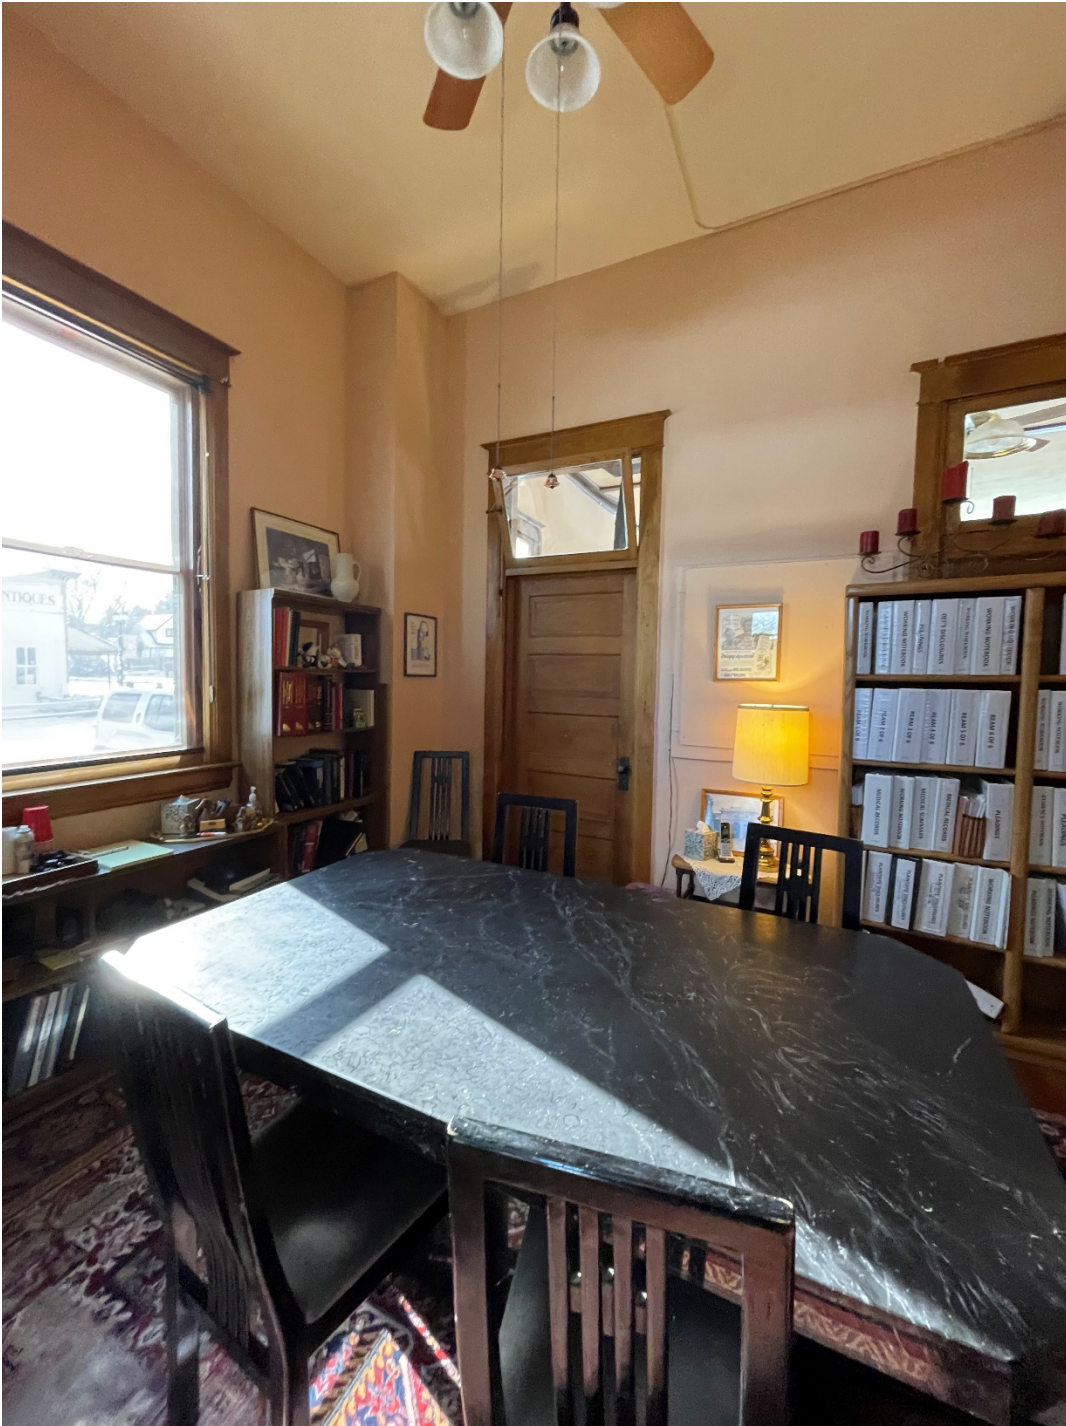
17 of 37.

Description of Photograph(s) and number: 188 S. Main Street, Main Level, secondary office.

Passing through a dark-stained wood door with glazed transom above, one moves from the main public room into a secondary office space, also located on the main level. This room measures approximately 12' x 13' and is currently used as a meeting room/ resource library. The floor, wall, and ceiling finishes in this space are similar to the main room, but the level of detail in wood trim and profiles is simplified. There is no crown molding and there are no profiled beams. Window and door trim are stained in a similar dark stain as to the main room. The interior doors dividing the spaces are paneled wood with decorative metal hardware and overhead transoms. (Photos 17 – 19). Another main vault/safe access door from the secondary room to the adjacent Bank Vault exists to access the vault from the northeast side of this room. (Photo 28).

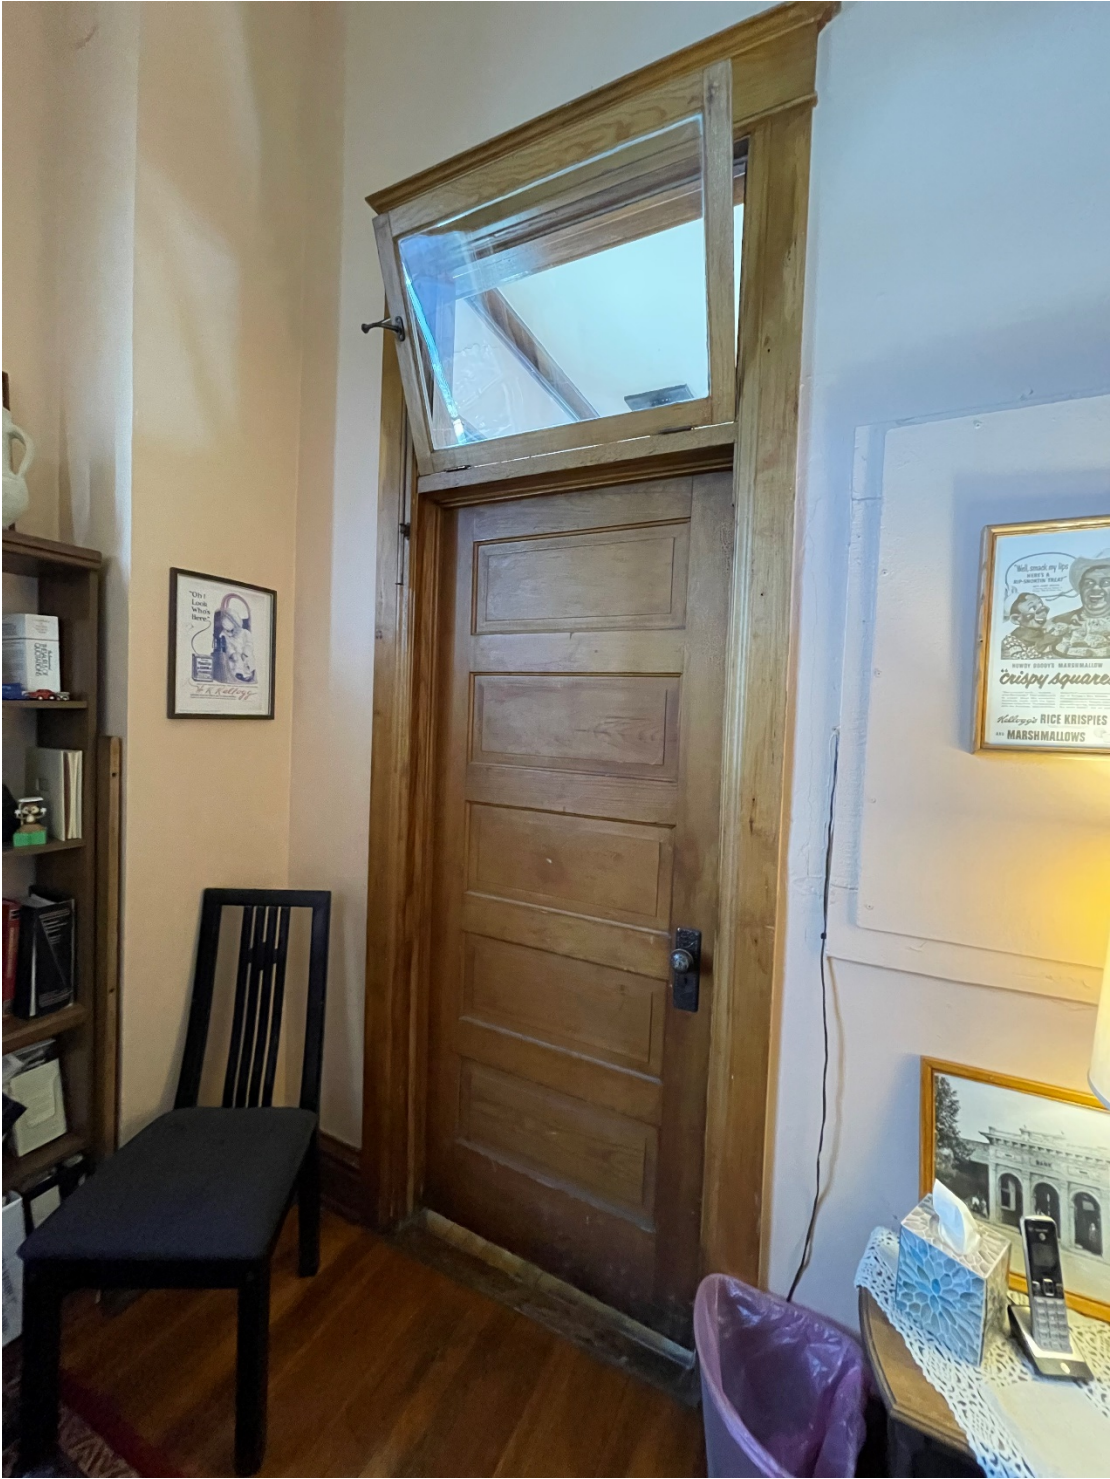
Description of Photograph(s) and number: 188 S. Main Street, Main Level, secondary office space, note operable transom over door.

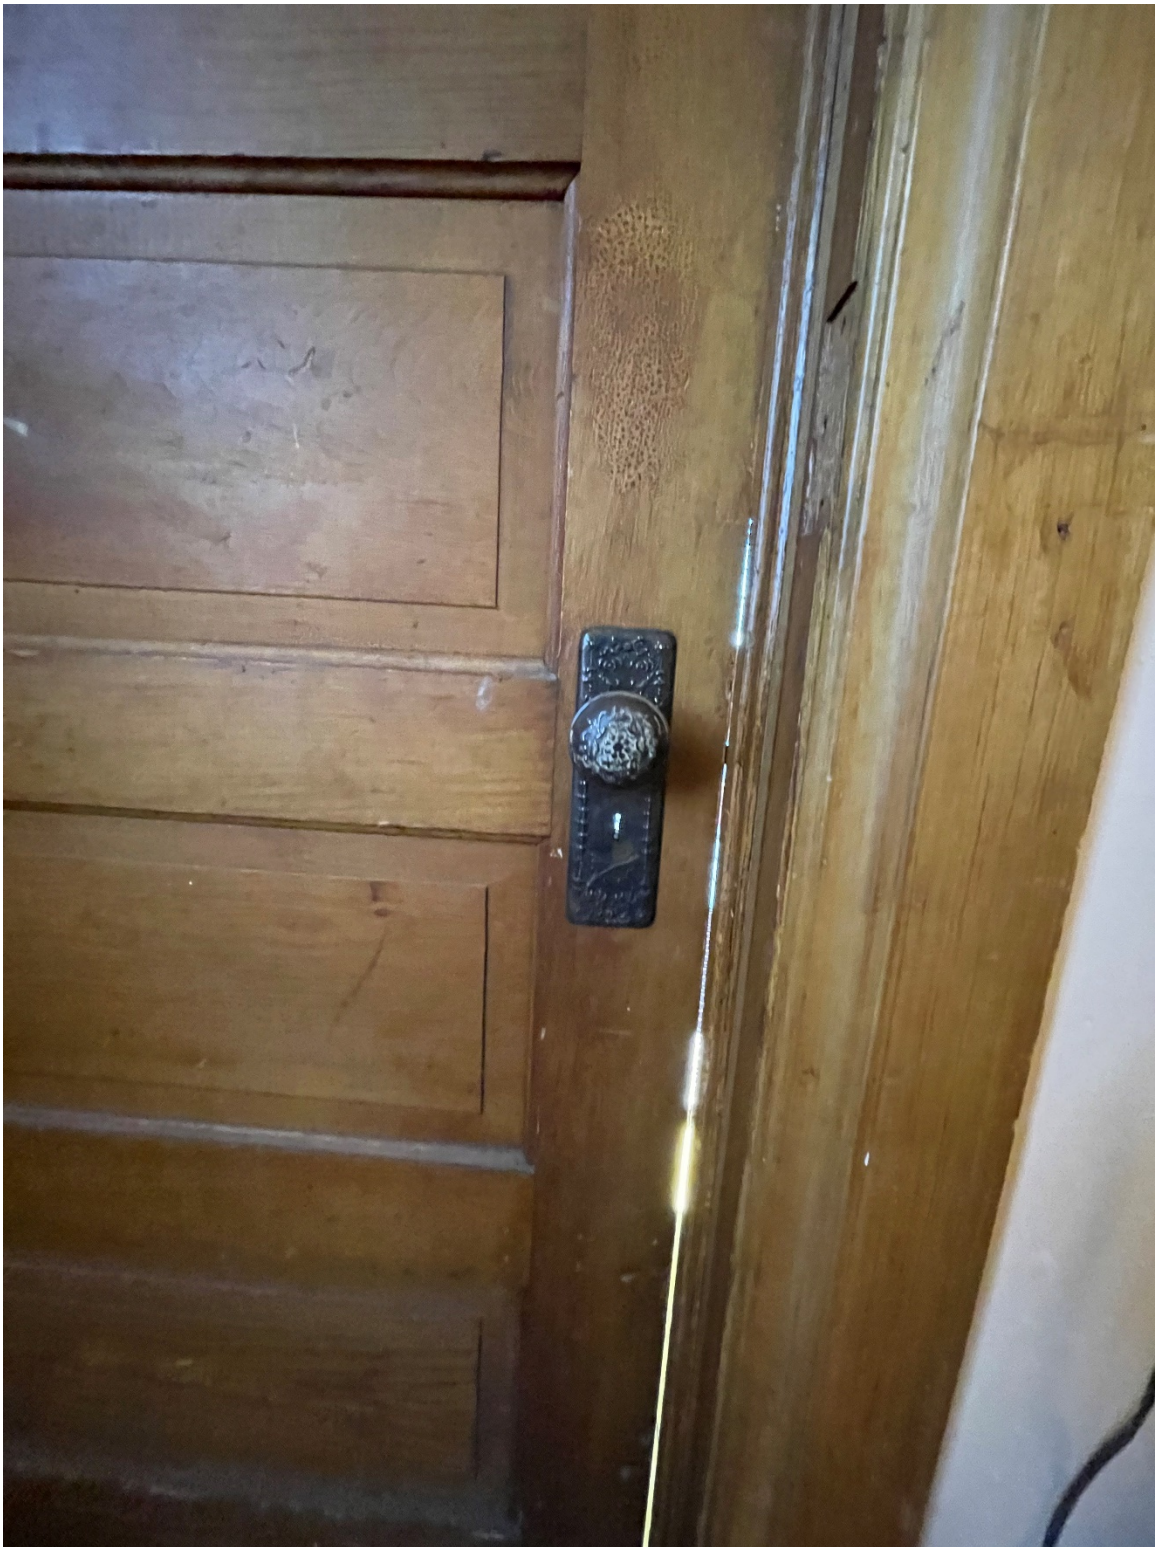
19 of 37.

Description of Photograph(s) and number: 188 S. Main Street, Main Level, secondary office space, note decorative door hardware.

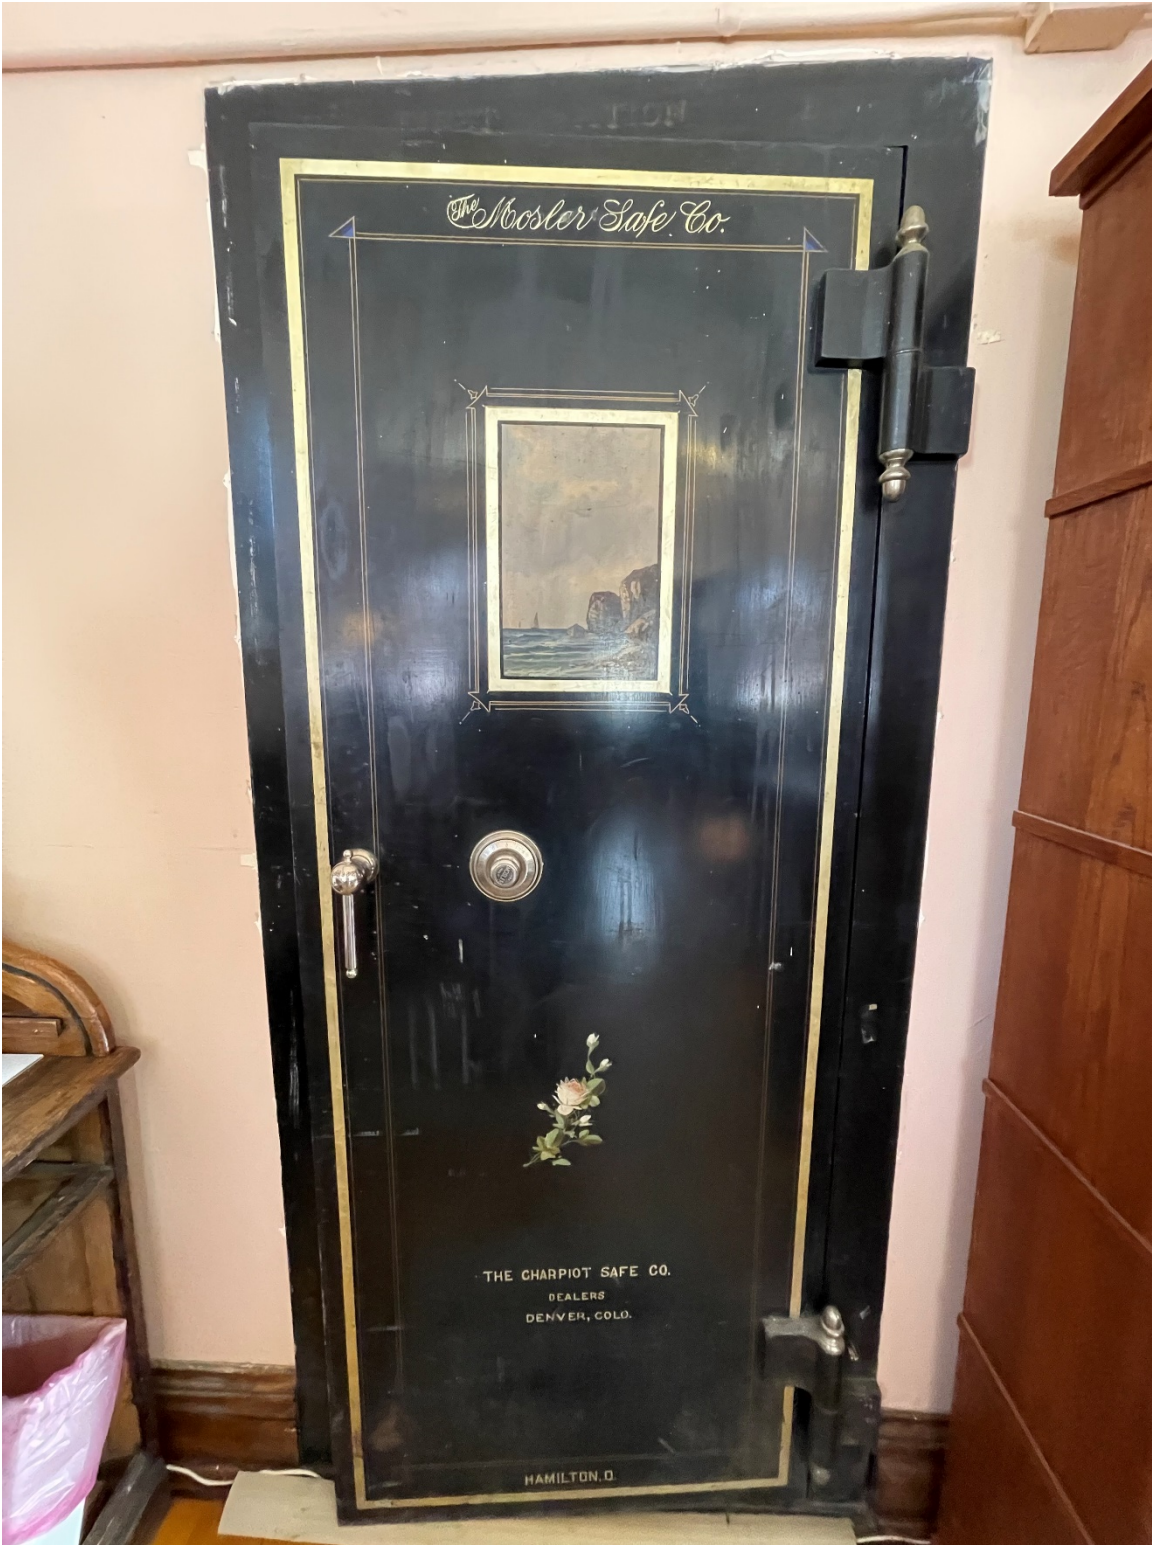
20 of 37.

Description of Photograph(s) and number: 188 S. Main Street, Main Level, Bank Vault/Safe door from Main Room.

On the northeast side of the main level exists the built-in, walk-in bank vault. The vault displays the brand name of Mosler Safe Company, established in 1869. The vault/safe door is secured via a traditional combination lock, bronze. (Photos 20-21). Additional hardware on the main-room side of the building is a polished white metal (presumed stainless steel) lever bar, with the numbers '198332' engraved into the ball of the lever. (Photo 22). There is a picture of a seascape on the upper portion of the vault/safe door, visible from the main level, main room (Photo 23). An additional painted floral detail is seen at the lower level of the vault/safe door, visible also from the main level, main room (Photo 26). Beneath the floral pattern, additional text in the lower quarter of the door reads 'THE CHARPIOT SAFE CO. DEALERS DENVER, COLO. HAMILTON, O.' in all capital letters. (Photos 20 and 26) The inside face of the vault/safe door has white-metal panels along the strike side and hinge sides of the door. These panels may provide additional reinforcing to the door. (Photos 24-25). A second pair of narrow, double doors creates a shallow vestibule beyond the main safe door (Photo 27).

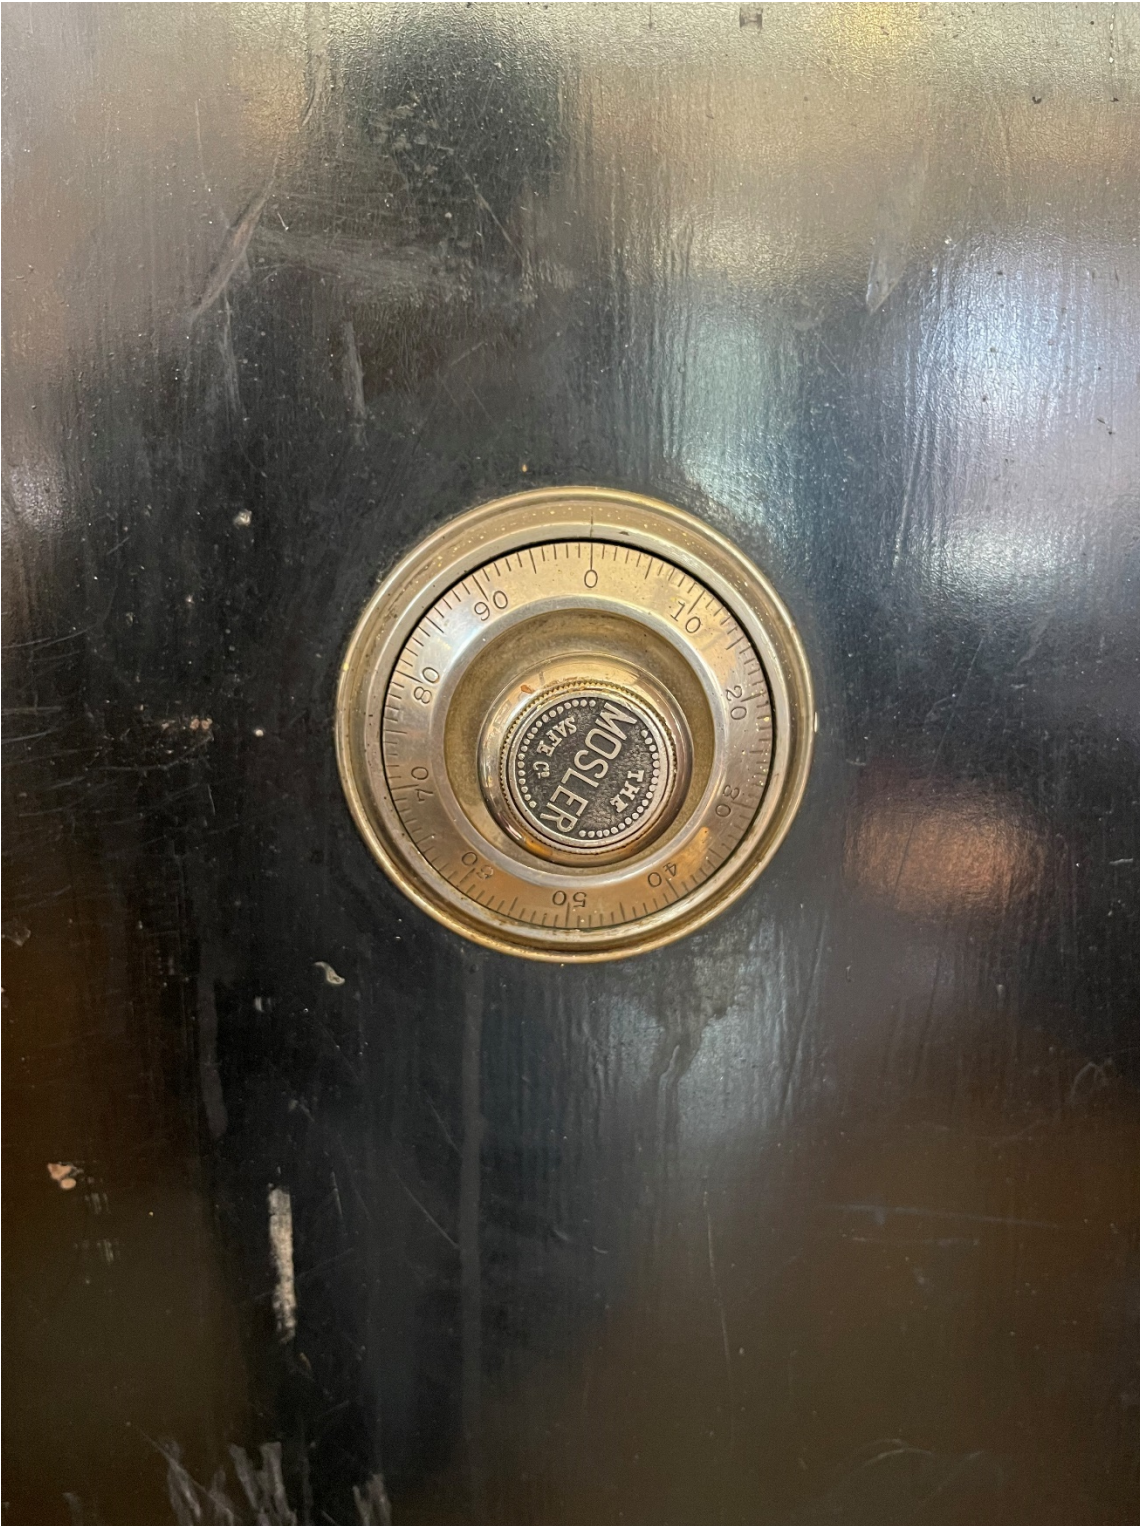
Description of Photograph(s) and number: 188 S. Main Street, Main Level, Bank Vault/Safe door from Main Room, detail of combination lock, Mosler brand.

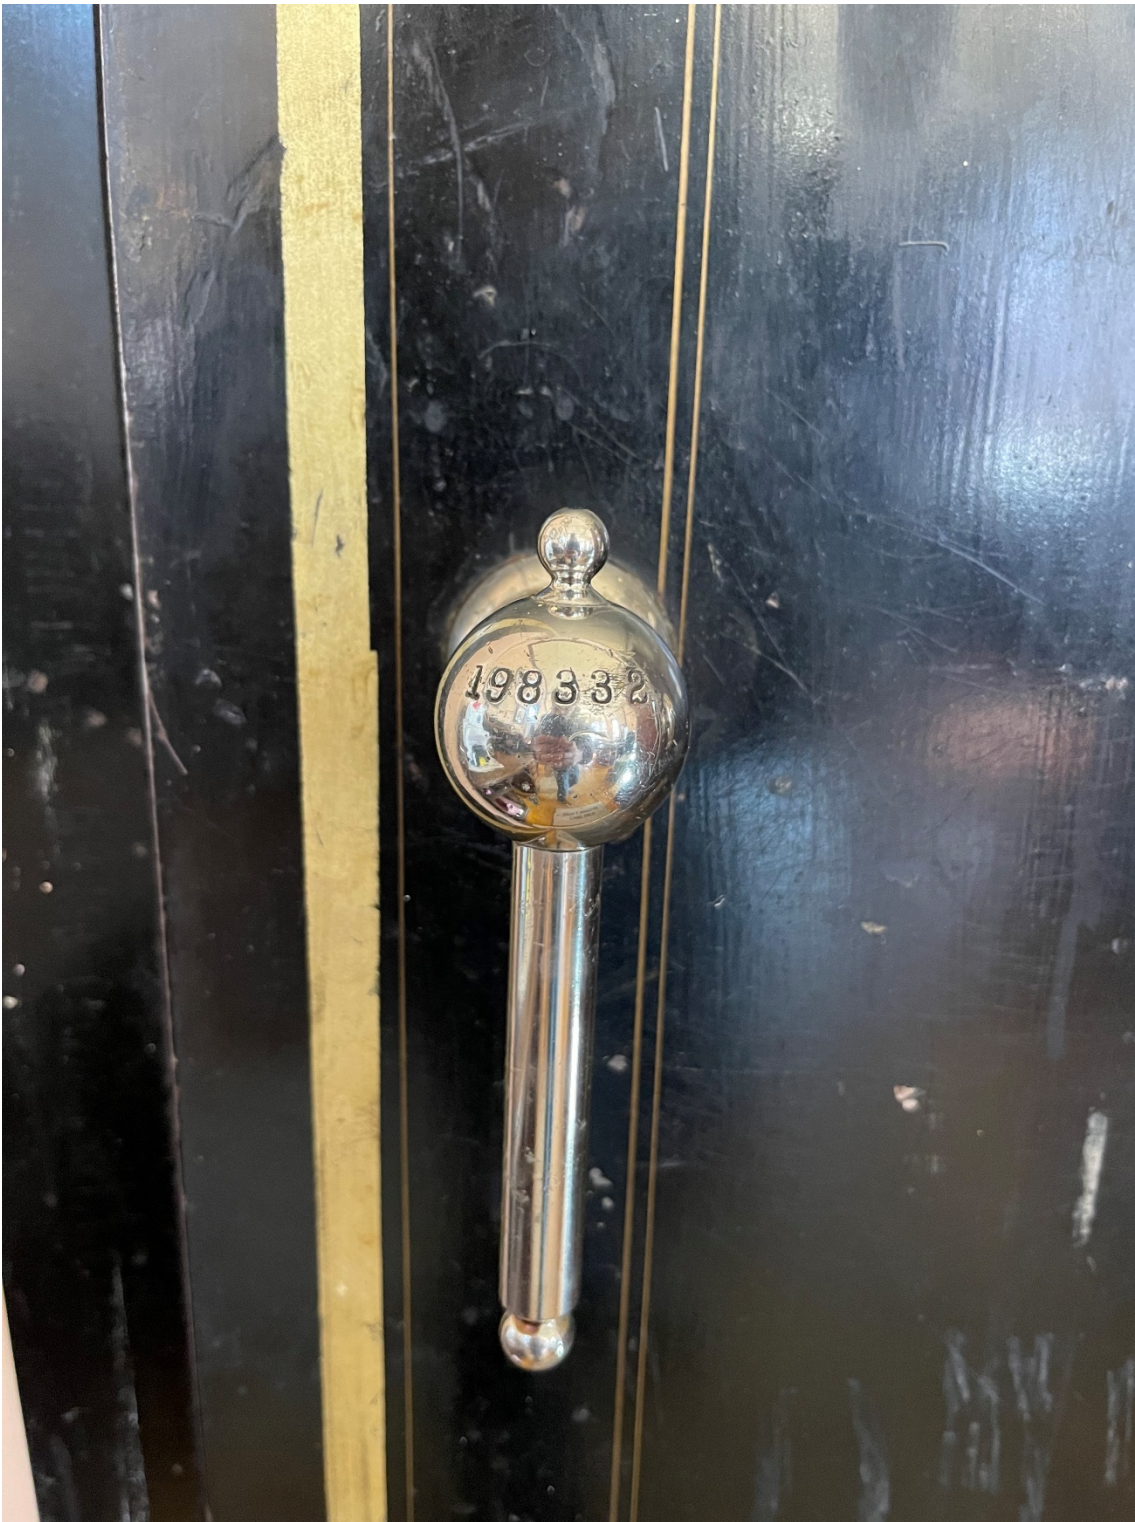
Description of Photograph(s) and number: 188 S. Main Street, Main Level, Bank Vault/Safe door from Main Room, detail of lever hardware.

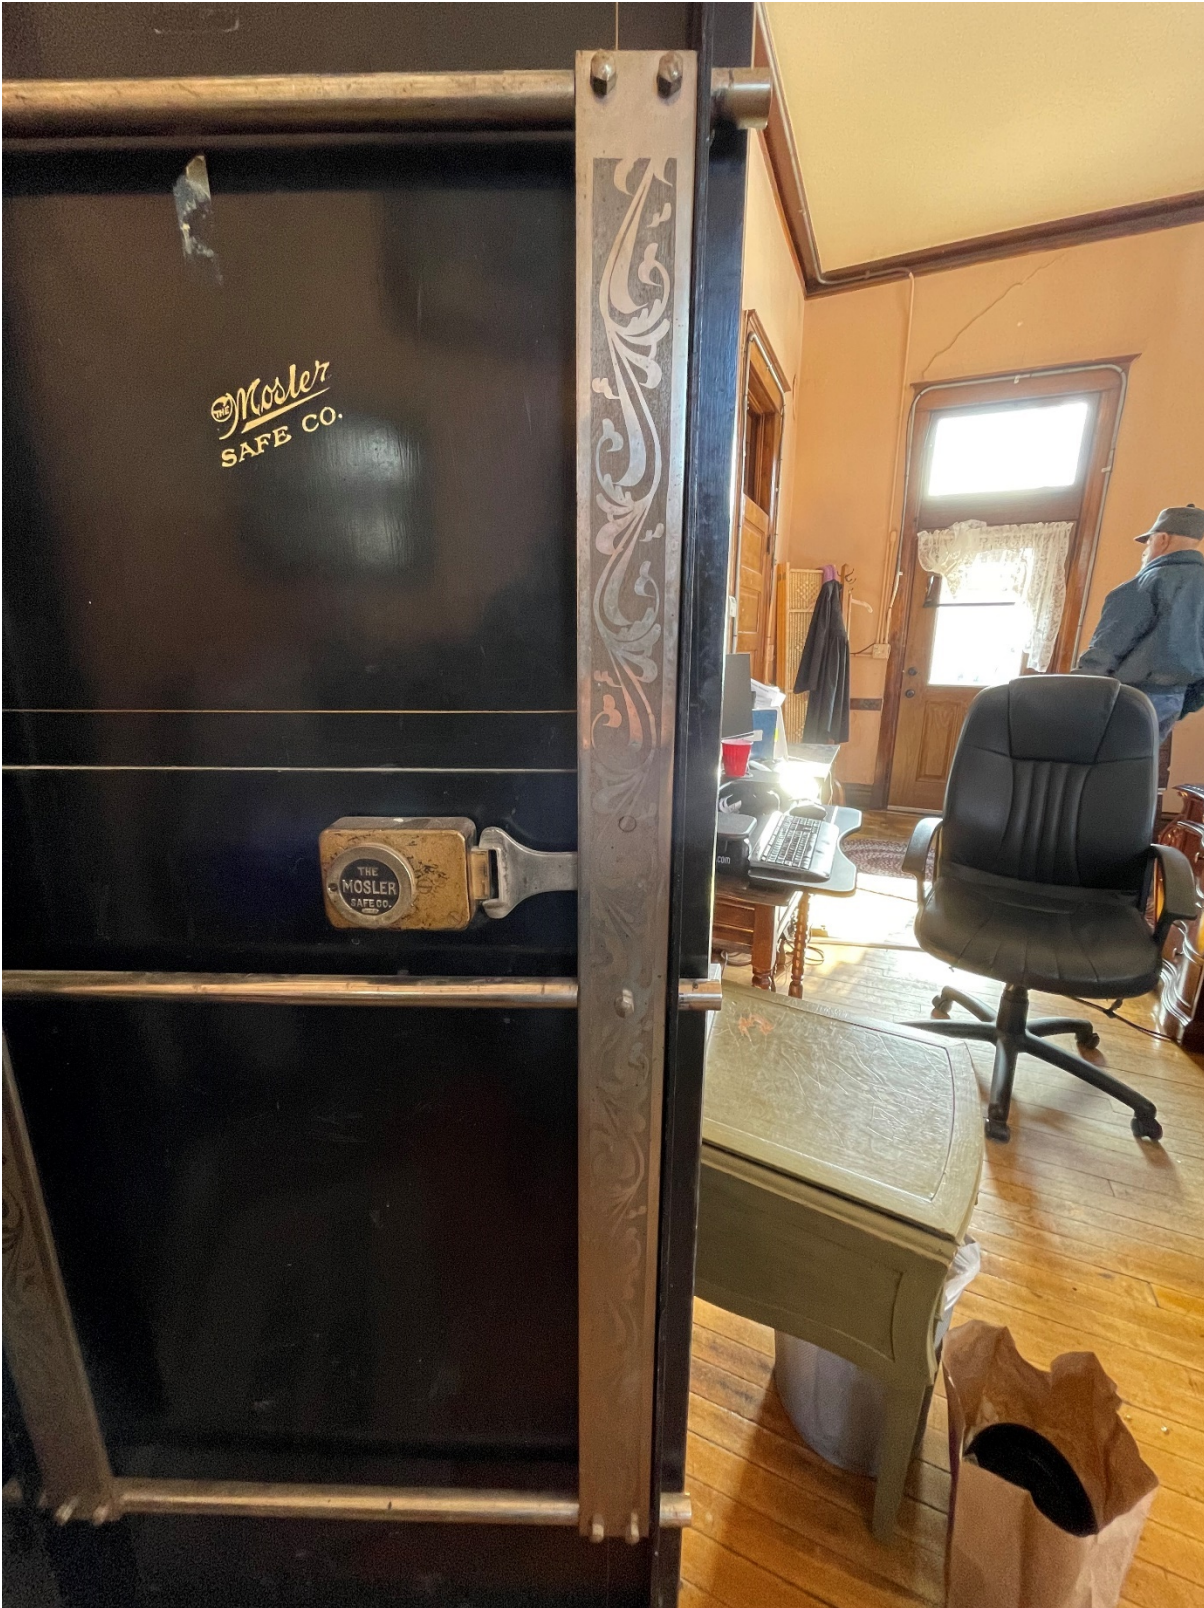
Description of Photograph(s) and number: 188 S. Main Street, Main Level, Bank Vault/Safe door from Main Room, interior door detail
24 of 37.

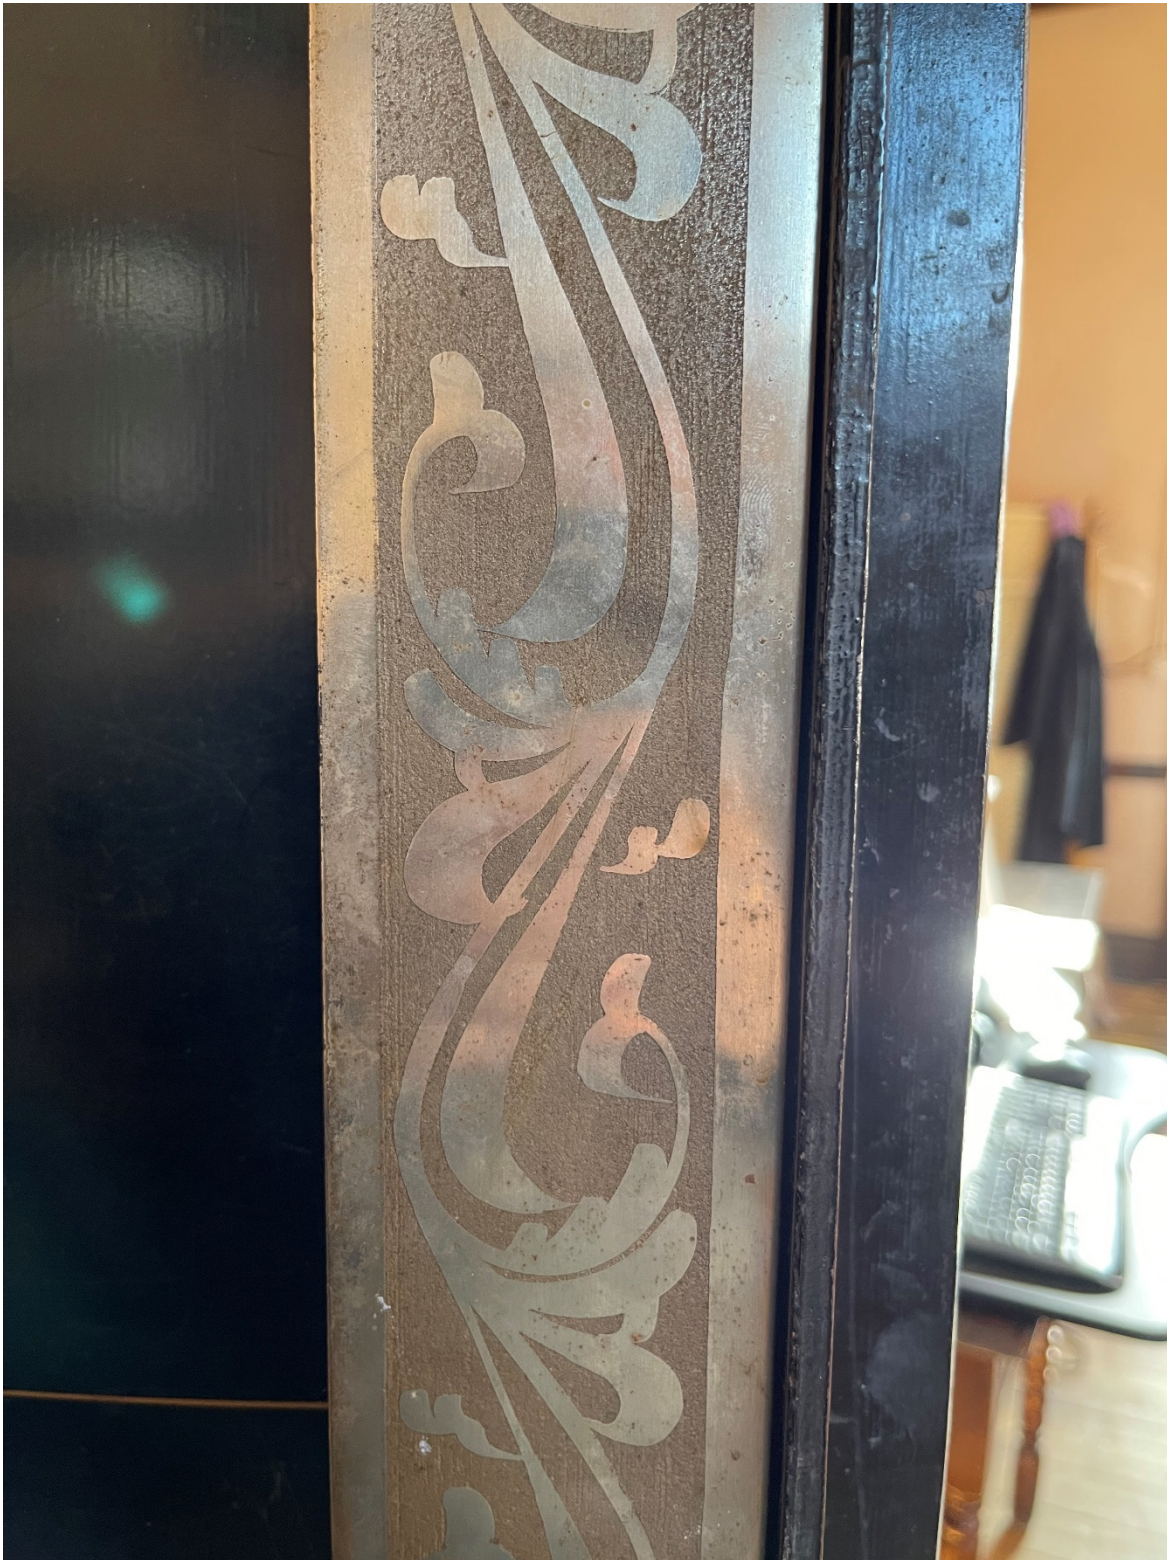
Description of Photograph(s) and number: 188 S. Main Street, Main Level, Bank Vault/Safe door from Main Room, interior door detail
25 of 37.

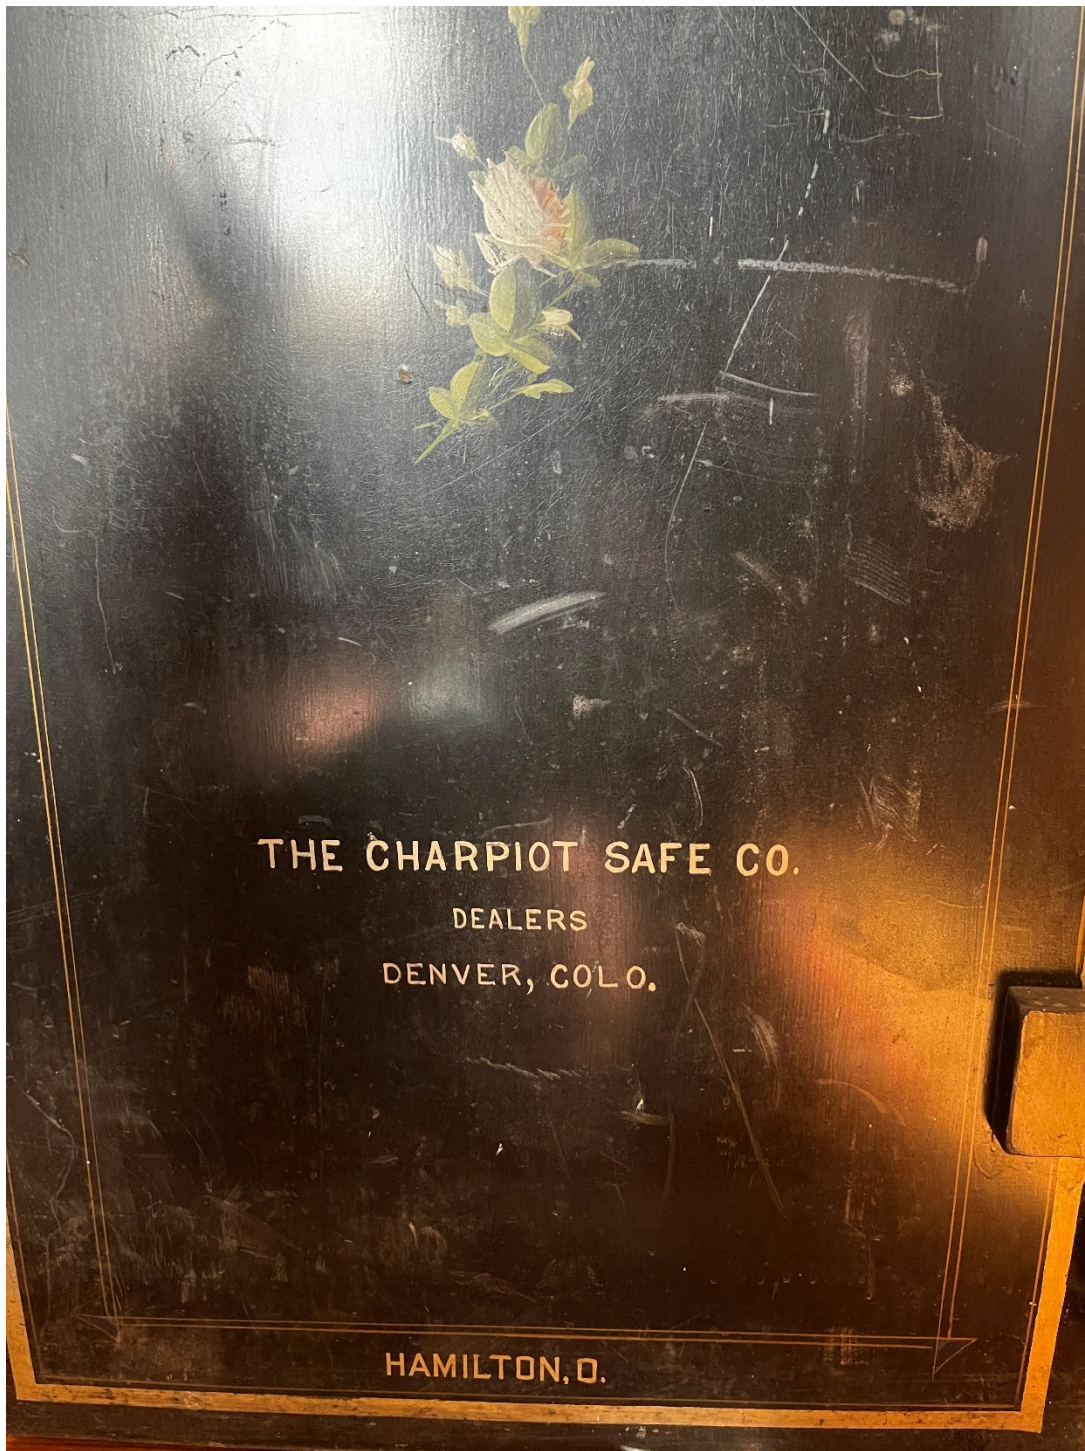
Description of Photograph(s) and number: 188 S. Main Street, Main Level, Bank Vault/Safe door from Main Room, floral detail, main room side of door.
26 of 37.

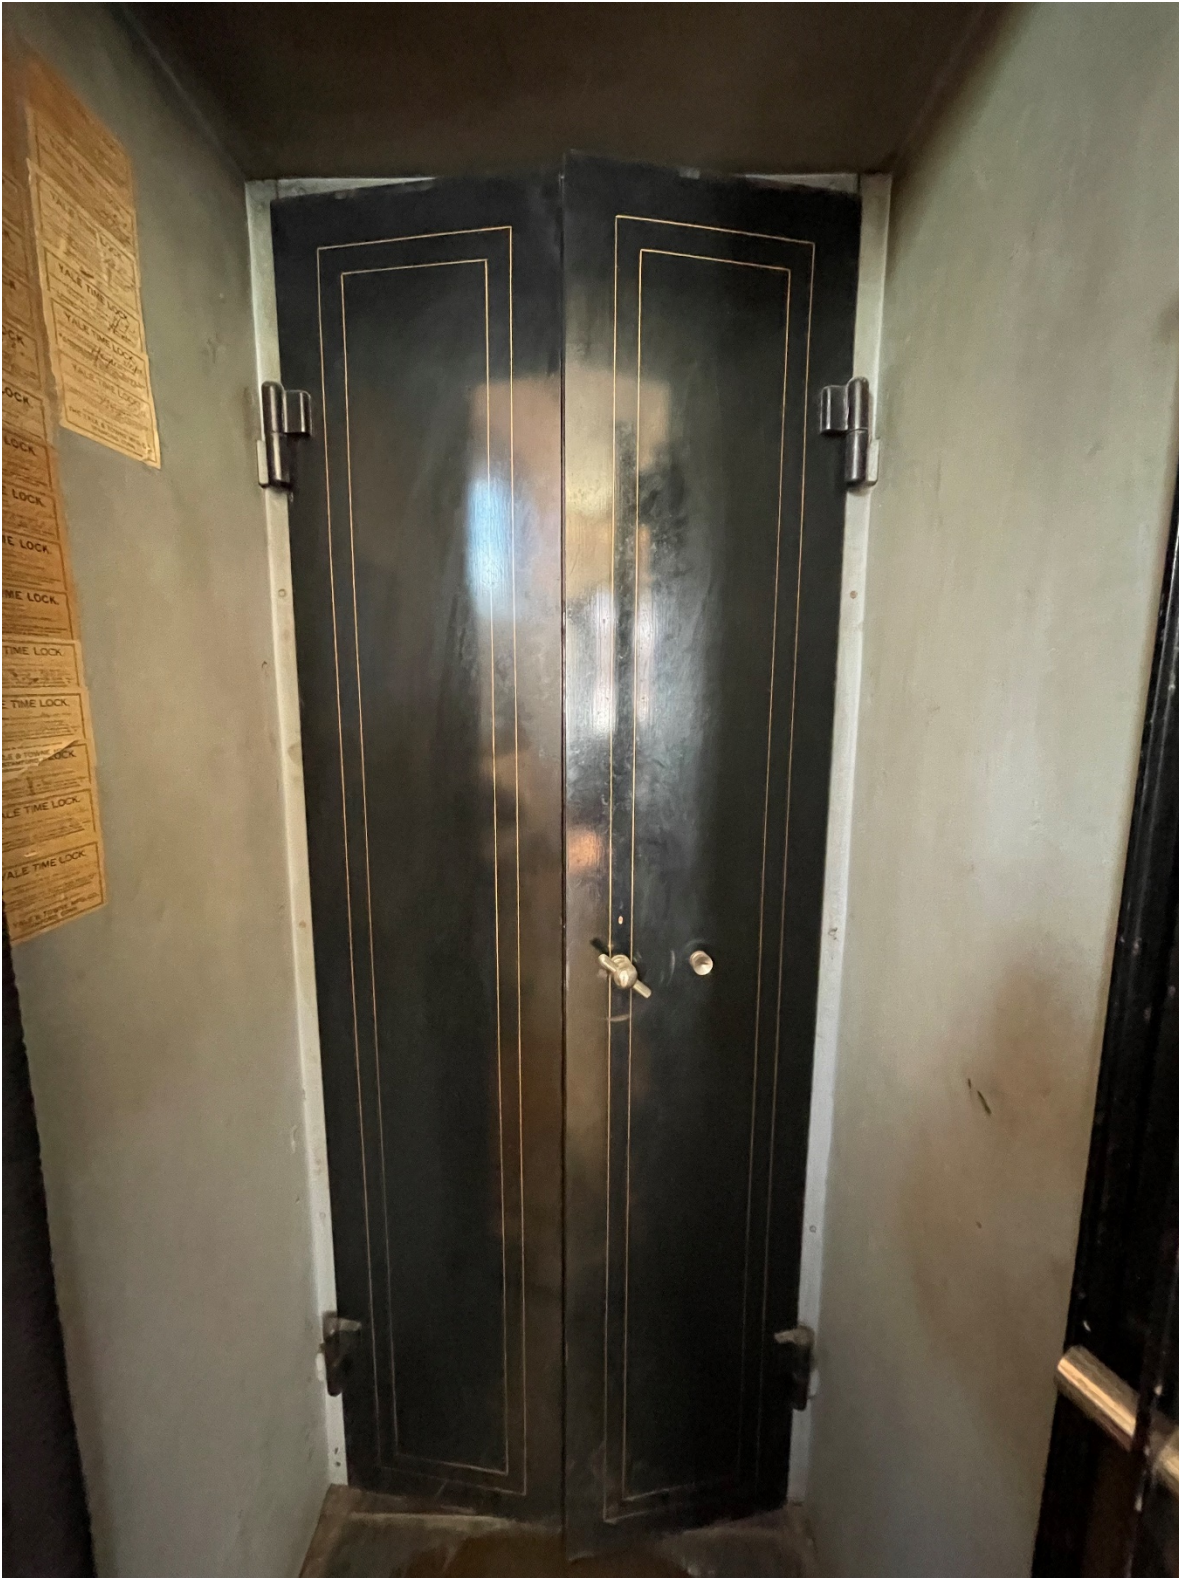
Description of Photograph(s) and number: 188 S. Main Street, Main Level, Bank Vault/Safe double door access from the main level main room vault vestibule.
27 of 37.

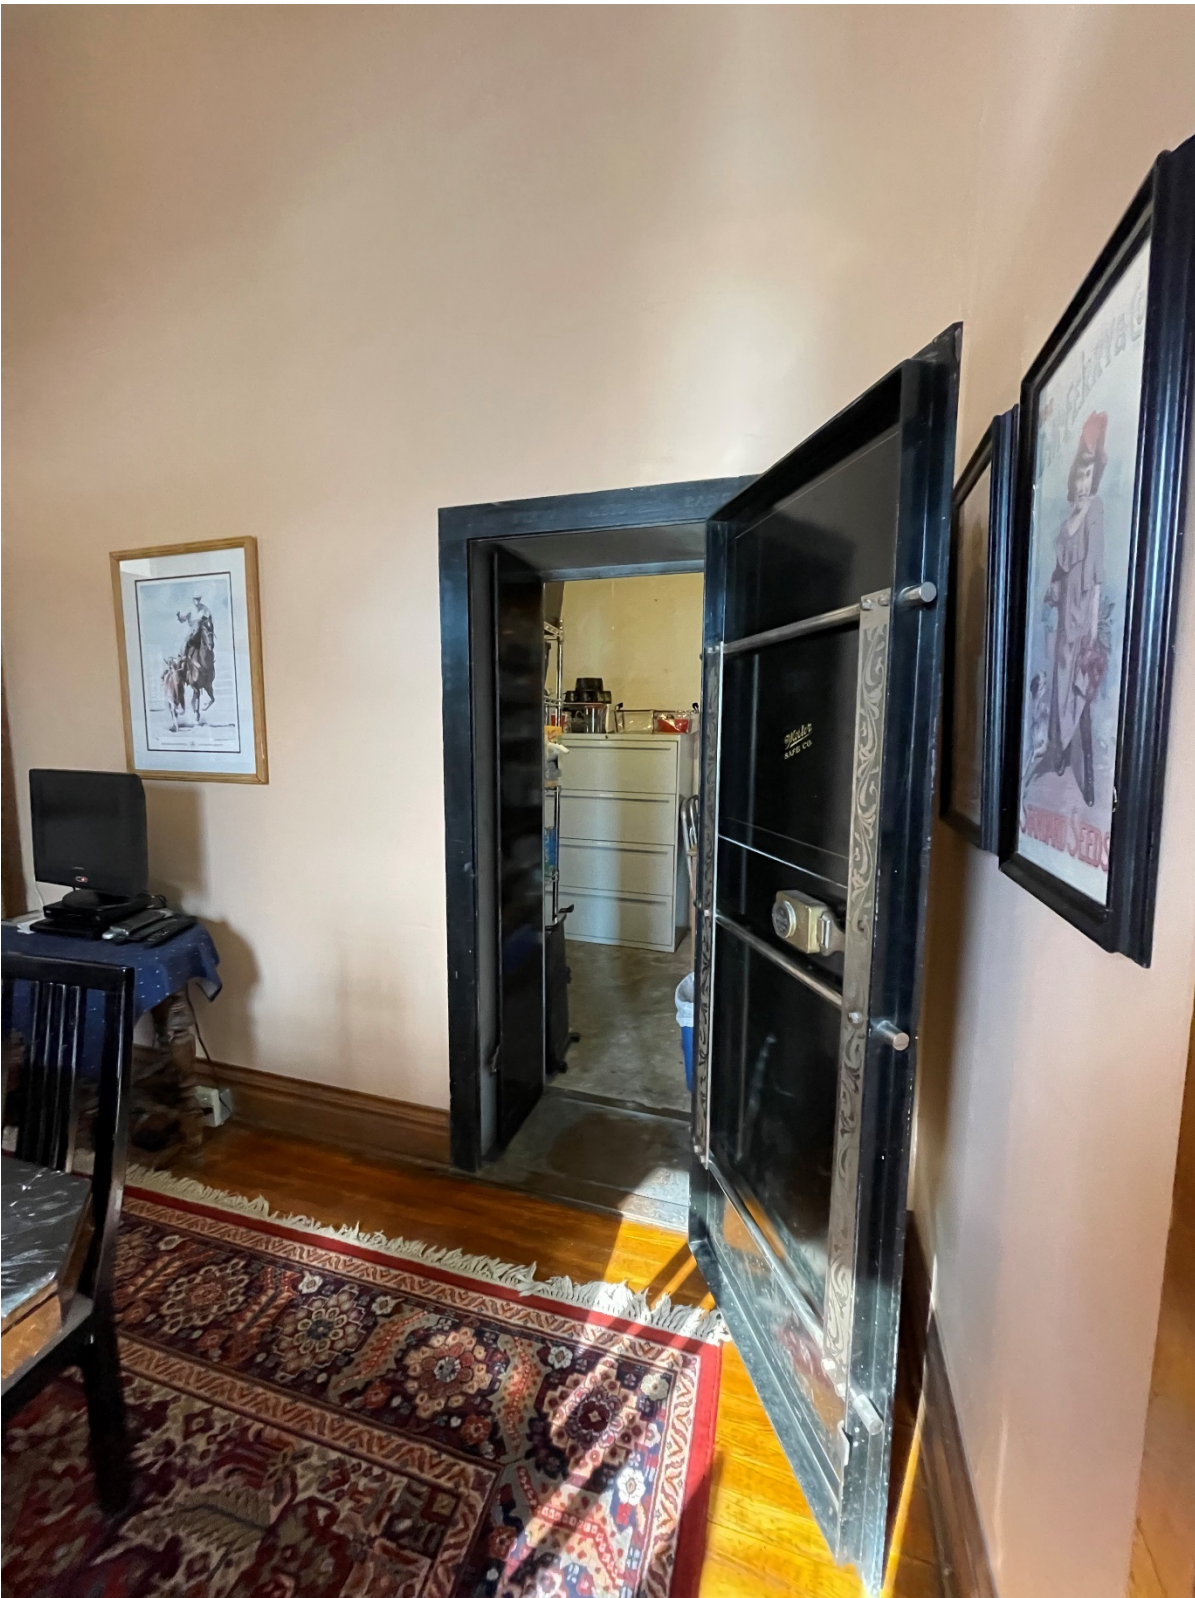
Description of Photograph(s) and number: 188 S. Main Street, Main Level, Bank Vault/Safe vault door from Secondary Room, main level.
28 of 37.

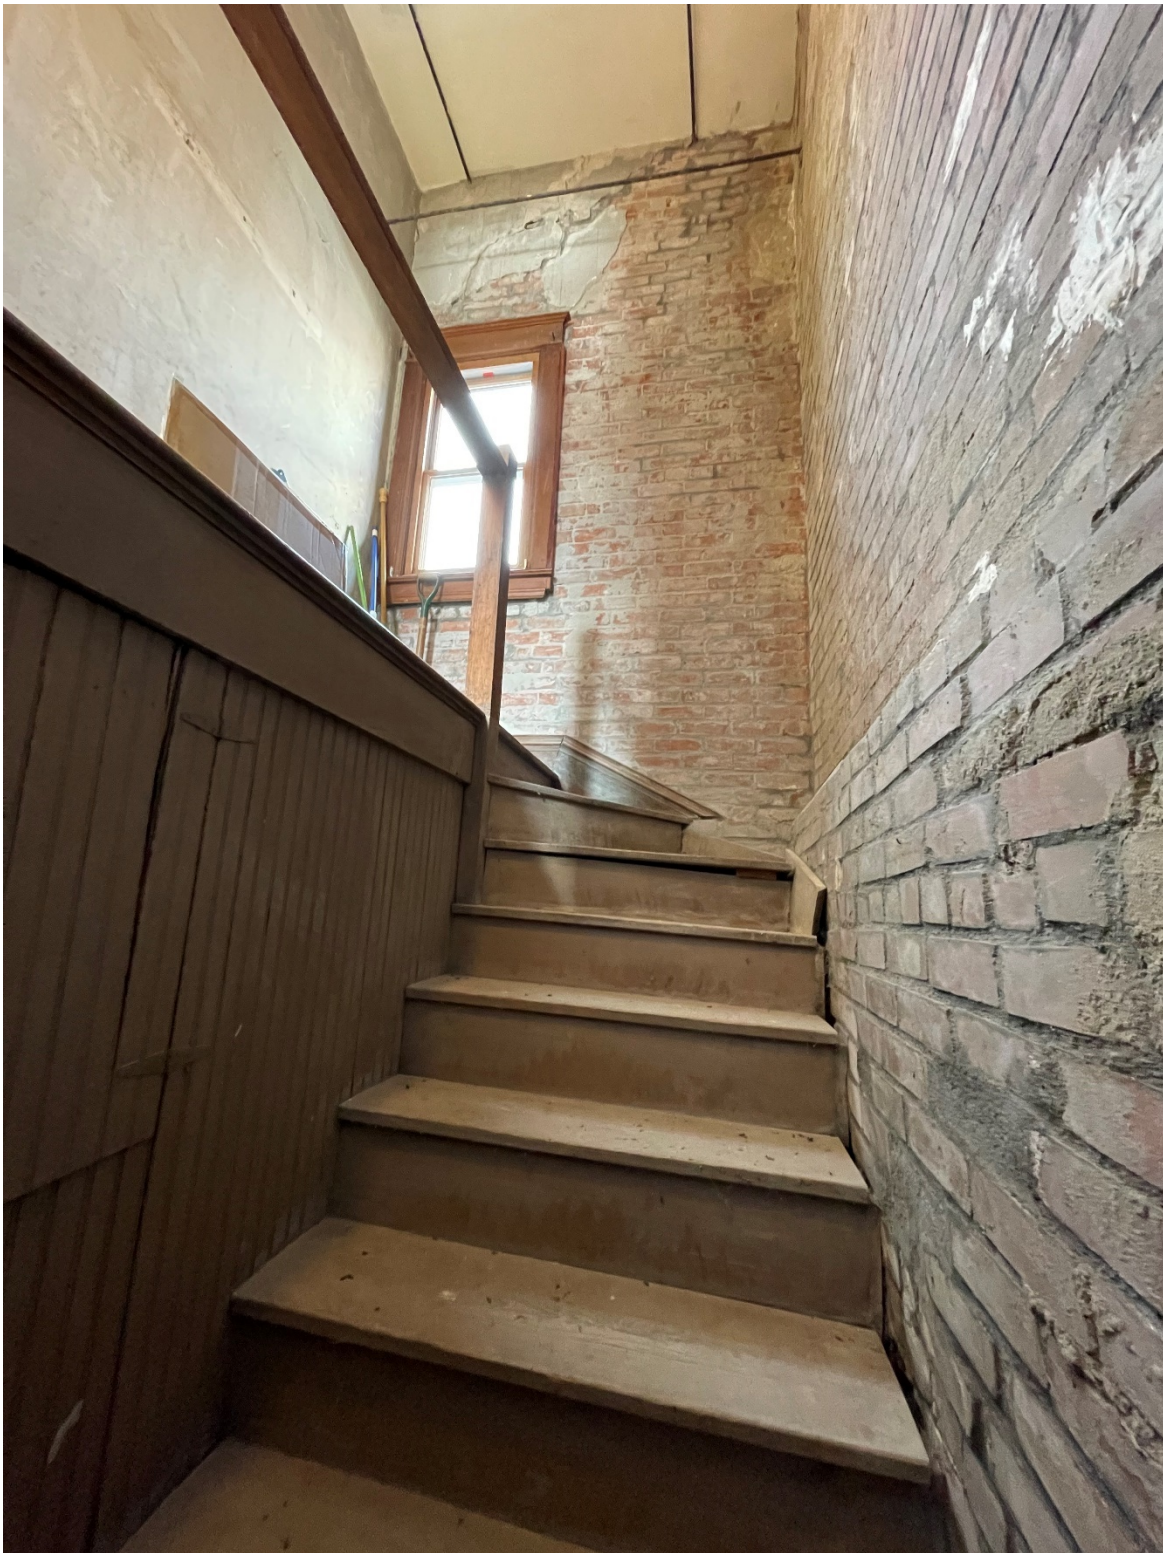
Description of Photograph(s) and number: 188 S. Main Street, Main Level, Tertiary room and passage access to stair to basement/cellár.
30 of 37.
