National Register of Historic Places Registration Form

historic name First National Bank of Elizabeth
other names/site number 5EL.321

street & number 188 S. Main Street not for publication
city or town Elizabeth vicinity
state CO county Elbert zip code 80107

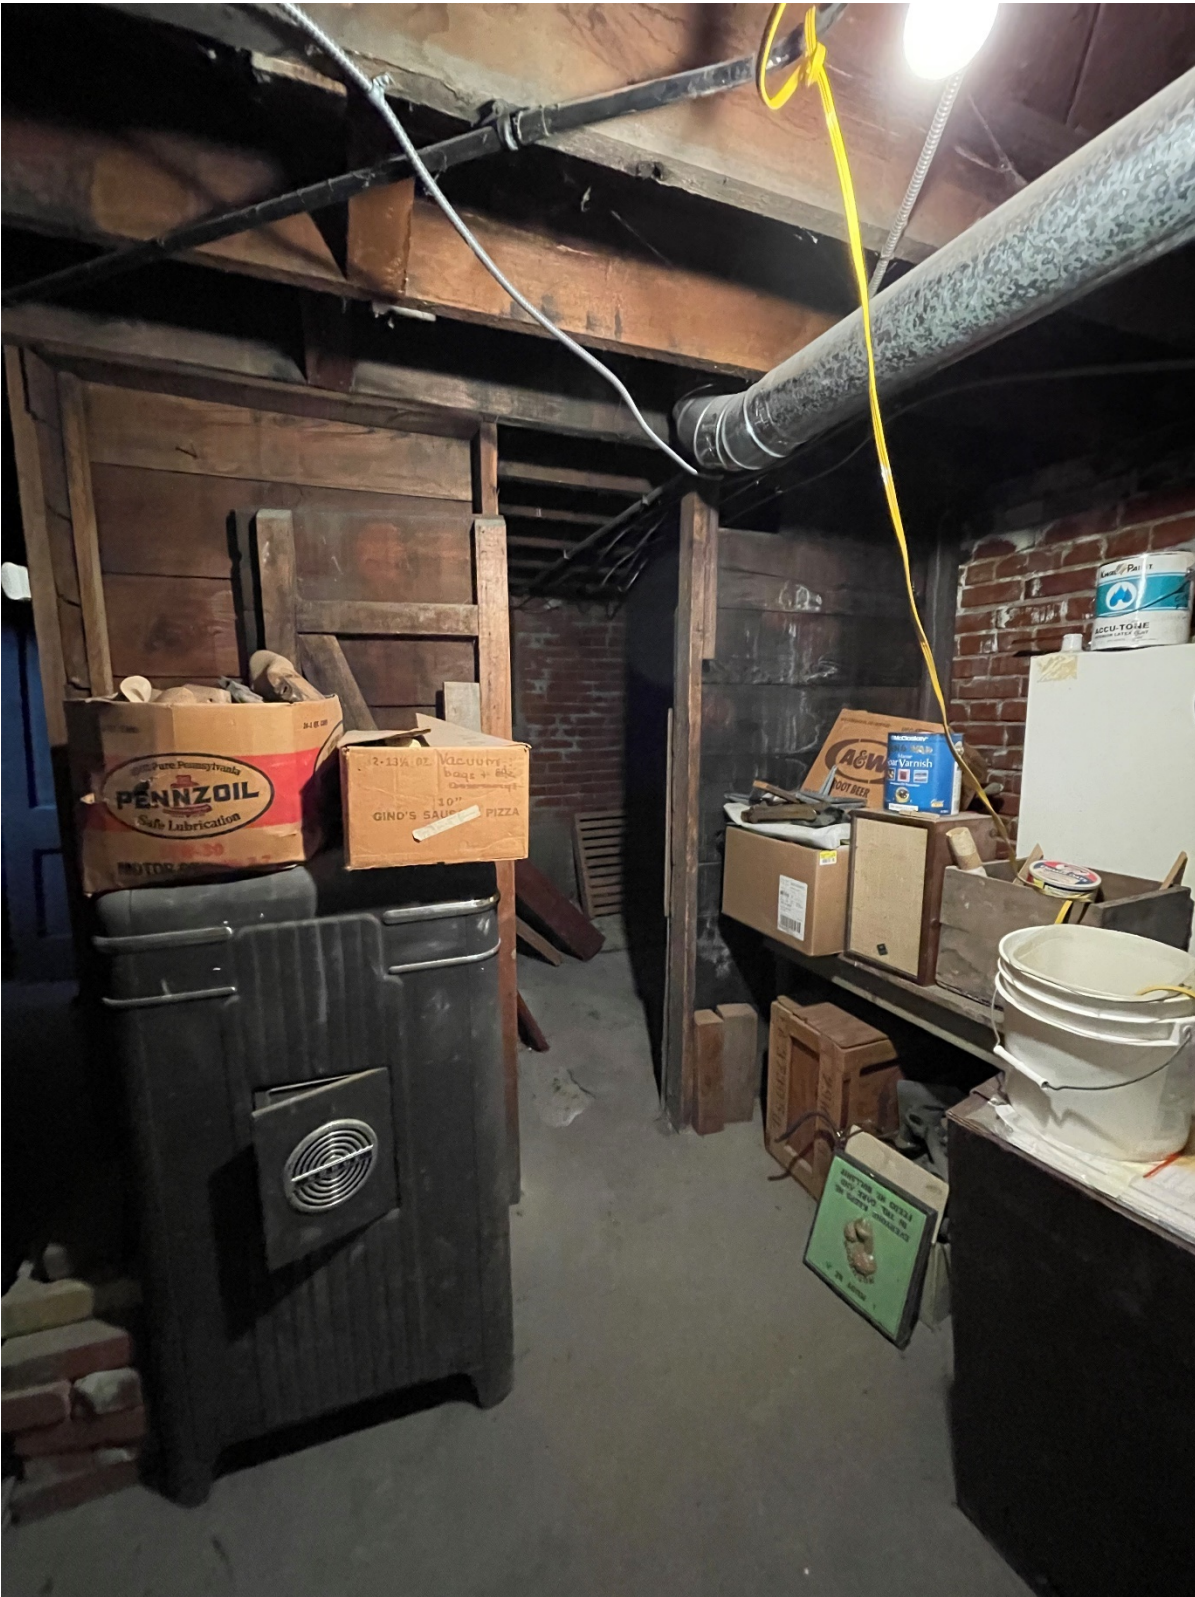
Description of Photograph(s) and number: 188 S. Main Street, Basement/ Cellar – general condition.
31 of 37.

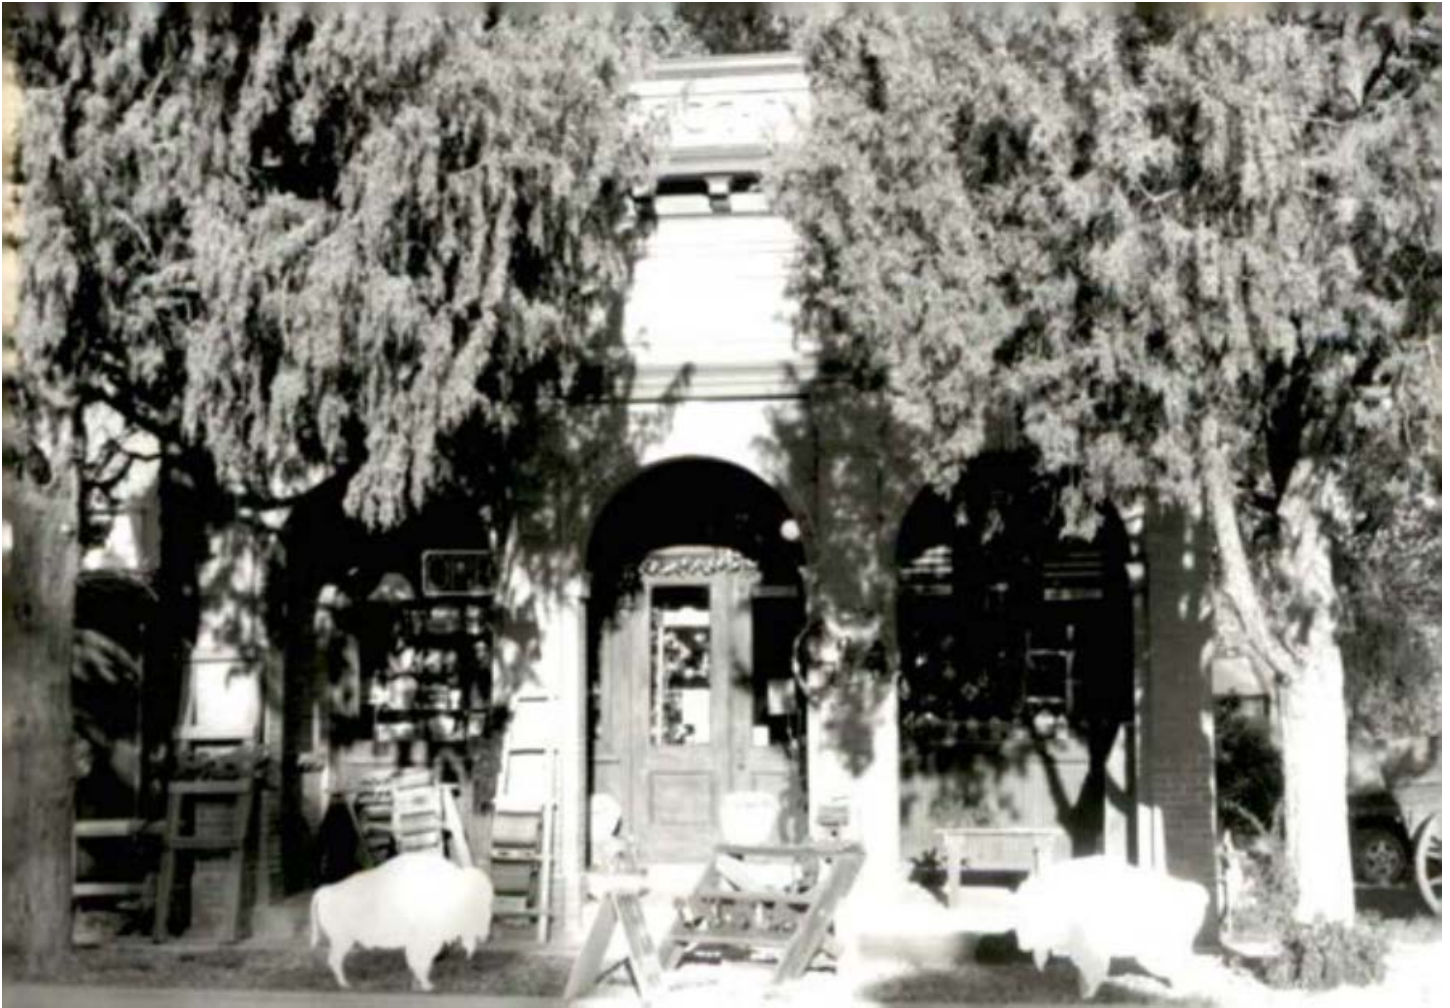
35 of 37.

Description of Photograph(s) and number: West (main elevation), photo copied from 1995 Colorado Historical Society Application, prepared by EC CO Grassroots Preservation Planning Phase II. Note the mature trees which have been removed (date unknown)
(TIFF file for photo not available)

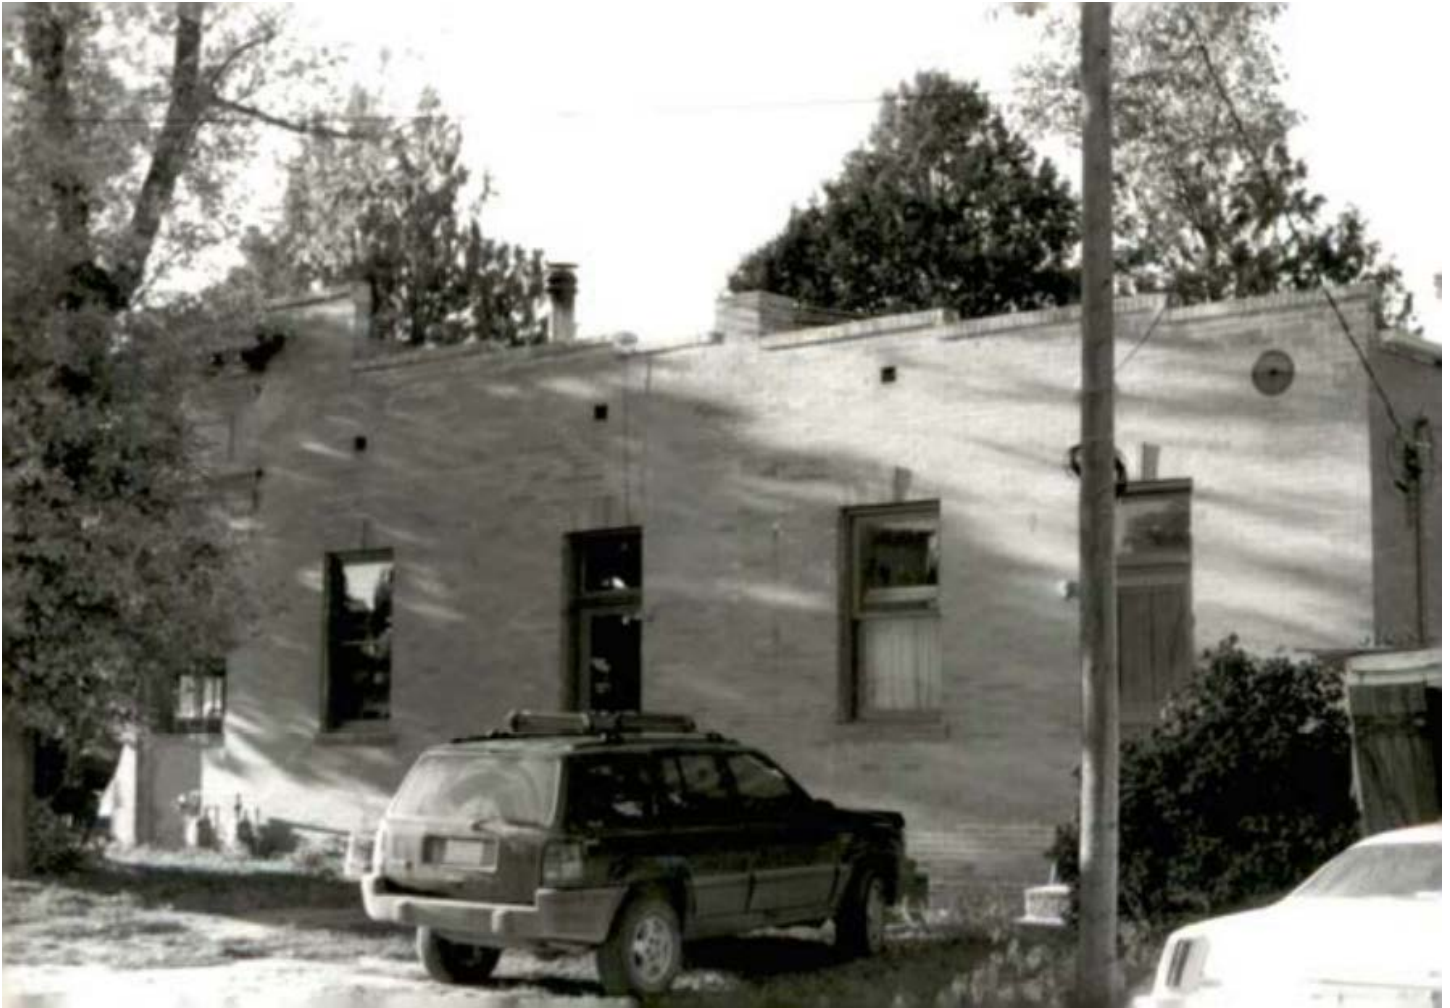
36 of 37.

Description of Photograph(s) and number: South elevation, photo copied from 1995 Colorado Historical Society Application, prepared by EC CO Grassroots Preservation Planning Phase II.
(TIFF file for photo not available)

The south side of the building faces a small, unpaved parking lot. There are two secondary doors on the south side of the building which are single wood leafs with singular rectangular fixed pane lites, framed in wood. Working from east to west, the south side of the building mimics the organization of the north side, with the exception of the additional secondary entry doors. Two wood windows similar to those found on the north facade are also featured on the south facade. From the southeast corner working west, the organization of the south façade is as follows: brick wall segment, secondary entry door with transom, brick wall segment, typical window, brick wall segment, secondary entry door with transom, brick wall segment, typical window, brick wall segment, southern return (wrap) of entry porch. The entry porch detailing and stepped cornice on the south elevation match that of the north side of the building. Each of the two secondary entry doors are reached via stone slab steps. Both doors have glazed transoms above. Like the north and east sides of the building, stabilization cables have been installed in the upper south east corner of the structure, above the east-most door, with evidence of mortar repair/replacement in the general area. Stepped-brick parapets are visible on the secondary (north and south-facing facades). (Photos 9, 10, and 11). Through-parapet scuppers are visible centered in the masonry above both windows and the west-most door, approximately 11 brick courses above the top of the masonry opening's brick keystones. There appears to be an original masonry chimney, approximately 4 brick courses tall above the parapet with patina finish on metal flashing, located approximately midway across and flush with the south side of the building. The secondary facades and the rear (east- alley) facade are of the same tan brick masonry. From the south side photos, one can also see a metal-flue stove or fireplace penetration, extending to just below the height of the tallest (west side) parapet height. (Photo 9)

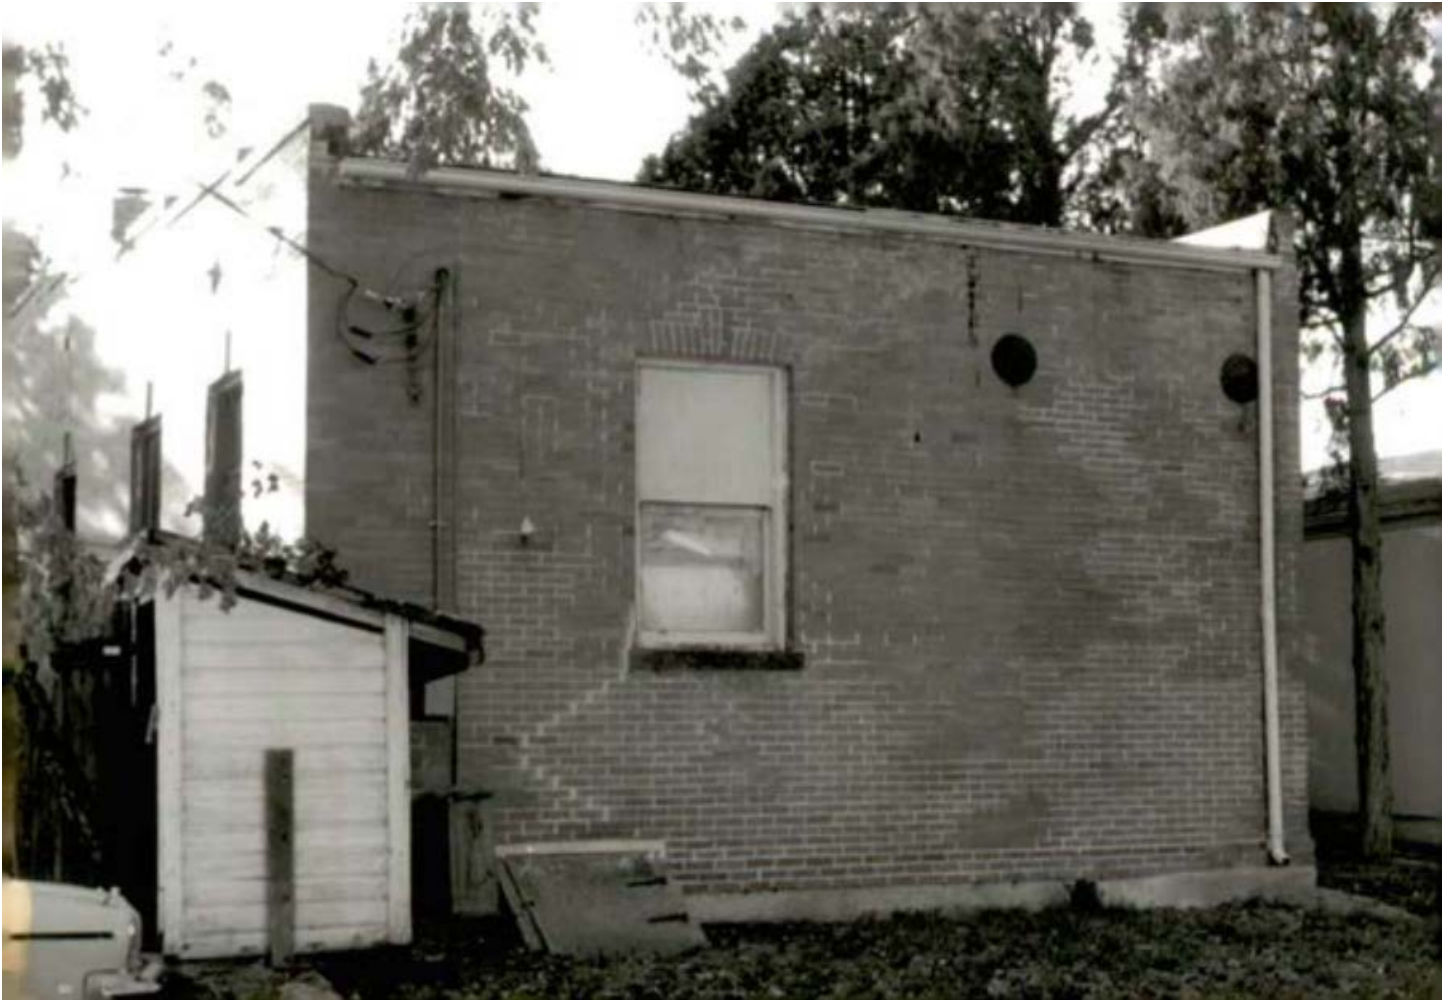
Description of Photograph(s) and number: East elevation, photo copied from 1995 Colorado Historical Society Application, prepared by EC CO Grassroots Preservation Planning Phase II.
(TIFF file for photo not available)

The rear facade has no parapet but supports a gutter at the low-end of the flat roof for roof drainage to grade. There is a small door on the rear facade, offering basement/cellar access along the building's foundation. (Photo 8). A similar pair of stabilization cables can be seen at the adjacent corner to the cables noted on the north side of the building (northeast corner). South of the center line of the east side, there is one typical hung window, matching in materials, style, masonry opening, size, and sill as to the other single-hung windows on the secondary elevations. A wood-paneled hatch just above grade level provides access to a presumed crawl space or foundation; this hatch has not been accessed at the time of building survey and application to the National Register of Historic Places.

A small, wooden outhouse structure is located on the southeast corner of the site. It is believed to be original to the building, as the building's current owners have noted that there is no indoor plumbing within the building. The structure is approximately 3 feet wide x 3 feet deep with a sloping wood roof. The high point of the roof is approximately 7'-6" above grade sloping north toward the masonry building to a low point of approximately 6 feet above grade. The wood siding is approximately 6-inch board siding and appears to have been painted a solid color (presumably white), however, the painted surfaces have not been maintained. The narrow entry door to the outhouse faces south. The structure appears to partially sit above a concrete or stone slab and is leaning slightly to the west. (Photo 8)
