National Register of Historic Places
Registration Form

historic name Smith/Friskey Ranch
other names/site number 5CF.2879

street & number County Road 339 (0.5 miles west of road) N/A not for publication
city or town Buena Vista X vicinity
state Colorado code CO county Chaffee code 015 zip code 81211

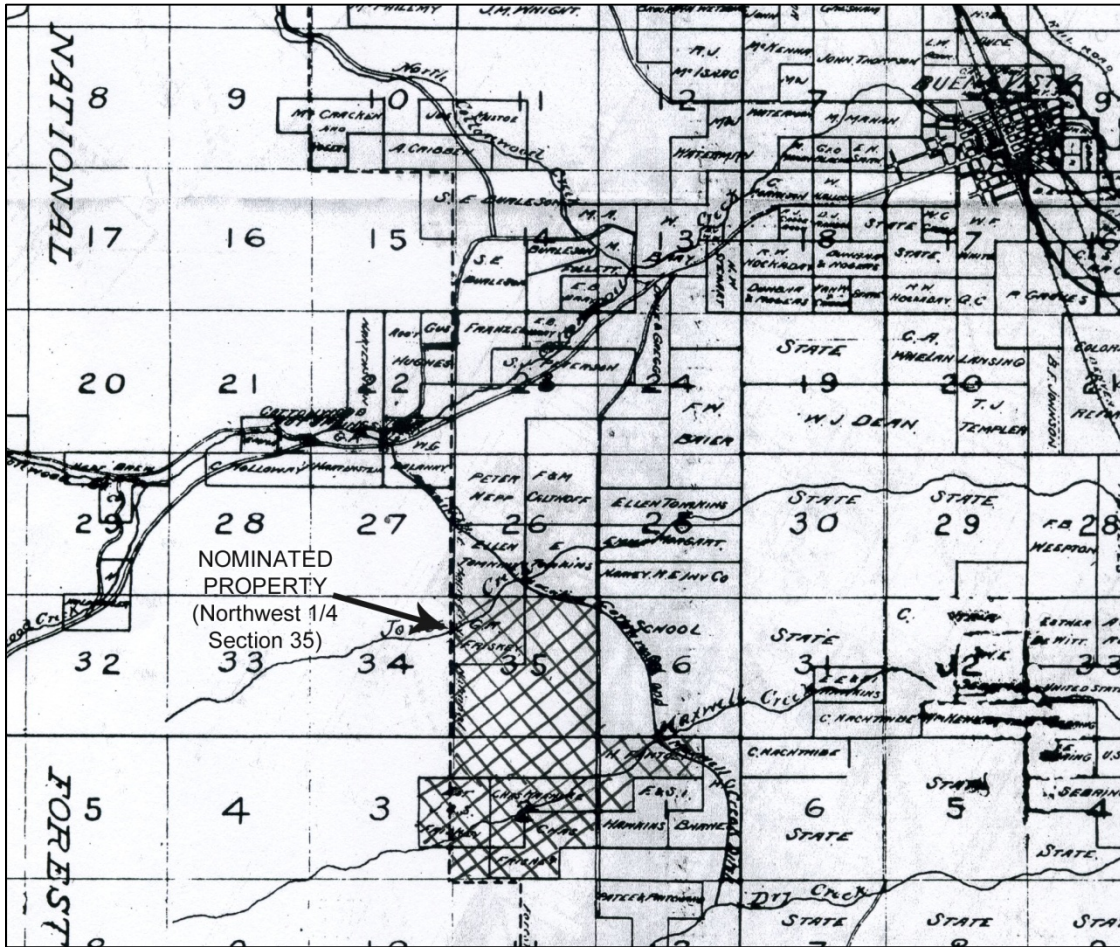
Figure 2. The Friskies acquired land along the west edge of the Arkansas Valley through outright purchase and acquisition of government patents. The arrow points to the nominated area. The crosshatched area is the maximum extent of the family's holdings, including the lands of Johanna C.S., Otto, Charles, Gustave, and Ernest Friskey. Buena Vista is in the upper right of the map, while the Leadville National Forest extends along the left edge. Courtesy of Shaputis, *Where the Bodies Are in Central Chaffee County, Some Land Owners and Old Roads in Northern Chaffee County, ca. 1900-10*, map.
