**United States Department of the Interior
National Park Service
National Register of Historic Places
Registration Form**

historic name SWANSON, GUSTAV AND ANNIE, FARM

other names/site number 5LR.1714

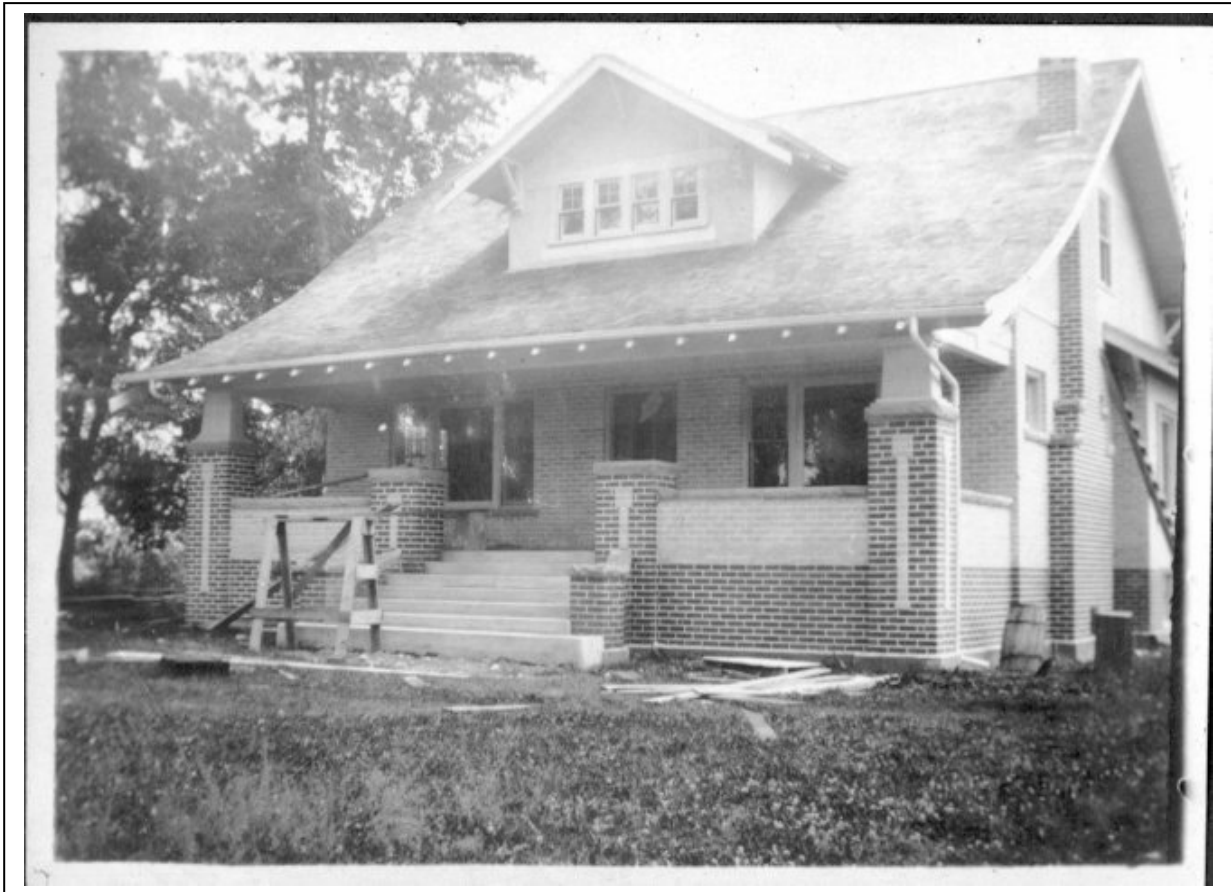
Gustav and Annie Swanson Farmhouse Under Construction - 1918

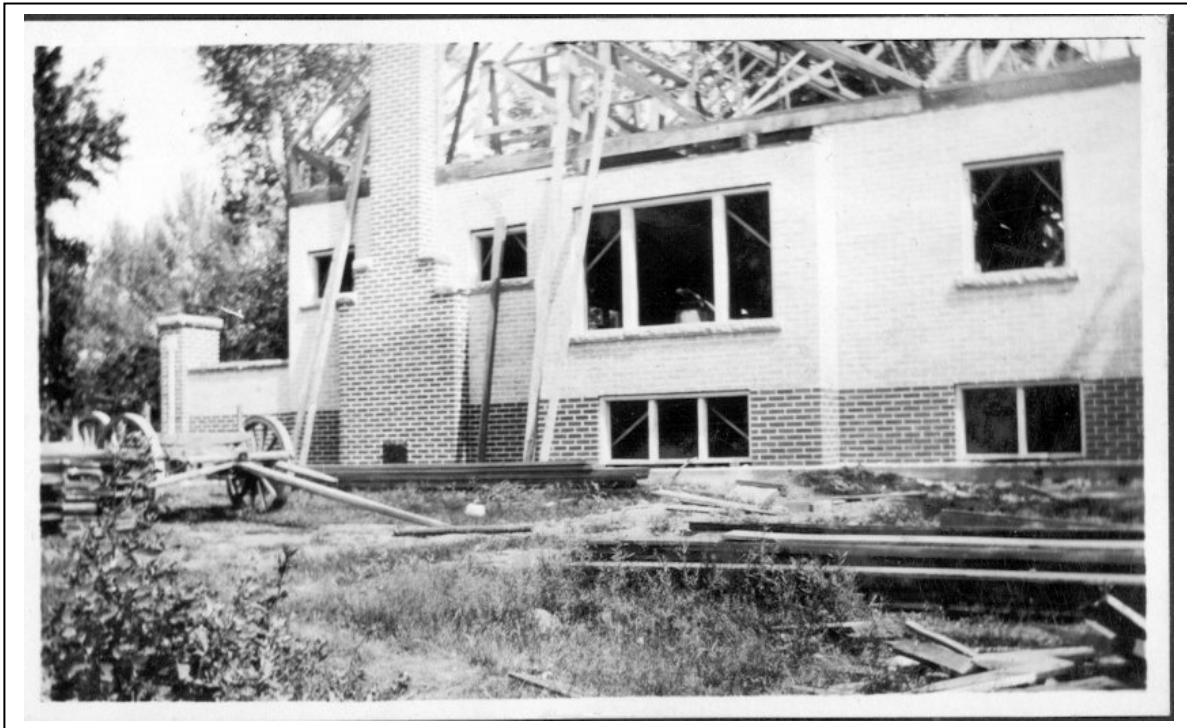
Swanson Farmhouse Under Construction - 1918

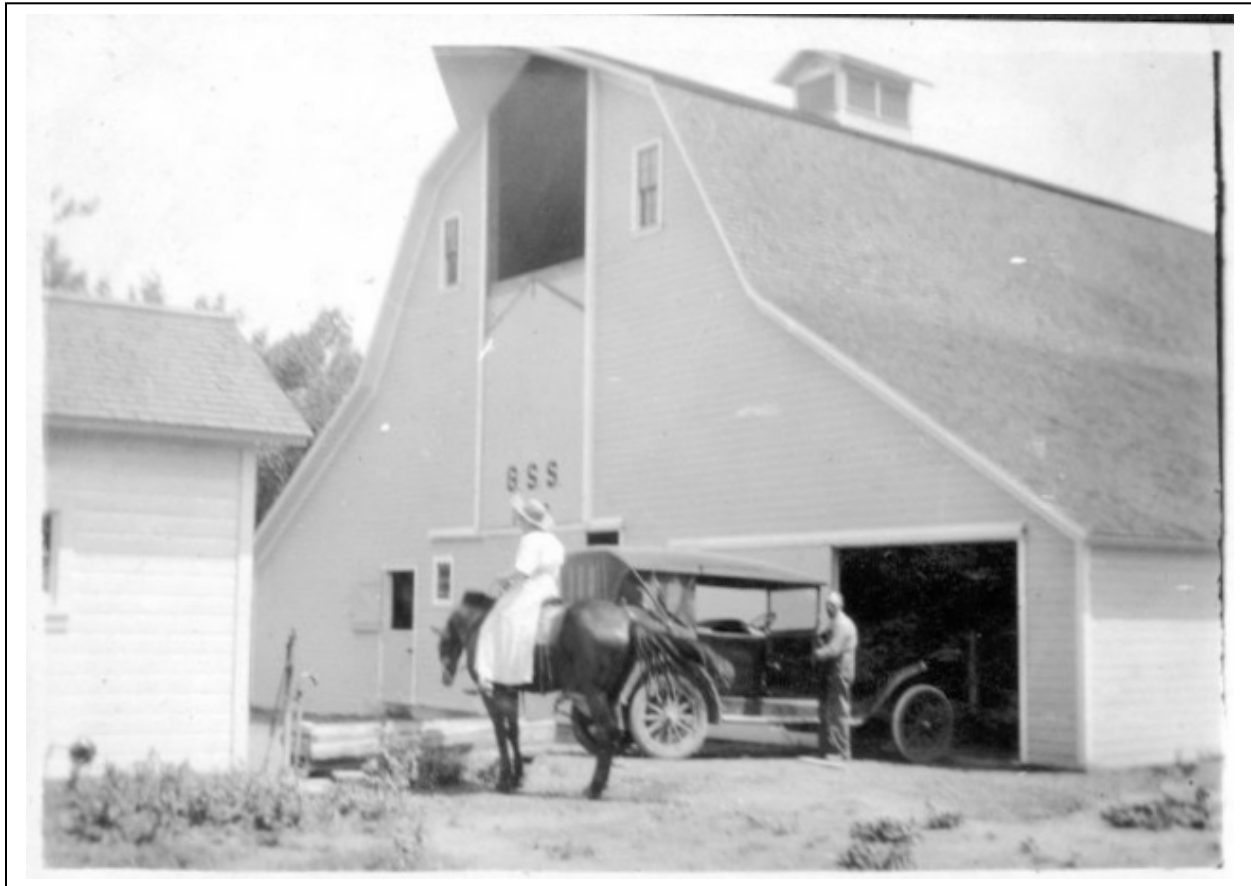
Swanson Barn - circa 1920

The 1917 barn, with a footprint of 50' x 68', is located on the east side of the farmyard and east of the house. This large west-facing wood frame building is constructed above a poured concrete foundation that rises as much as 12" above grade. The foundation is crumbling in the doorways and entrances and at the building's northeast corner. Finished with white painted weatherboard walls and a gambrel roof with boxed eaves and asphalt shingles, the symmetrical building essentially consists of a central gambreled core with shed-roof wings to the north and south. Projecting above the central ridgeline on the roof is a rectangular wood frame ventilator with louvers on all four sides and a gabled roof.
