## COLORADO STATE REGISTER OF HISTORIC PROPERTIES NOMINATION FORM

Historic Name Colorado State Fairgrounds

Street Address 1001 Beulah Avenue

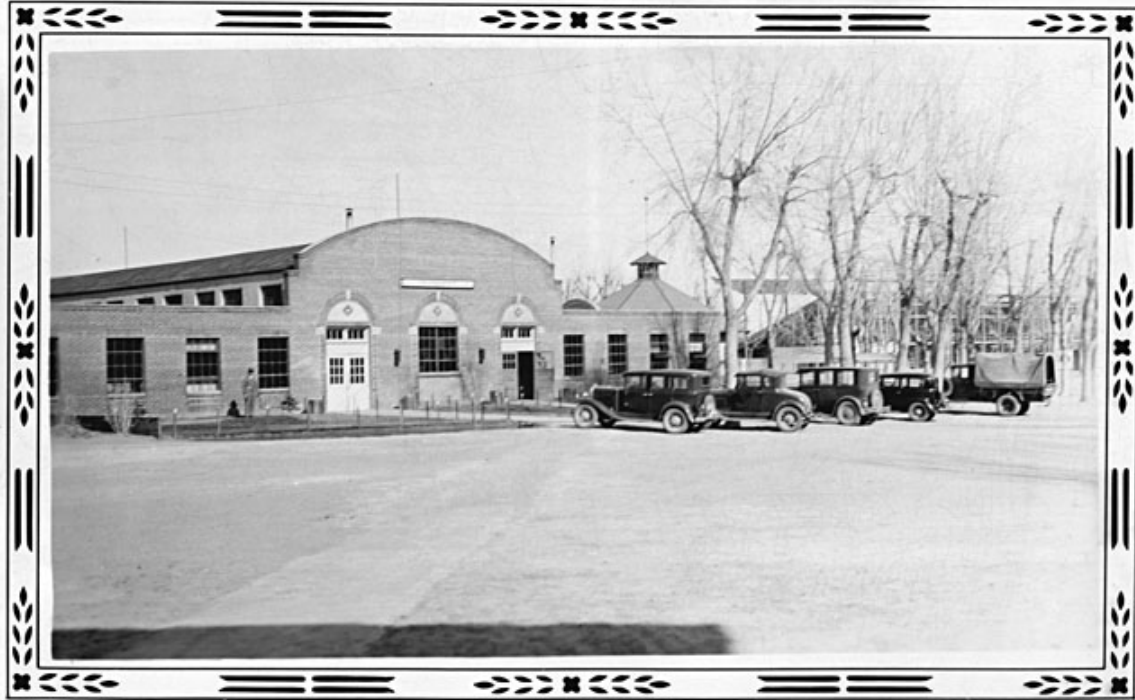
*The Creative Arts Building was designed by Walter Mordaunt and completed in 1928. This photograph was taken in the 1930s when a CCC camp used the building as administrative headquarters. (Pueblo Public Library)*

A new brick building, called the Exposition Building was constructed in 1928. Now known as the Creative Arts Building, the structure was designed by well known Pueblo architect Walter DeMordaunt and was jointly funded by the State Fair Commission and the Pueblo Manufacturers and Jobbers Association. The old wood grandstands, were replaced by a steel and wood structure in 1930.

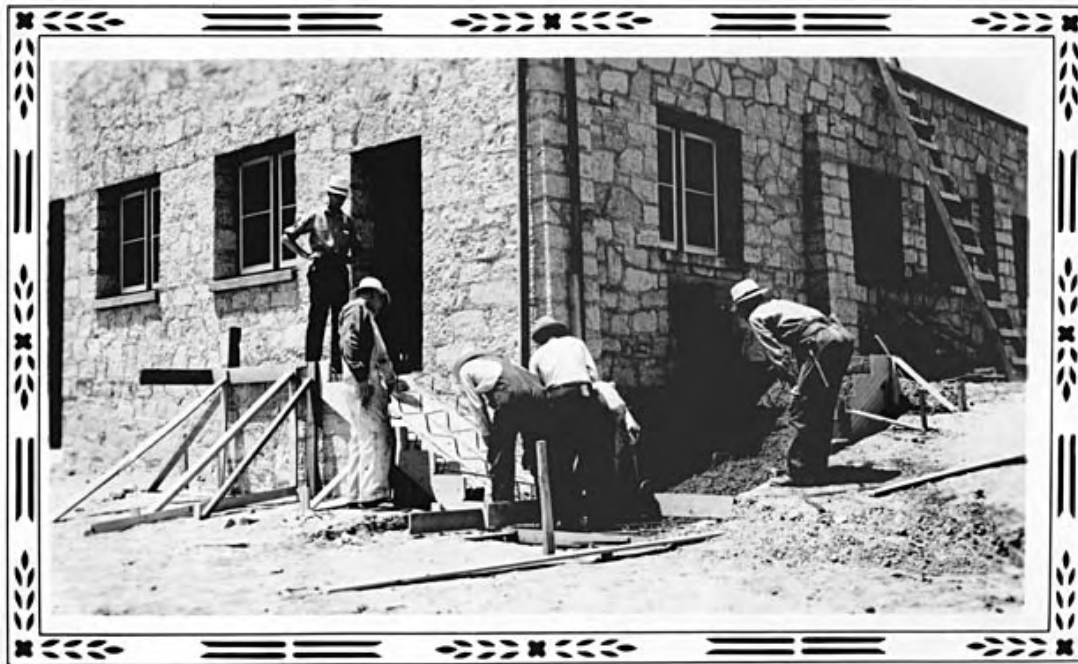
*Workers at the Swine and Sheep Building (1934-1936). Pueblo Public Library Photo Collection*

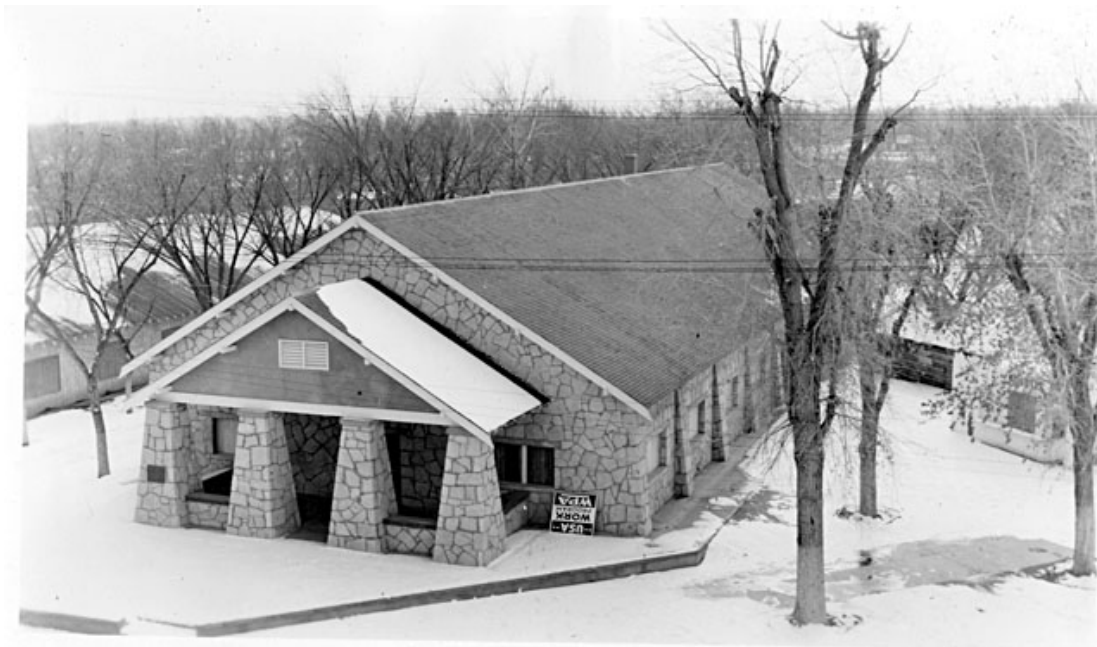
*The 4-H Auditorium, a building in Camp Tobin, was constructed in 1938 using WPA funds. Note the upside down WPA sign to the right of the porch. Pueblo Public Library Photo Collection.*

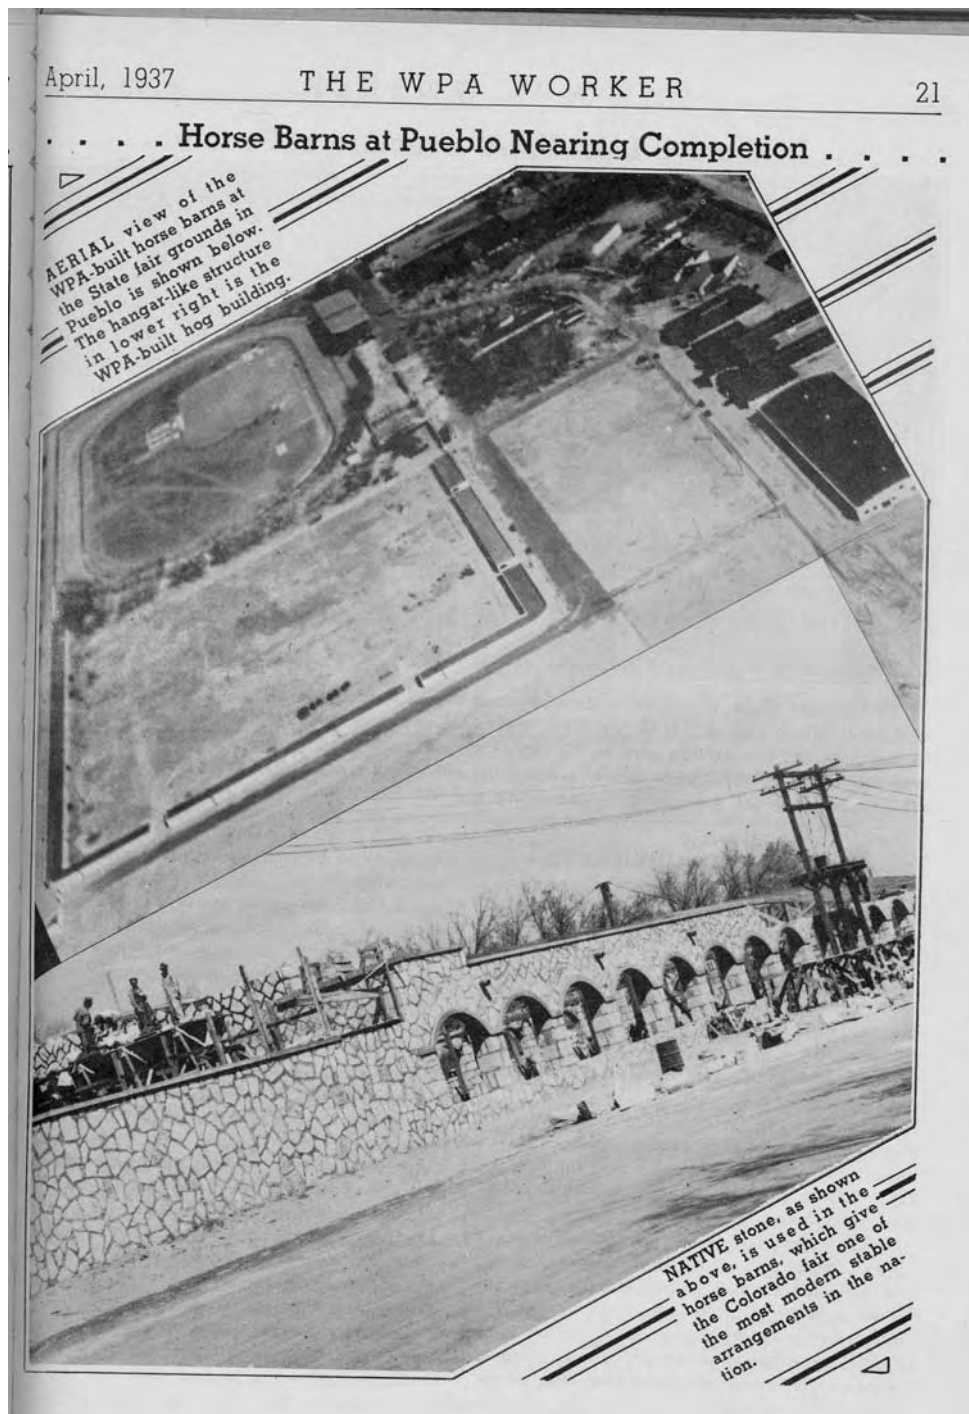
A page from the April 1937 WPA worker shows the fairgrounds and the work on the paddock (Colorado Pavilion).
