COLORADO STATE REGISTER OF HISTORIC PROPERTIES NOMINATION FORM

Historic Name Denver & Rio Grande Western Railroad Flanger OT

Property Name Denver & Rio Grande Western Railroad Flanger OT

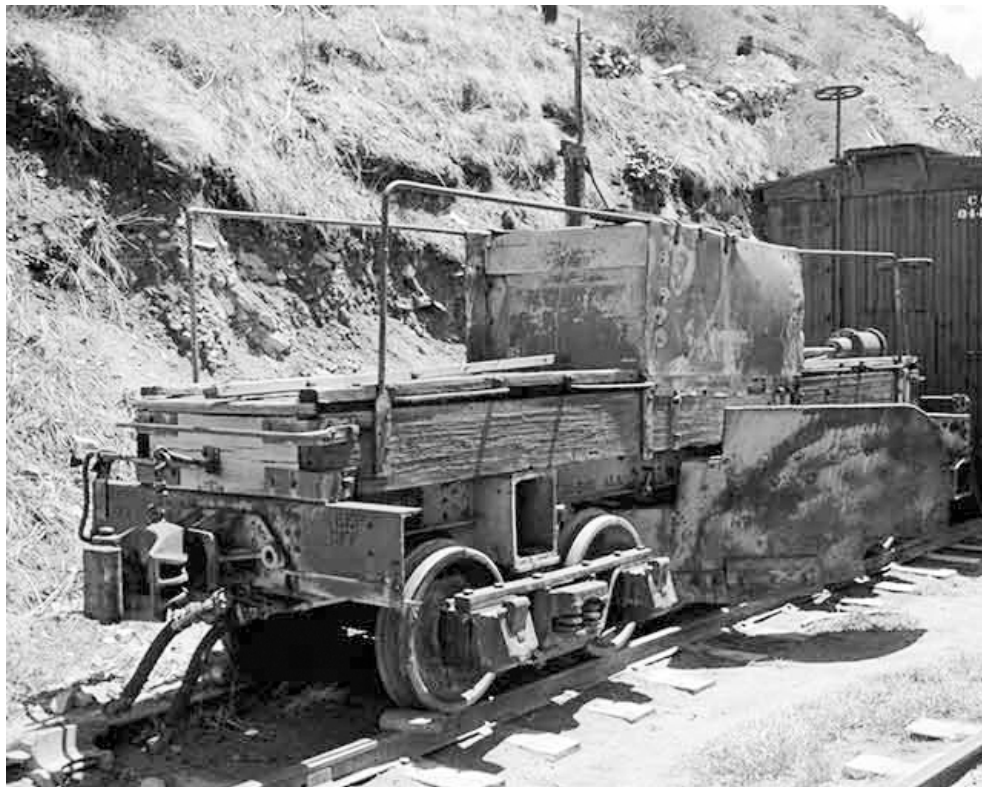
4. *Flanger OT in Central City, 1972 – note box is missing. Photo by Jerry Day (Day, Email).*

In circa 1971 the tool box was removed and never replaced (Day, email). When Lindsey Ashby, the current owner, bought Flanger OT in November 1971 he moved it to Central City, Colorado, for use on the Colorado Central Narrow Gauge Railway. In the late 1970s he moved it to Silver Plume, Colorado, for use at the Georgetown Loop Railroad. He replaced “D & R G W” with “G B & L”. The blades were painted red in front and black in back. Two control valves were added to the two front outside corners of the snow shield.
