United States Department of the Interior National Park Service National Register of Historic Places Registration Form

historic name Rankin Presbyterian Church

street & number 420 Clayton Street [N/A] not for publication

state Colorado code CO county Morgan code 087 zip code 80723

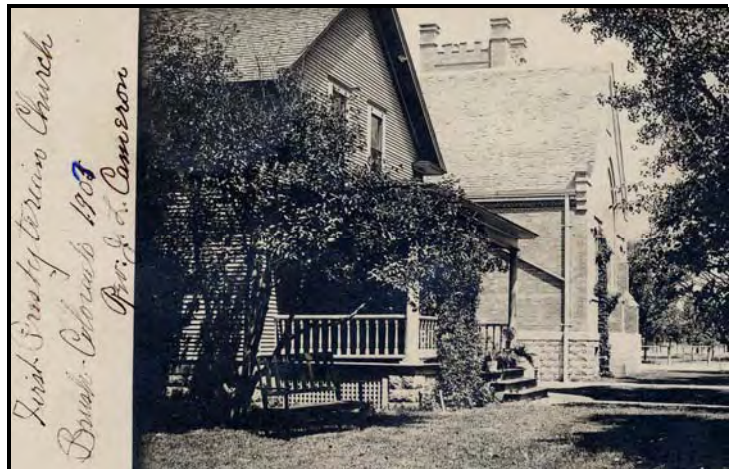
Rankin Presbyterian Church parsonage and church, view from the southeast. Ca. 1907. Photo from Rankin Presbyterian Church Archives.

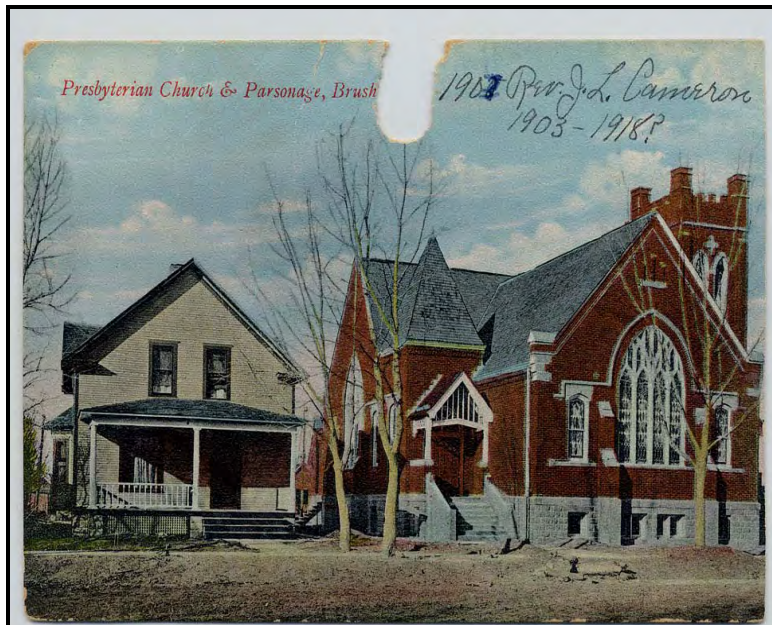
Rankin Presbyterian Church and parsonage shortly after completion. Postcard from Rankin Presbyterian Church Archives. Ca. 1907.
