COLORADO STATE REGISTER OF HISTORIC PROPERTIES NOMINATION FORM

Historic Name Boor Ranch/Boor Homestead

Other Names Redmond Ranch District

DESCRIPTION and ALTERATIONS

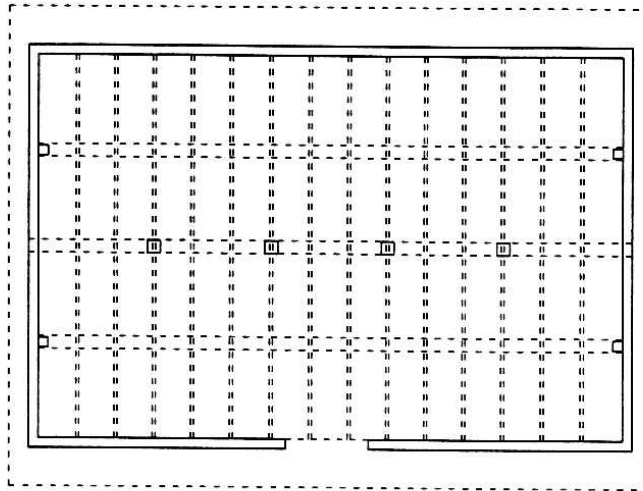
Barn Elevation

Constructed by the William Boor family, the barn was dismantled by James Redmond circa 1920 and rebuilt on its current location. The barn is a two-story, rectangular log building with a steeply pitched, side-gambrel roof. Logs are both peeled round and squared hewn, with most of the hewn logs appearing in the lower portion of the barn and serving as sills. Vertical boards are present on the upper story, with the west side featuring board and batten in the upper portions. Wood flooring is present in the interior. Chinking and daubing is present between the original logs. The building sits atop a rock foundation. A Dutch door, located on the south facade, is set in a wooden frame attached by metal hinges. Hay doors are located on the second story on the east and west sides. A hay hood shelters the loft entrance of the east. Metal roofing covers the flared roof eaves. The roof originally was gabled and converted to a gambrel about 1920, when James Redmond moved the barn. Redmond was from the Midwest and believed the barn should have a gambrel roof in order "to look as though a barn should look" (Wanda Redmond interview). Asphalt shingles replaced the original wood shingles on the roof in the 1950s, and a metal roof was installed in 1980. The barn is used to store tack and house livestock.

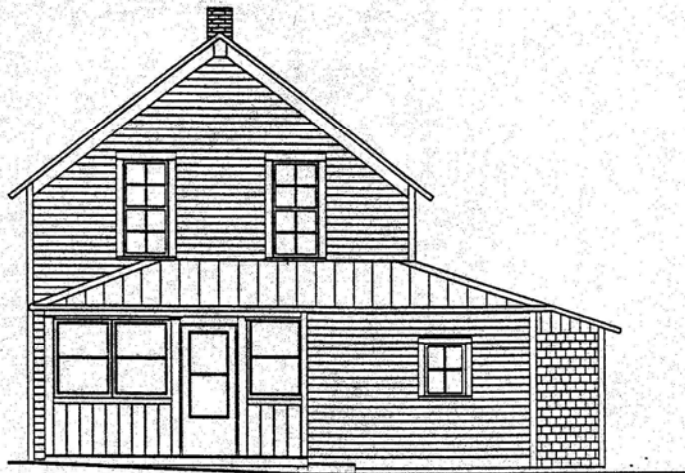
Main House Elevation

Constructed circa 1890 for Emma Boor, the house is a two-story, vernacular style residence with an irregular floor plan and asymmetrical massing. The current house consists of the original two-story log cabin, encase in later siding, the shed roof addition on the north, an enclosed porch on the east facade, and a newly constructed wood deck. The main cabin was originally a two-story, hand-hewn log building, measuring approximately 28 feet by 20 feet. The initial entrance was located on the south side and has been replaced with a window. The cabin had a side-gabled, wood shingled roof at this time, with a centrally positioned brick chimney. The residence was constructed low to the ground in order to provide easy access for Emma Boor, who was handicapped and required crutches. The shed roof addition was attached to the north elevation and the enclosed porch added to the east side at around the same time that the Redmond family came into ownership of the property, approximately 1920. The additions were made of frame and board construction. At this time, the main entry was reoriented to the east and the entire house was covered with a variety of wood sidings. The east facade features horizontal wood siding, the north side features a combination of vertical, horizontal, and shingle wood siding, while the south and west sides are covered in vertical wood siding. With the reorientation of the building, the house became front-gabled house with a hipped roof porch and shed roof addition. The entire house is currently covered with a metal roof installed in 1990; originally it was wood shingle replaced by asphalt shingle in about 1952. Windows are primarily four-over-four, double-hung set in wooden frames; however, the north elevation features a small slider window, indicating where the bathroom was created in the shed roof section in 1954. Under the shed roof overhang, just to the east of the bathroom window, is a door that has been closed off since the 1920s. Horizontal boards cover the bottom half of the door, causing only the 4 light window portion of the door to be visible. Two six-over-one, double-hung windows appear on the west elevation of the addition. The house rests on a rock foundation.
