COLORADO STATE REGISTER OF HISTORIC PROPERTIES NOMINATION FORM

Historic Name Eleventh Avenue Hotel

Street Address 1112 N Broadway

Name Mardita M. Murphy Date 01-24-2019

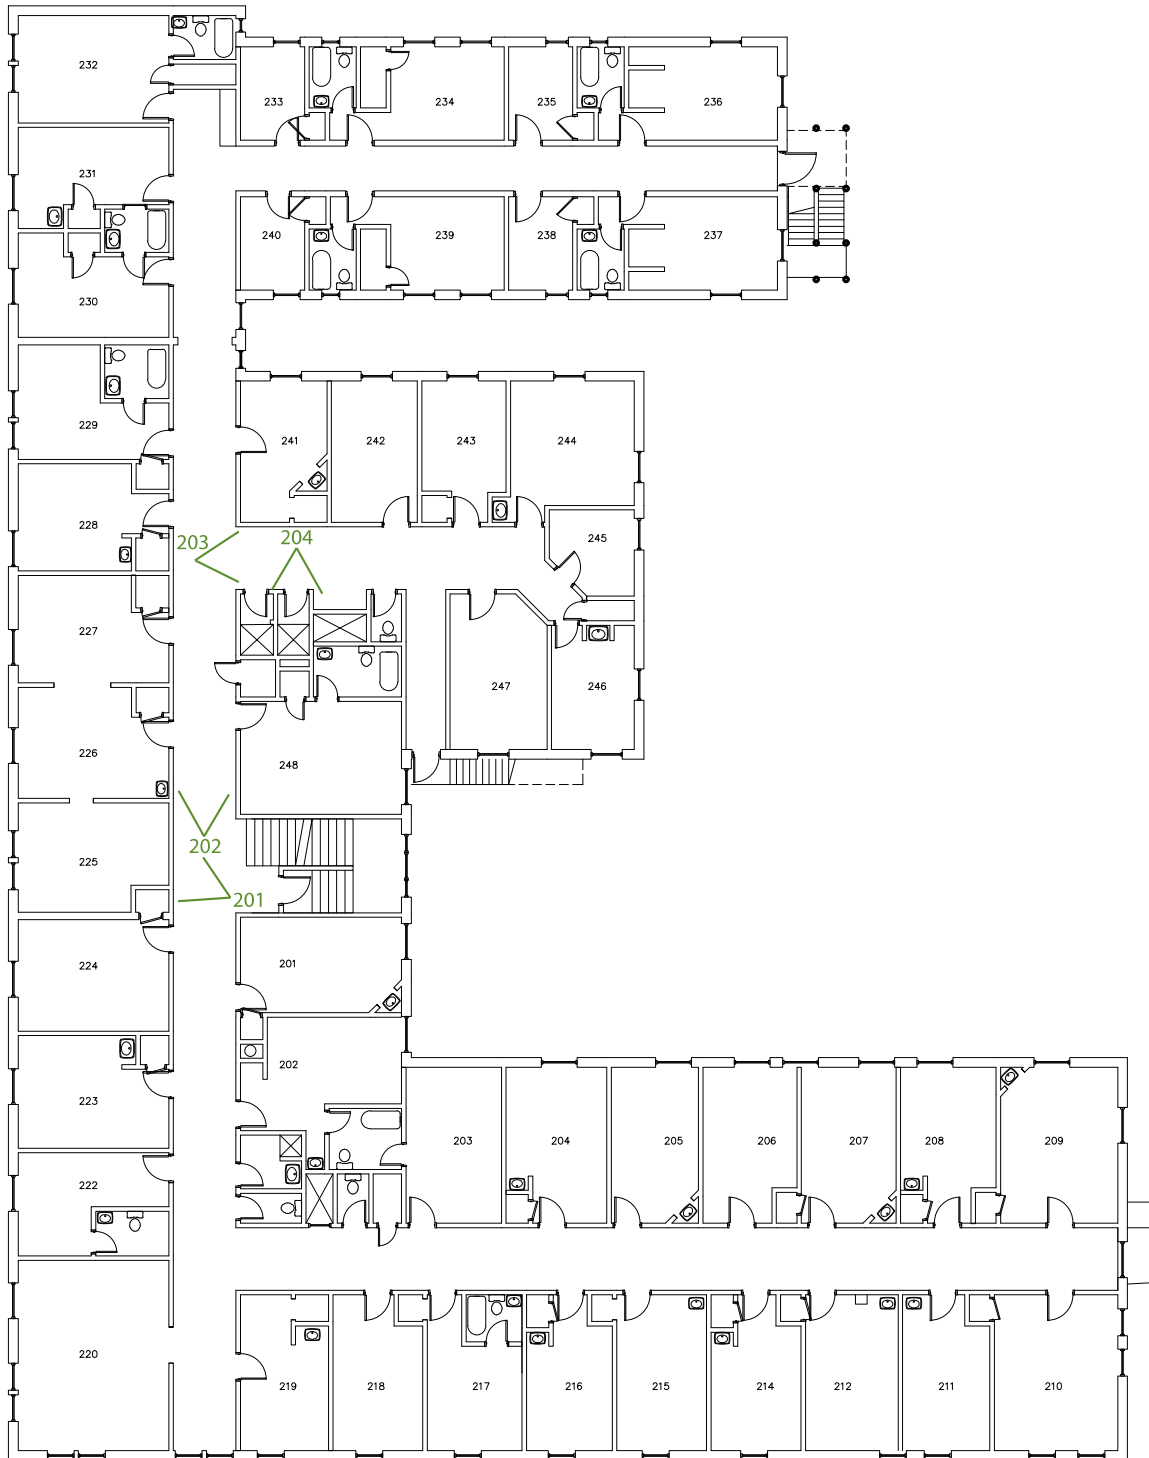
SECOND FLOOR PLAN
N.T.S.

The second and third floors of the hotel remain in near original condition with historic wood base moldings, chair rails, and wood doors with transoms that have been sealed for fire code reasons. The single rooms are largely in original configuration with community bathrooms that have been updated over time. The second floor is a double loaded corridor configuration. This level has undergone one large change with the relocation of the hotel front desk from what is now Room 225 to the first floor entrance area. The 1903 building layout features three community bathroom stalls banked near the south wing and three near the north wing. The third level features the same floorplan as the second. On the third level, two light shafts are topped with skylights. The rooms in the 1909 addition were constructed as apartments, which had en-suite bathrooms and bedrooms. These suites have since been modified and the bedrooms have been subsequently separated to create single rooms.

TOTAL 2ND FLOOR 13058 GROSS SF

The Eleventh Avenue Hotel rides the line between the mid-priced hotel and the rooming house type. The 1903 building featured a central lobby and hotel front desk on the second floor, which has since been relocated to the first floor level. The arrangement of residential rooms is compact and clever, allowing each room access to a window. The central core and wings all exhibit double-loaded corridors with each individual room featuring a private locked entry, appropriate furnishings, a radiator and a sink. Multiple rooms shared common bathrooms located along the main corridor at the junction of each wing. Each room had a transom window located directly above the entry doors. In the 1909 addition the rooms were upgraded to include a private bathroom within each hotel room. The 1909 addition aligns clearly with the mid-priced hotel type. One of the most significant features of SROs is the light well, which afforded daylight and fresh air to all of the interior rooms on the second and third levels.

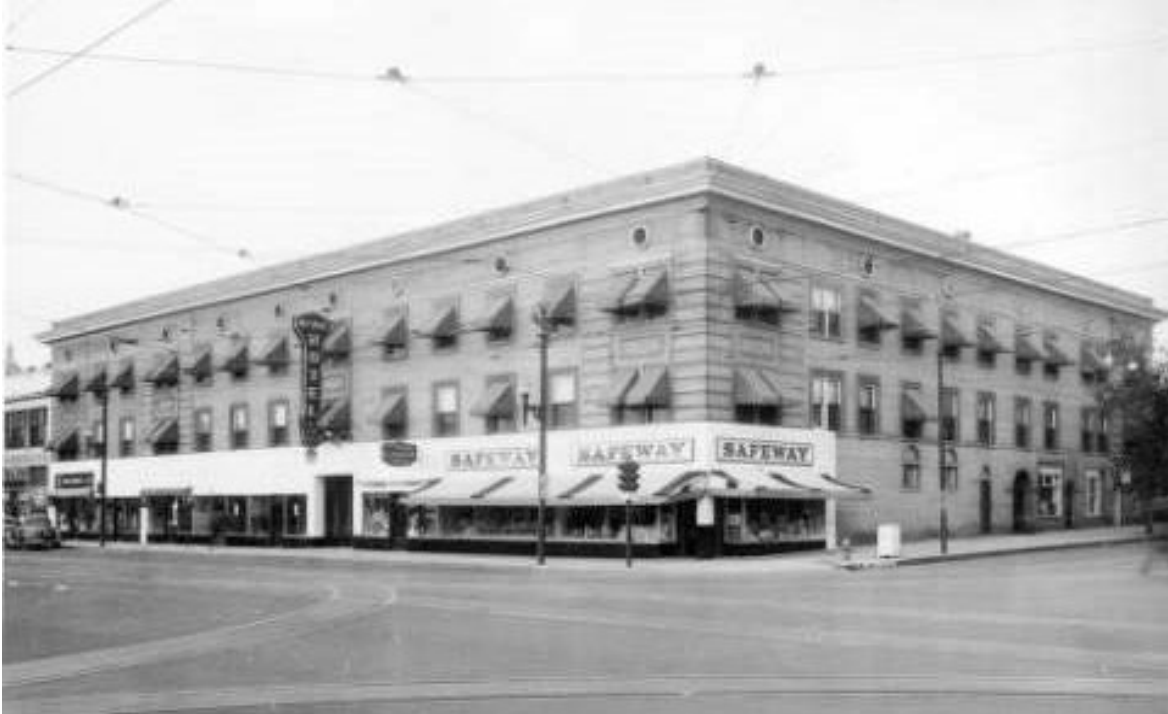
H01: Northeast corner of the Broadway and Eleventh Avenue intersection in 1928.
Source: Denver Public Library, Western History Library Archive Collection

The ca. 1948 neon sign was repainted by hand and its original neon lighting was repaired and replaced as needed during a recent exterior rehabilitation. The neon sign featured in the historic 1928 photograph was likely the original signage for the hotel. The sign form had a bell shaped top and a linear element running down from the bell's center. The bell shape featured the text "Eleventh Ave" above "HOTEL" in vertical neon type below. Building permits suggest a projecting neon sign repair or replacement was carried out in December 1948 with the Frontier Paint Company. It is possible this is when the existing sign was installed. The existing historic sign has an angular form with two sharp edges pointing away from the building towards Broadway.
