COLORADO STATE REGISTER OF HISTORIC PROPERTIES NOMINATION FORM

Historic Name Denver & Rio Grande Western Railroad Boxcar No. 60294

Other Names Denver & Rio Grande Western Railroad Automobile Boxcar No. 65179

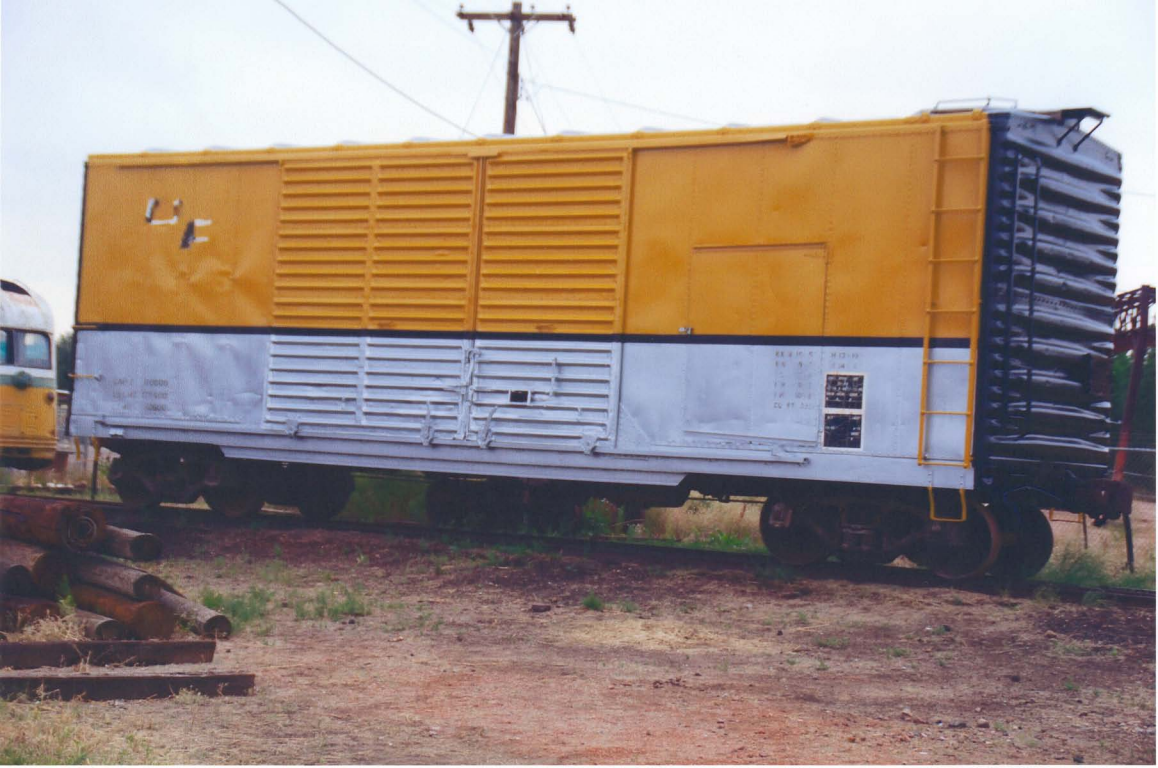
- 1 Side view of Boxcar No. 62094 showing double loading doors
- 2 Oblique view of Boxcar No. 62094
- 3 Interior view of Boxcar No. 62094 showing part of metal bars for damage prevention

Given the purpose of the car, it displayed a most unusual characteristic: double boxcar doors on each side. The “main” door is 8 feet in width, but a second adjacent door is 15 feet wide. The doors can be opened at the same time to create a larger opening of 23 feet.
