United States Department of the Interior National Park Service National Register of Historic Places Registration Form

historic name Chadbourn Spanish Gospel Mission

**National Register of Historic Places
Continuation Sheet****United States Department of the Interior
National Park Service**Chadbourn Spanish Gospel Mission
El Paso County/ ColoradoSection number 7 Page 1**DESCRIPTION**

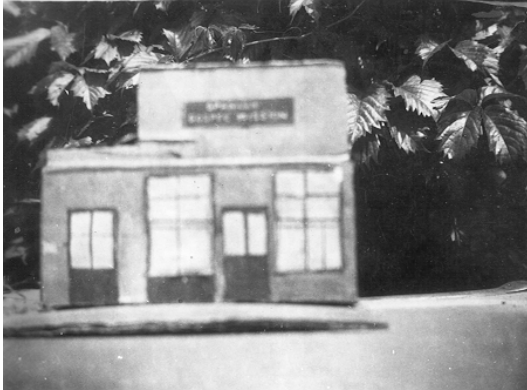
H1. Model of building created c.1939 showing east elevation with original storefront.

In 1939 the owners undertook an ambitious renovation project in order to change the appearance of the building to that of a Spanish Mission. Two small models were made of the existing commercial storefront and the proposed Mission Revival style building (Photos H1-H3). The models were displayed in various downtown store windows in order raise money for the project. The Advisory Committee provided the majority of the funding for the renovation while volunteer laborers from the community carried out the work. Raymond C. Whitlock, a local builder, served as the supervisor. The project involved adding a Spanish style square bell tower to the northeast corner, enlarging the south addition, adding a curvilinear parapet, reducing the size of the storefront windows on the façade, and covering the wood clapboard walls with stucco. Many of the project's building materials were reused from a project at the First United Methodist Church recently completed by Raymond C. Whitlock, including a number of stained glass window panels that were placed in the Mission's new windows. The Advisory Committee held a dedication ceremony upon the completion of the project on April 25, 1940. A *Gazette* article announced, "Remodeling of the Chadbourn Mission has been completed and a splendid building is now in use by the Spanish speaking people" (To Dedicate, 1940). The renovation asserted the building's function with great clarity and was executed in a style that represented the heritage of the surrounding community.

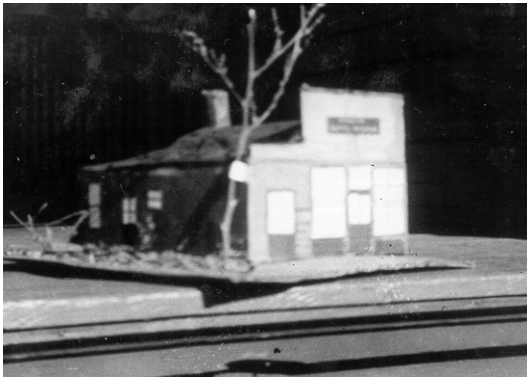
H2. Model of original building created c.1939 showing south elevation.

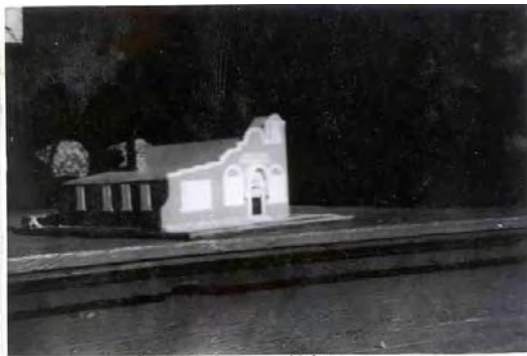
H3. Model created c.1939 showing proposed "Spanish Mission" design for building.

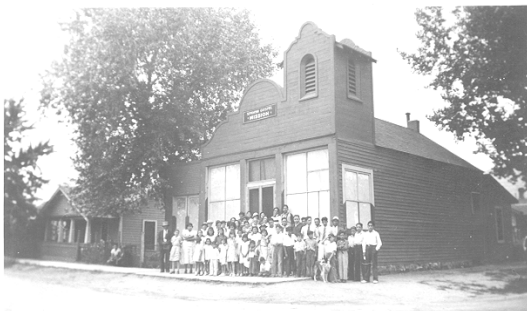
H4. c.1939 photo showing partial completion of renovation project, including the bell tower and curvilinear parapet.
