United States Department of the Interior
National Park Service
**National Register of Historic Places
Registration Form**

historic name MILNER-SCHWARZ HOUSE
other names/site number 5LR.6744

street & number 710 SOUTH RAILROAD AVENUE
city or town LOVELAND
state COLORADO code CO county LARIMER code 069 zip code 80537

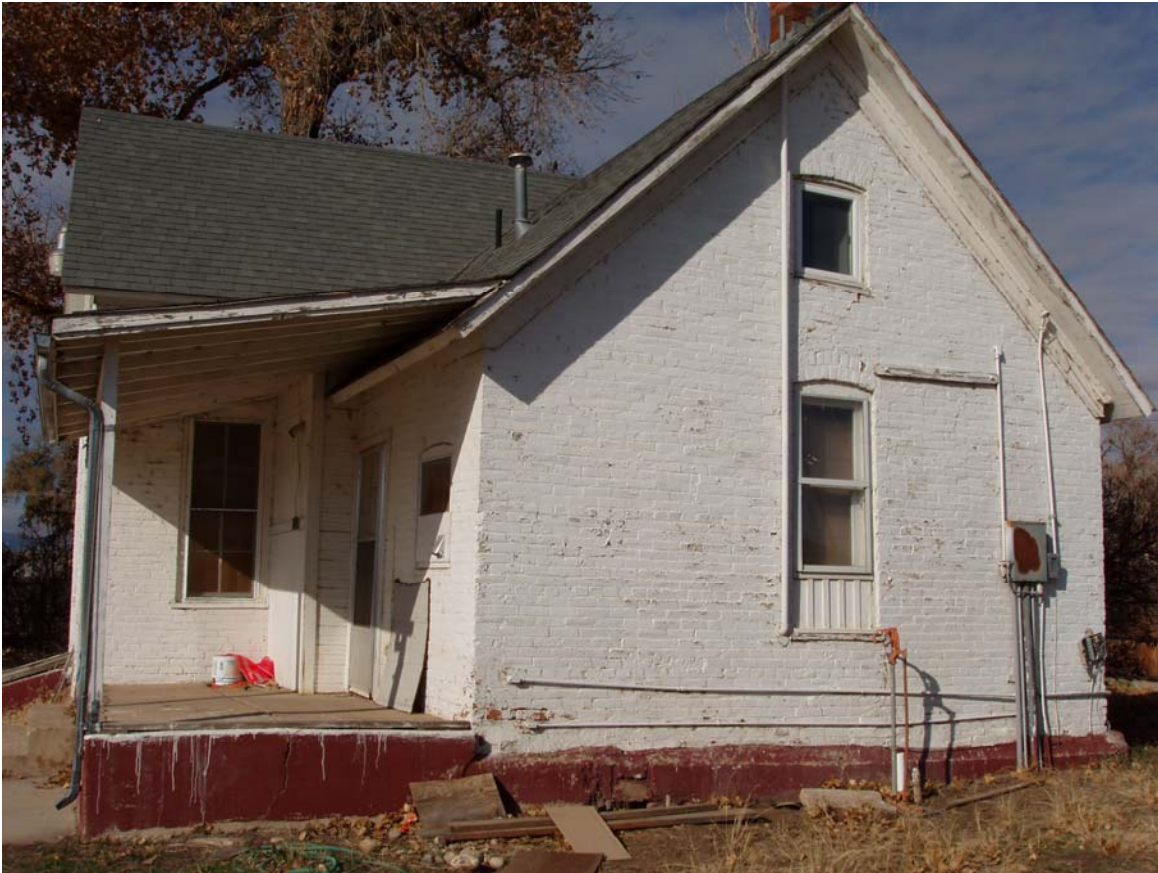
Fig. 8 2009 Northeast Façade, prior to restoration

The upper story of the northeast façade of the kitchen wing includes a four-light in-swinging casement window. The lower level of the kitchen portion features a four-over-four double-hung sash window with painted wood frames and surrounds with a double rowlock segmental brick arch header. The main section of the house is set back from the kitchen wing and also features a four-over-four double-hung sash window with a double rowlock segmental brick arch header. A utility panel box is mounted on the western end of the northeast façade and an

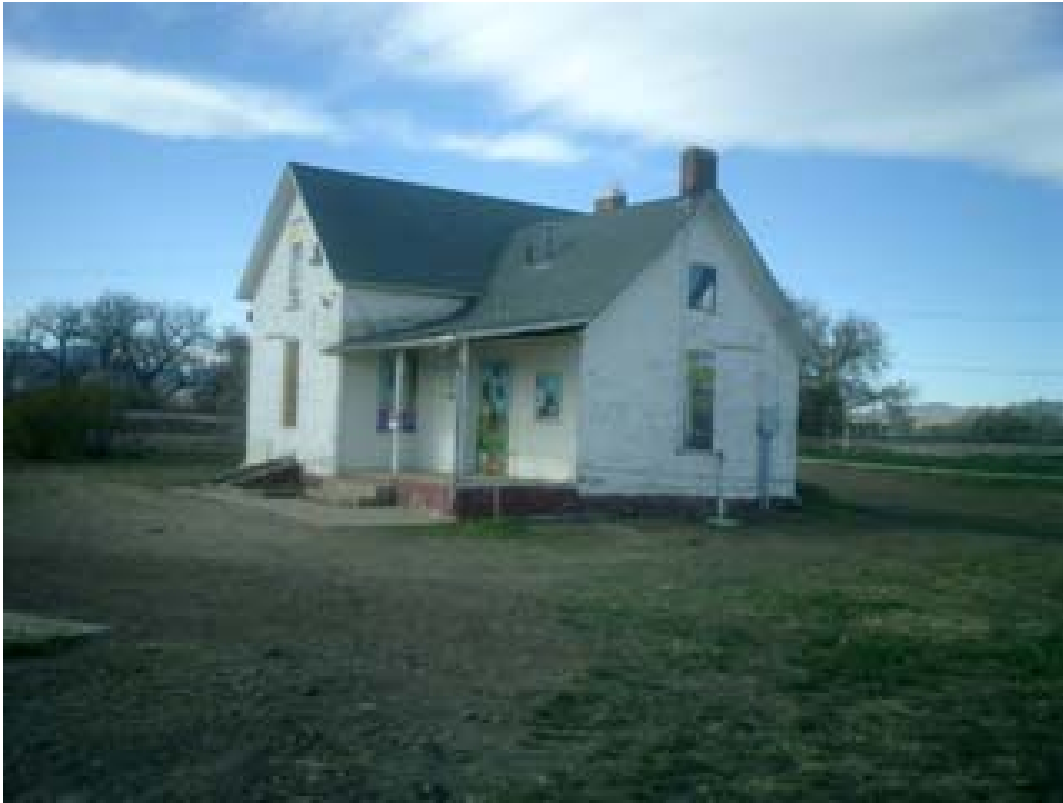
Fig. 10 2009 Northeast-facing side, prior to restoration

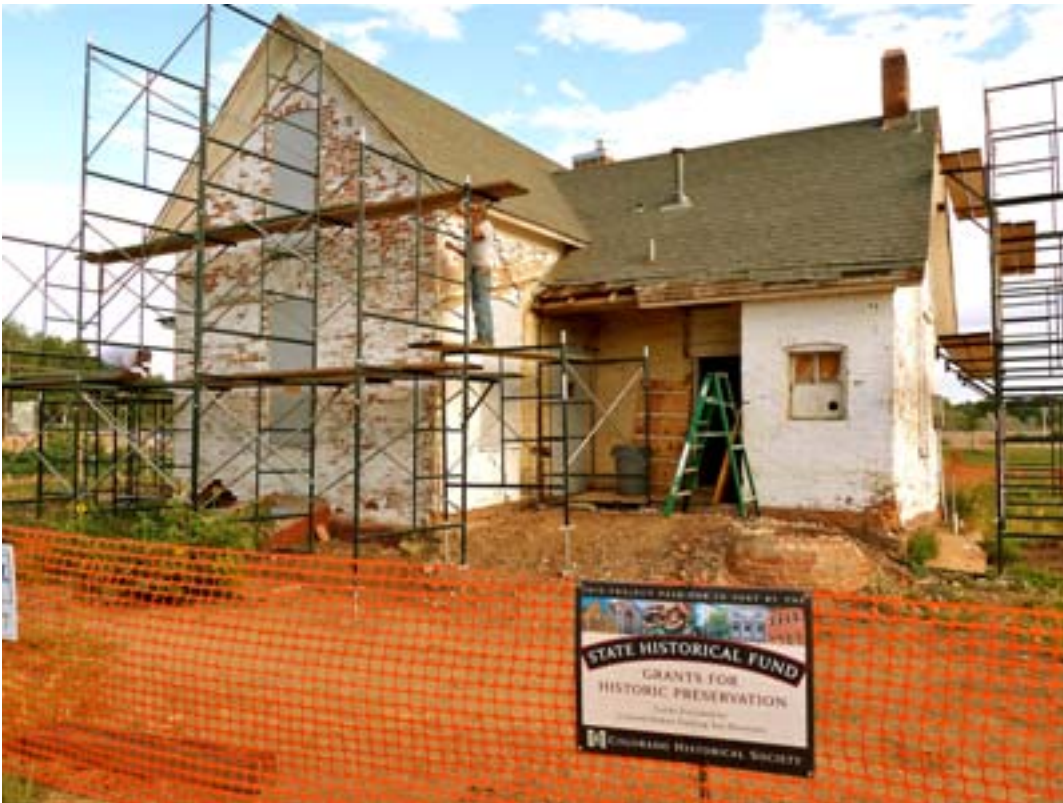
Fig. 11 2010 Southeast Façade, during restoration

Using Colorado State Historical Fund (SHF) grant assistance, the Milner-Schwarz House underwent significant rehabilitation and restoration from 2010-2012. The foundation was repaired and a new perimeter drainage system was installed. A non-historic rear porch, along with the rear enclosure including the bathroom was demolished and a new rear porch floor deck, step and concrete were installed. The front porch was repaired and restored, and missing elements were reconstructed using historic photographs and the historic balusters and spindles available. The exterior paint was removed; the brick masonry was repointed and a new coat of paint was applied. The wood fascias and box soffits were also repaired and restored. The original wood windows were repaired and five non-historic wood windows were replaced with wood windows in the same configuration as the original wood windows found elsewhere. Storm windows were also added to the windows to prevent vandalism. The original wood doors were repaired and non-historic doors replaced. New galvanized sheet metal gutters and downspouts were also installed.

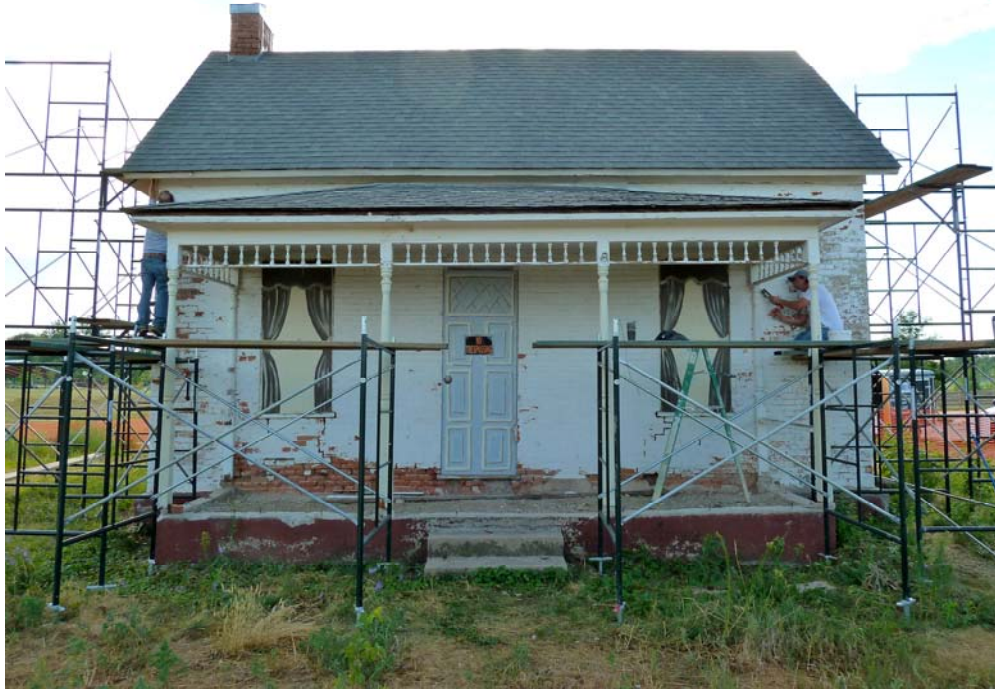
Fig. 12 2010 Southwest Façade, during restoration

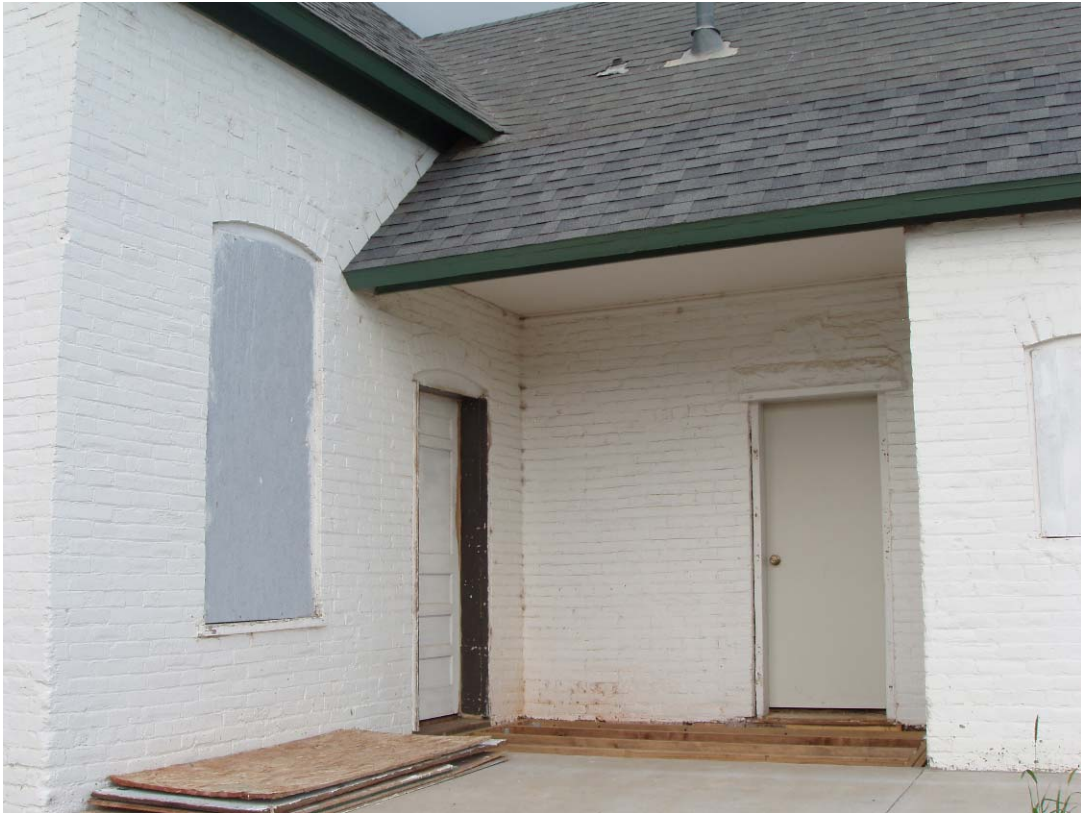
Fig. 14 2011 Southeast Porch, during restoration

The southeast façade of the house features a rear porch. The porch is substantially concrete with a small portion at the entry consisting of wood plank floor. The gabled roof extends over the wood entry portion. Two small concrete steps provide access to the rear porch. Domestic water for the home was historically contained in an underground cistern that remains in place and is now enclosed in the concrete rear porch. The opening is still visible and is covered by a wood lid. An off-center door leads into the kitchen wing; originally exposed to the exterior, this door had been enclosed by the addition of a bathroom and entry space. Recent restoration work removed this enclosure and re-exposed the door. The masonry opening is unique due to its rough-cut sandstone lintel. Due to the poorer quality of the brick masonry workmanship above this opening, it appears likely it was not an original component to the building and was reconstructed later. To the right of the rear porch door, an area that may have historically served as dry storage features a four-light in-swinging casement unit with a double rowlock segmental brick arch header. On the main section of the house, the upper and lower levels each feature one four-over-four double-hung sash window with double rowlock segmental brick arch header centrally aligned. Between the upper and lower windows the upper floor reinforcement can be seen with a small wood panel bolted to the masonry. The cellar/crawlspace is accessed by an opening with retaining walls and three concrete steps covered by a solid panel of wood, bolted to the retaining walls.

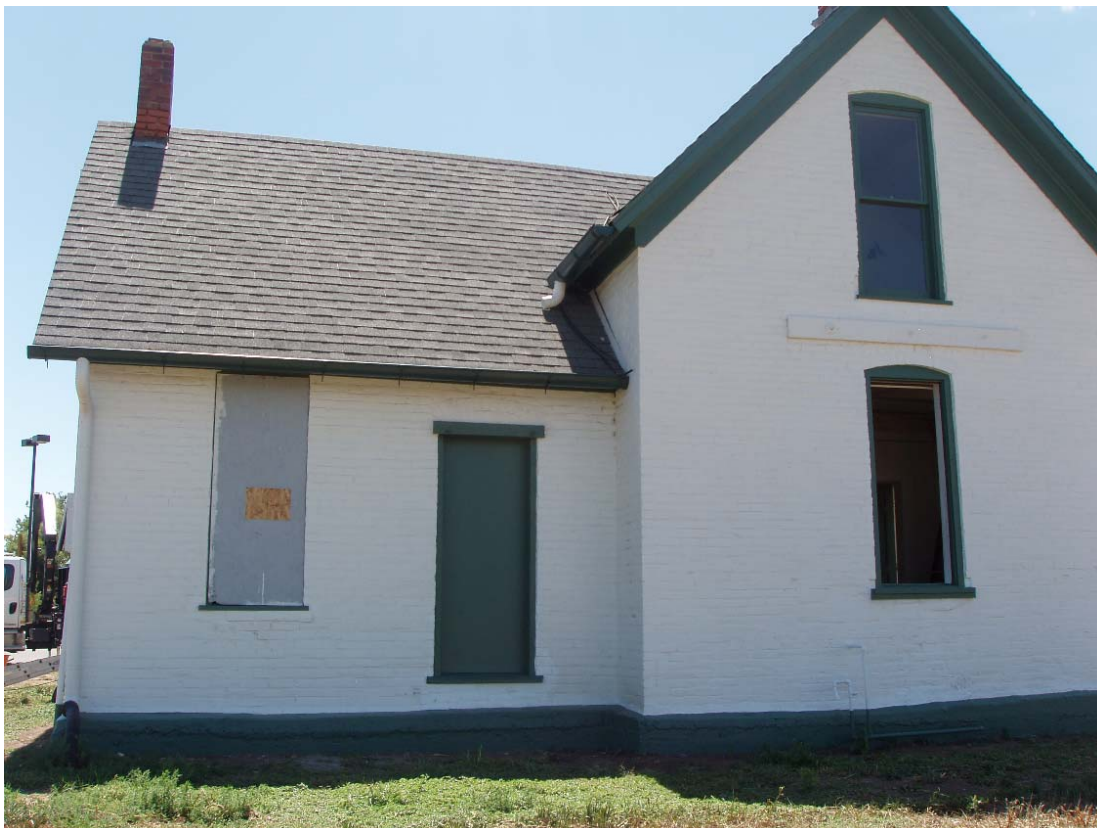
Fig. 15 2011 Northwest-facing side, during restoration

This side features the rear wing kitchen set back from the main portion of the house. The upper story of the main portion features a one-over-one double-hung sash window with painted wood frames and surrounds and a single rowlock segmental brick arch header. Directly below the upper story window is a four-over-four double-hung sash window with painted wood frames and surrounds with a double rowlock segmental brick arch header. Between the upper and lower window is an extension of inner wall blocking to support the flooring at the upper level. It is believed that this was necessary because the framing as constructed at the chimney flues failed at some point. Because the roof top chimneys are directly above the windows, the chimney flue would have had to come up beside the window. These reinforcements are seen on the walls that have a rooftop chimney. Reinforcement can also be seen on the southeast wall; interior evidence shows that a rooftop chimney in this location likely existed historically. On the kitchen wing there is a four-over-four double-hung sash window with painted wood frame and surrounds and a non-historic solid wood four-panel door with painted trim beneath a double rowlock segmental brick arch header. This door sits at least 1' above grade and likely had steps leading out onto the now landscaped grounds.

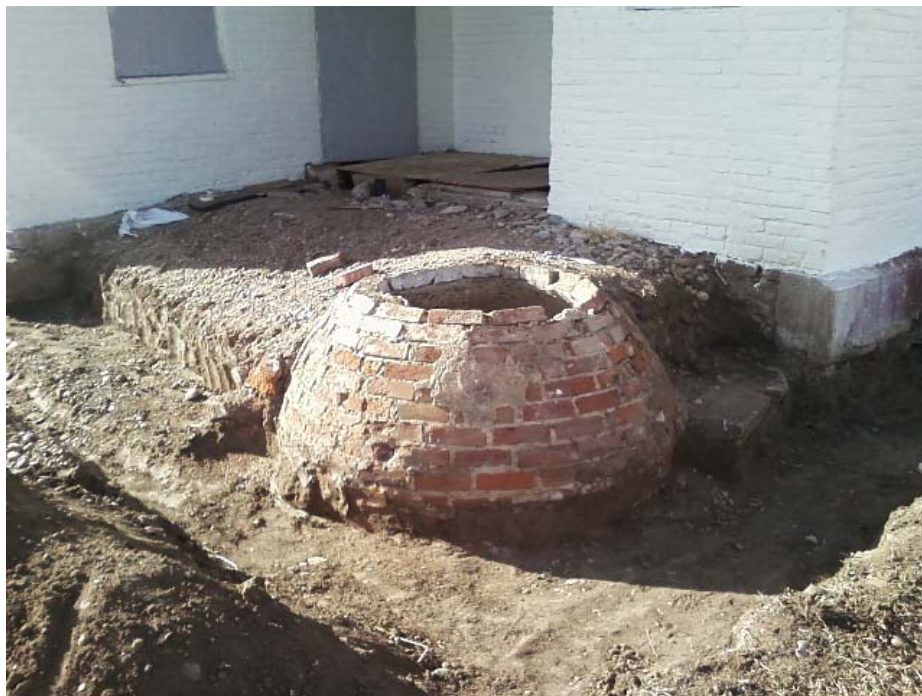
Fig. 17 2011 Cistern Uncovered (Northeast -facing side), during restoration

During the restoration and rehabilitation project, an archaeologist conducted an on-site survey and discovered the house cistern. However, no other archaeological resources were found. All of the restoration and rehabilitation work completed under the guidance of the Colorado State Historical Fund and by the LHS and was in accordance with the Secretary of Interior's Standards for the Treatment of Historic Properties.

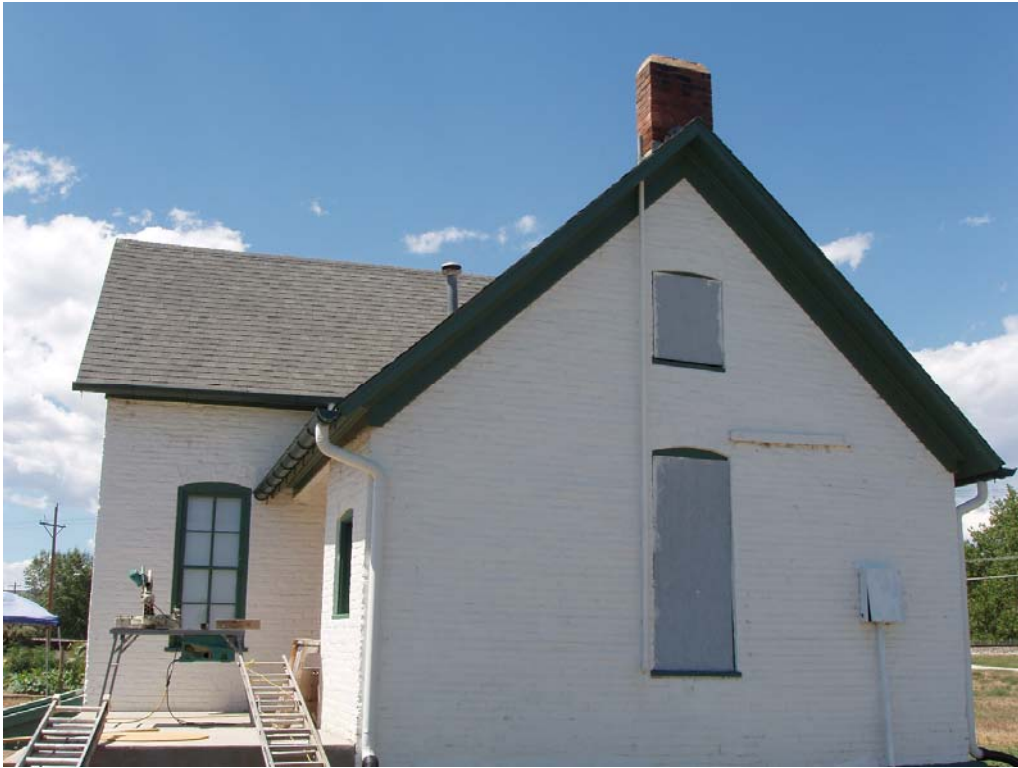
Fig. 18 2011 Northwest-facing side, during restoration

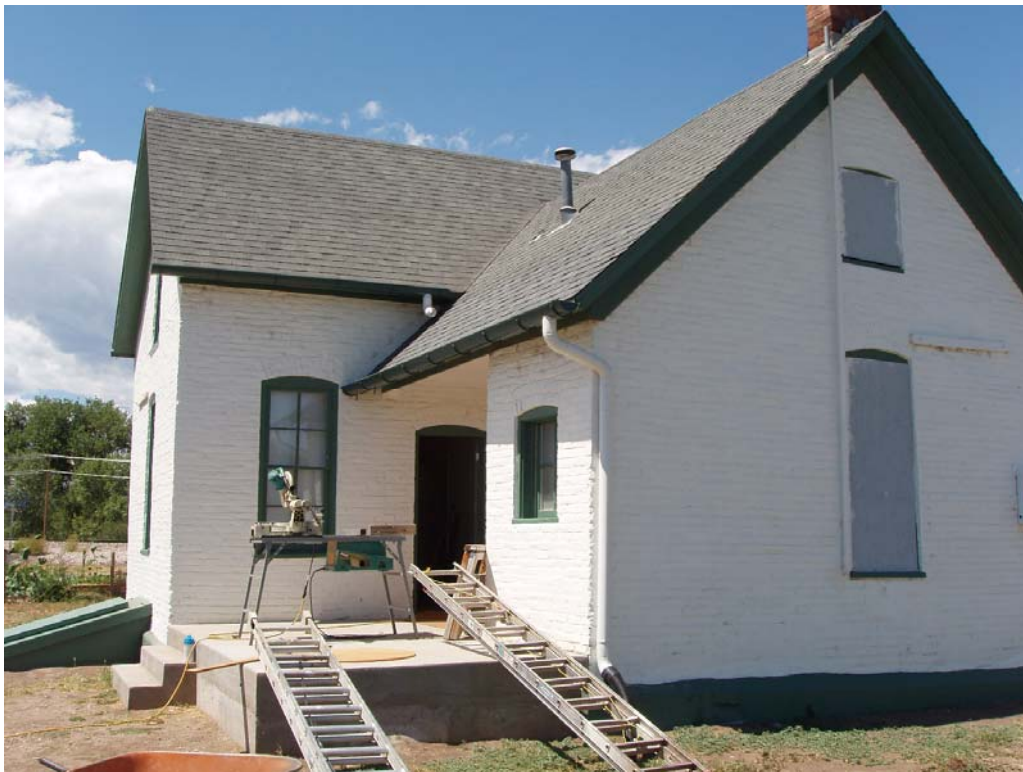
Fig. 19 2011 Northwest-facing side, during restoration
