National Register of Historic Places Registration Form

Historic name: Emerick, Charles, House

Street & number: 1211 Nevada Avenue

City or town: Trinidad State: CO County: Las Animas

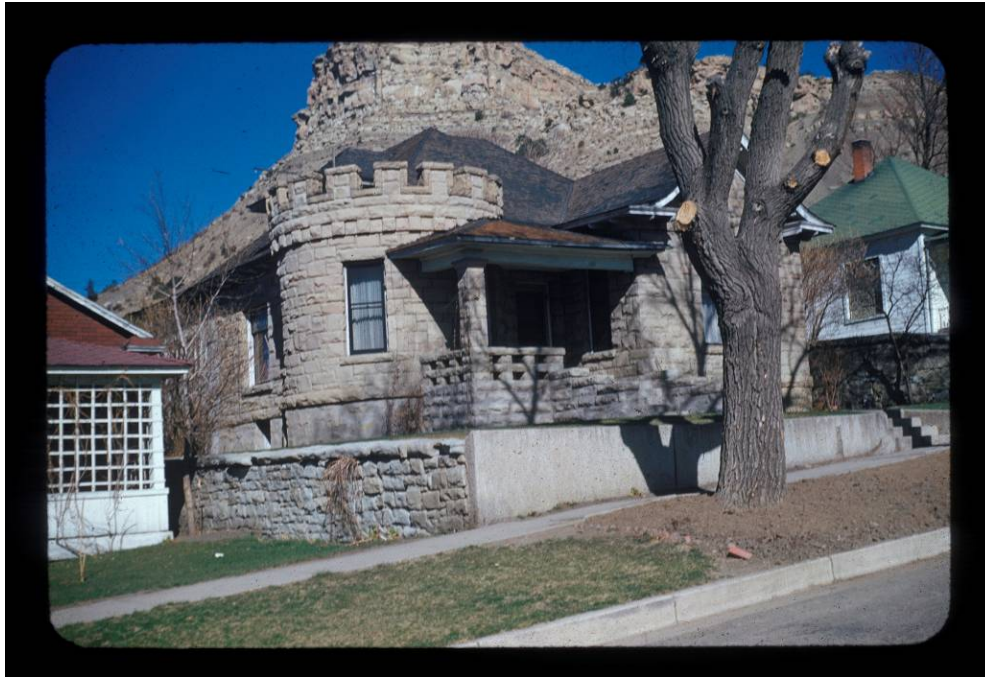
Fig 7 – Charles Emerick House, circa 1950

East (main) façade (Photos 2-3, 7-8, & Figure 7)

extends along the entire width of the property (see Sketch Plan and Photos 3, 4, 5, 6 and Figure 7). Additionally, matching stone retaining walls run along the south and north property lines beginning at the set back of the house and continuing west until they reach the carriage house on the north side and nearly to the west property line on the south side. The house faces east with the escarpment of Simpson's Rest dominating the background towards the northwest (Photo 2 and Figure 7). Of particular note is that the house is not centered on the property. The building's north side is approximately 5' from the retaining wall. The south side of the building is 13' from the top of the south retaining wall. The carriage house-garage, which measures 19' x 32', is located at the northwest corner of the property. Curiously, the building encroaches into the alley by 6'-6". Historically, many of the buildings on the west side, for several of blocks in Taylor and Robinson's Addition, also encroached into the alley. A newer wooden picket fence exists along the front and sides of the property. Historic lilacs line the south border of the yard and two Chinese elm trees, approximately 30 years old, now grow in the grassy area near the curb.

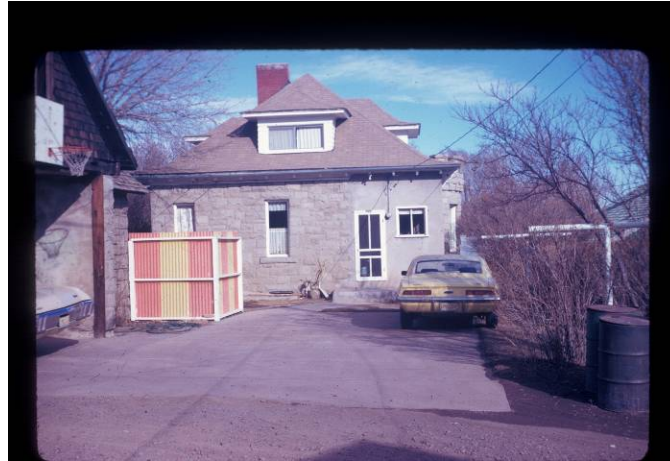
Fig 11 – West-facing (rear) of house after resurfacing of backyard with concrete, 1967.

After the current owner purchased the property he constructed a wooden picket fence, which is located along the front and sides of the house. Sometime between circa 1952 and 1967, a concrete slab (Figure 11) replaced the soil and grass at the back of the house. Between 2009 and 2012, the owner built a series of trellises, an open gazebo and a gable covered carport on the concrete slab (Photo 11).

The owner replaced the dormer window on the west-facing side with a slider prior to 1967; the south-facing dormer window has also been replaced. However, the north-facing dormer window is original. A window on the north-facing side of the main level was removed and covered with concrete near the northeast corner. It is not known when replacement of the window took place, but it appears that it has been that way for several decades. Originally, the narrow windows in the tower were one-over-one single-hung windows. However, due to deterioration, the current owner replaced these with fixed windows using the same window opening. This was completed in the last five years. Also, between 1952 and 1967, a small open porch at the back of the house, on the southeast side, was enclosed (Figure 11). It was clad in stucco with an opening for a door and window on the west side and two double windows on the south side (Photo 10, and Figure 11). The space is now used as a mudroom with an entrance into the kitchen.

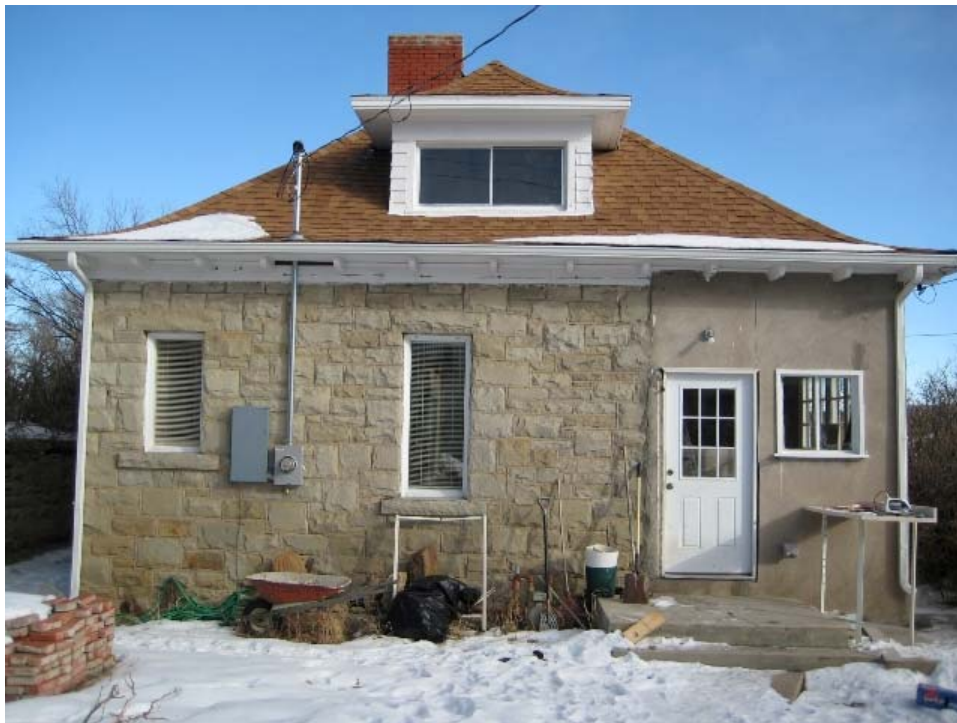
Fig 15 - West side of house. Camera pointing east. Photo by Fritz Augustin, 2008.

The west-facing (rear) side has two narrow windows, one near the center and one to the north. The once open porch on the southwestern portion of the house has been enclosed and contains the back door and a slider window to the south of the door. Inside are the original door to the basement and a door into the kitchen. The enclosed porch is now used as a mudroom. Located on the hipped roof is a hipped roof dormer with one sliding window. It is clad in the same material as the other dormers.

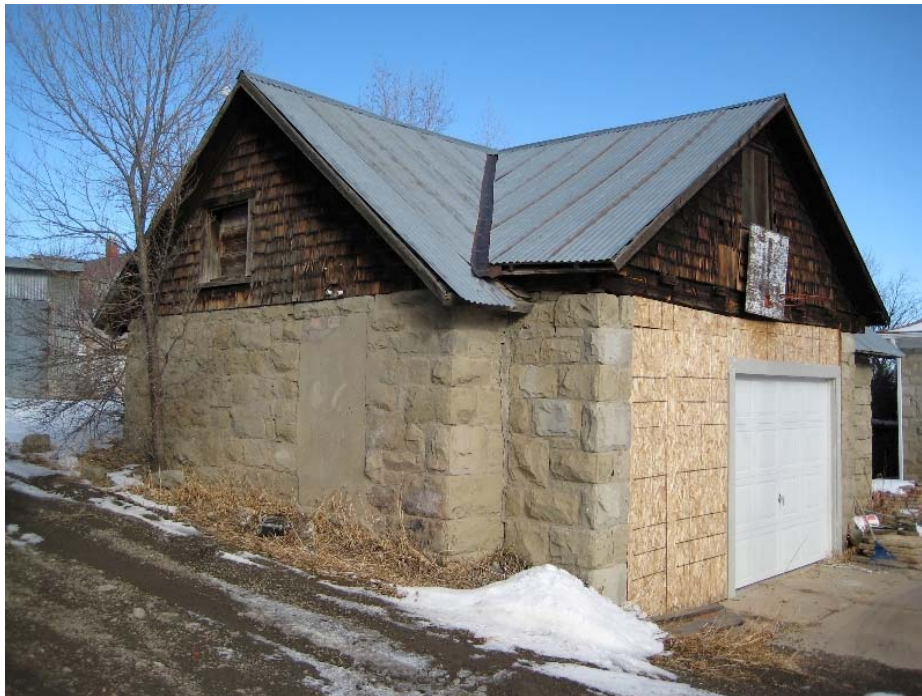
Fig 17 - West and south side of garage. Camera pointing northeast.
Photo by Fritz Augustin, 2008.

A previous owner modified and decreased the garage door/carriage entrance opening at an unknown date (see Figure 17). Because of the area's deterioration the current owner replaced the portion that had been boarded up with new wood siding. He also had a new garage door installed to replace the previous one, which was an accordion style door that was falling apart. The current owner replaced the rotted shingles that were above the garage door in the gable end with new shingles in kind and a new vent was put in place of the old one. Galvanized metal roofing replaced the old rough-cut shingles circa 1960 (Photos 13, 16, 17, and Figure 10). Sometime in the years past a window on the building's west-facing side was removed and

covered with concrete (Figure 17) and the same was done for a window on the north-facing side; both of these changes appear to have occurred several decades ago. The building and its attic are now used for storage. At various places, where needed, the current owner repointed the sandstone pieces.
