United States Department of the Interior National Park Service National Register of Historic Places Registration Form

historic name Steamboat Laundry Building

**National Register of Historic Places
Continuation Sheet****United States Department of the Interior
National Park Service**Steamboat Laundry Building
Routt County, ColoradoSection number 7 Page 1**DESCRIPTION**

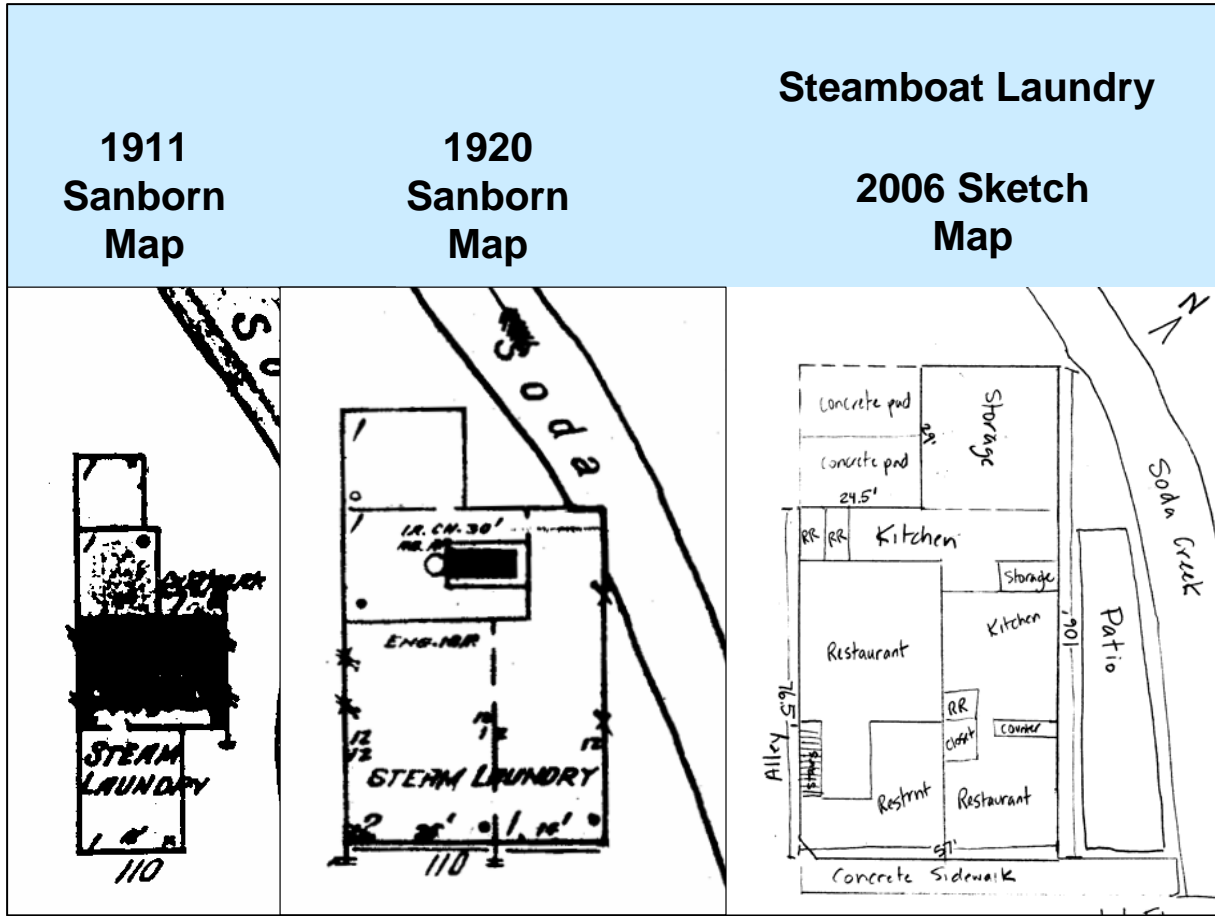
The drawings above are all to approximately the same scale and show the evolution of the building from 1911 through 2006.
